Mayslake Peabody Estate
Forest Preserve District of DuPage County

Master Plan Report

November 1, 2024

Facility Condition Assessment Report

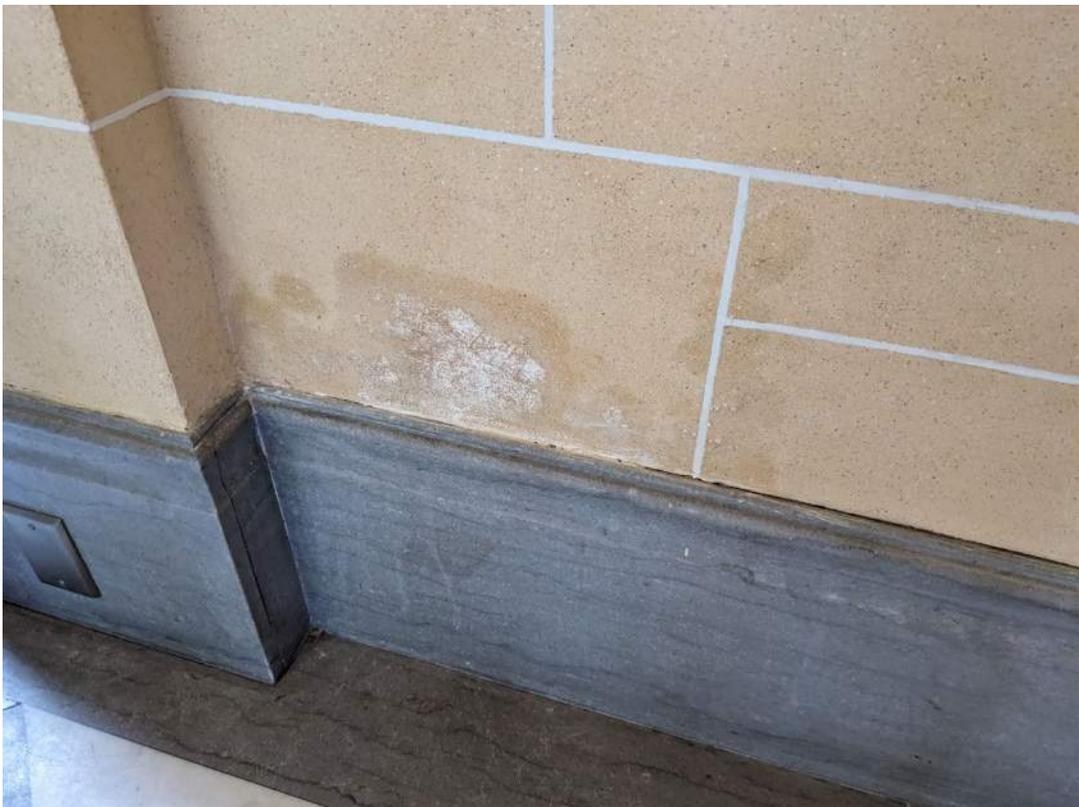
Figure 2 Mansion. Plaster damage in Solarium.

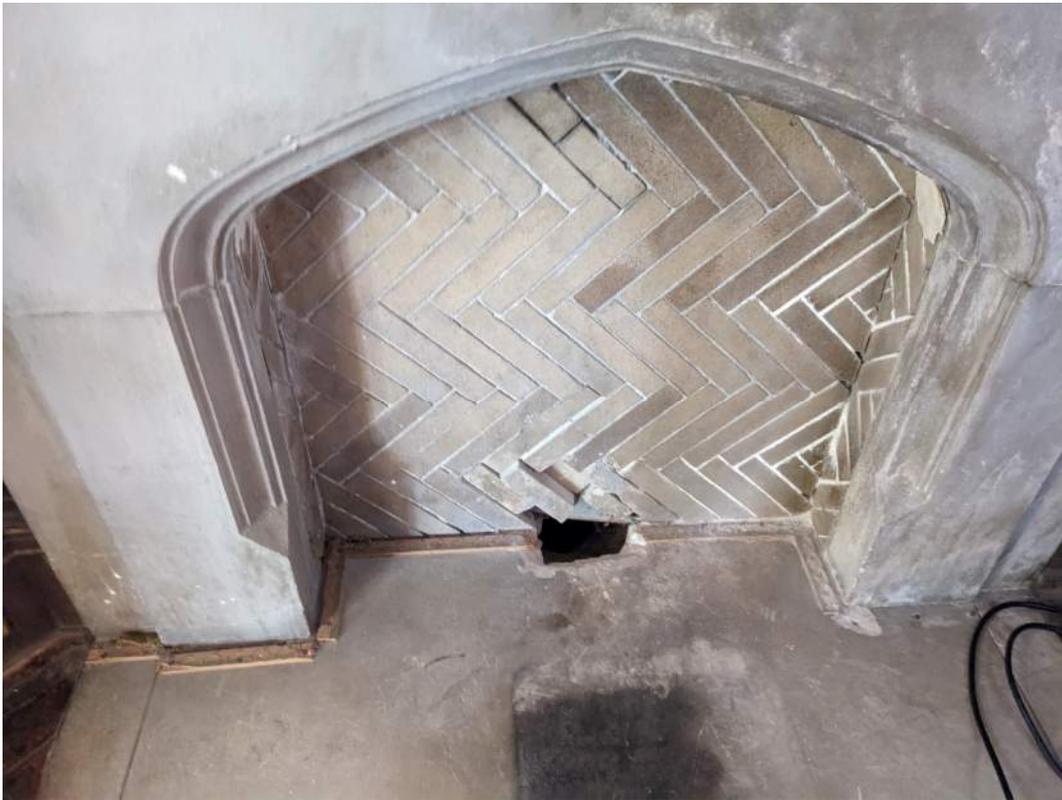
Figure 3 Mansion. Loose tiles in Study fireplace.

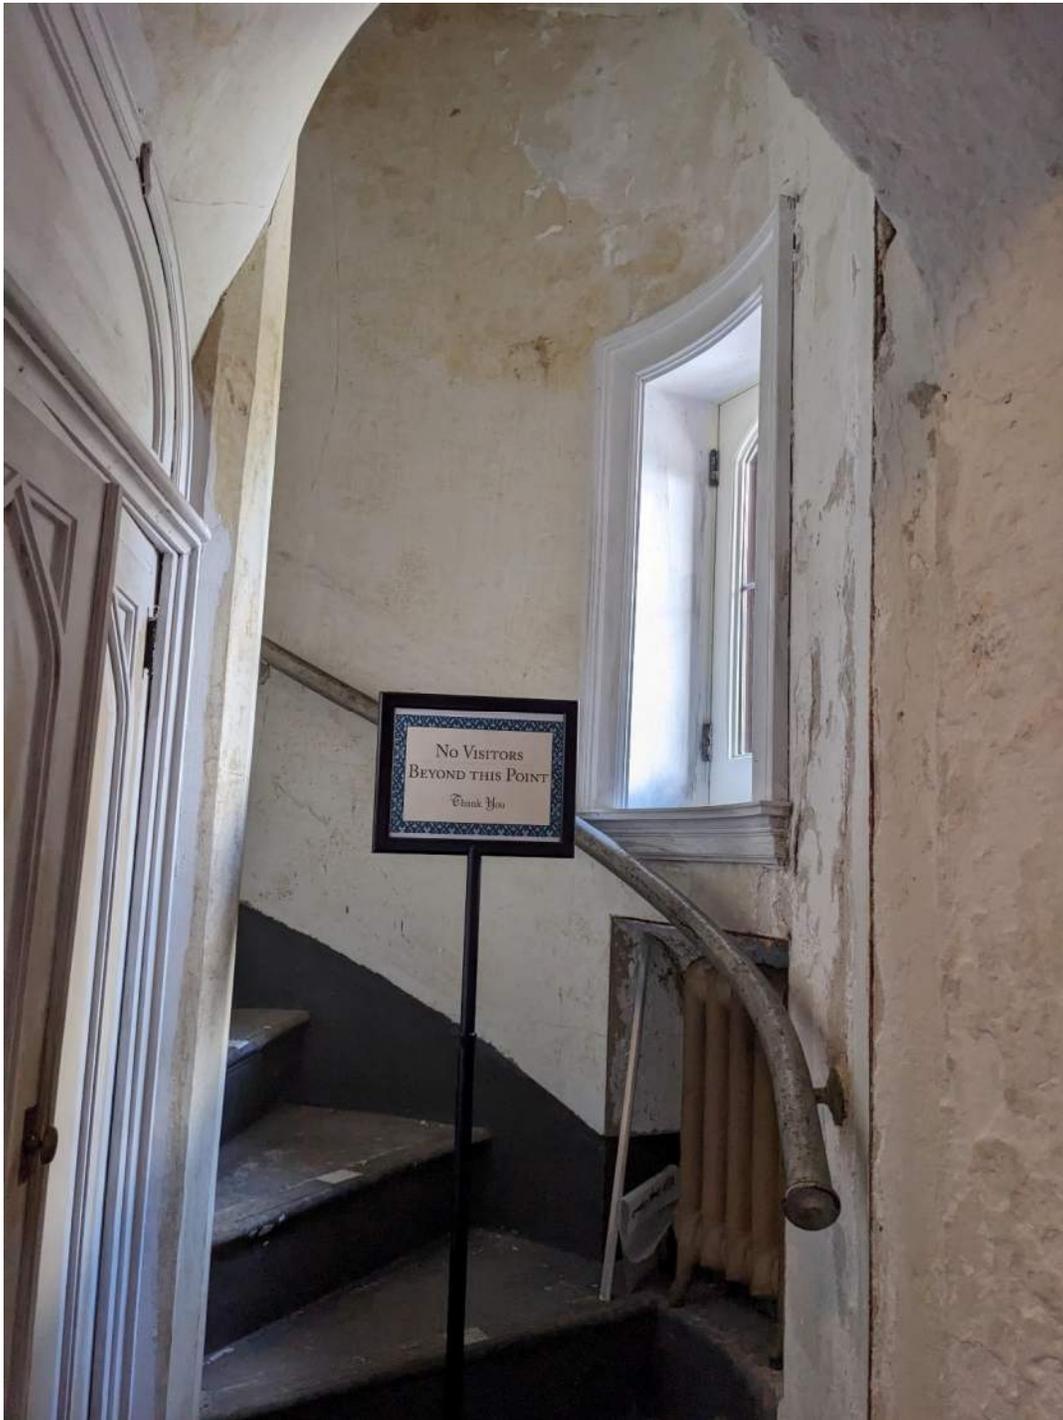
Figure 7 Mansion. Deteriorated plaster in circular stair.

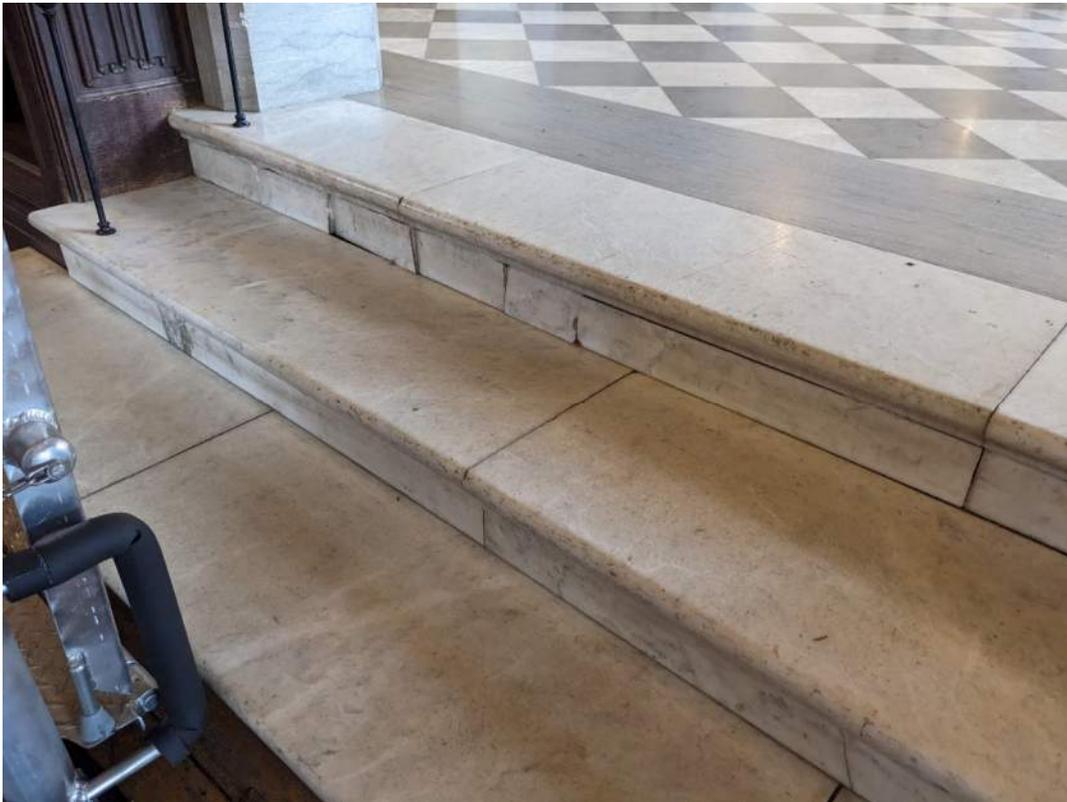
Figure 8 Mansion. Damaged marble riser between Library and Living Room.

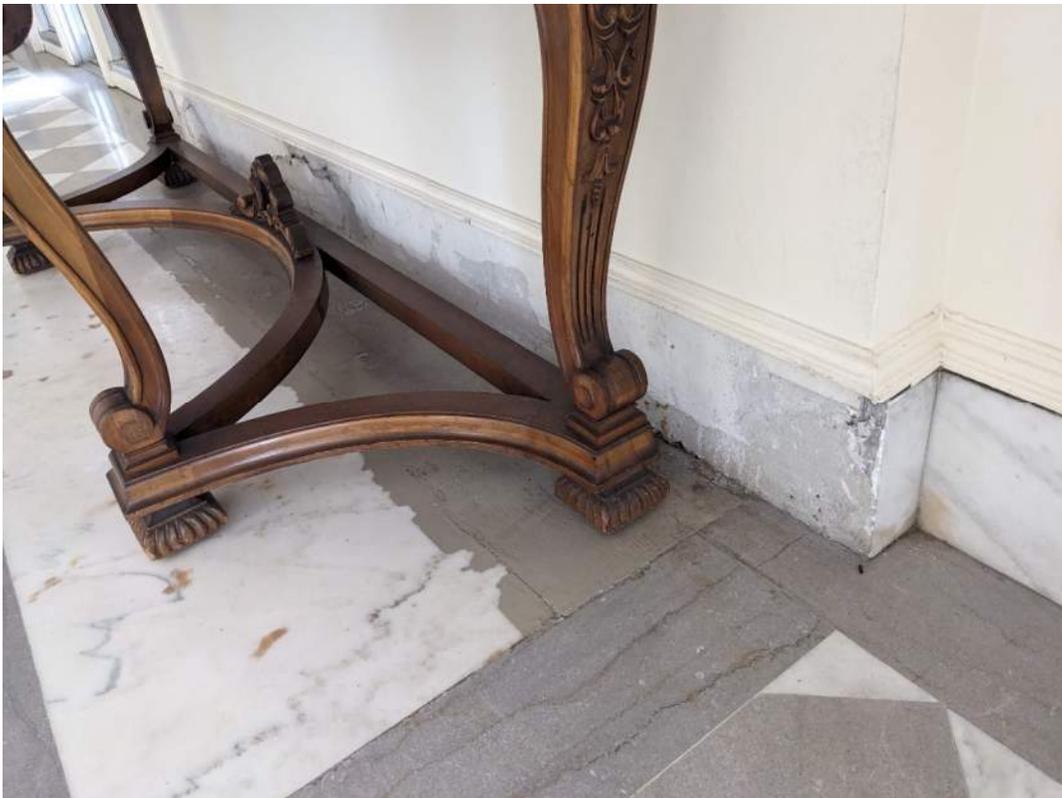
Figure 11 Mansion. Missing marble base in Dining Room.

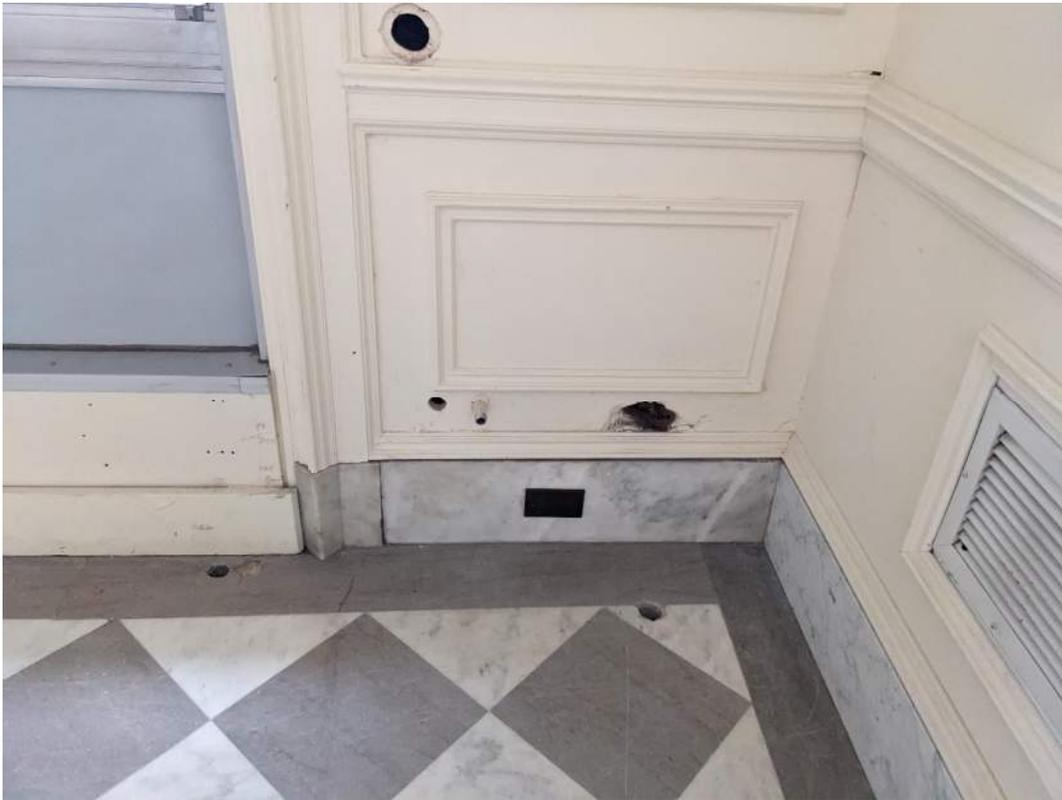
Figure 12 Mansion. Damaged wood wainscot in Dining Room.

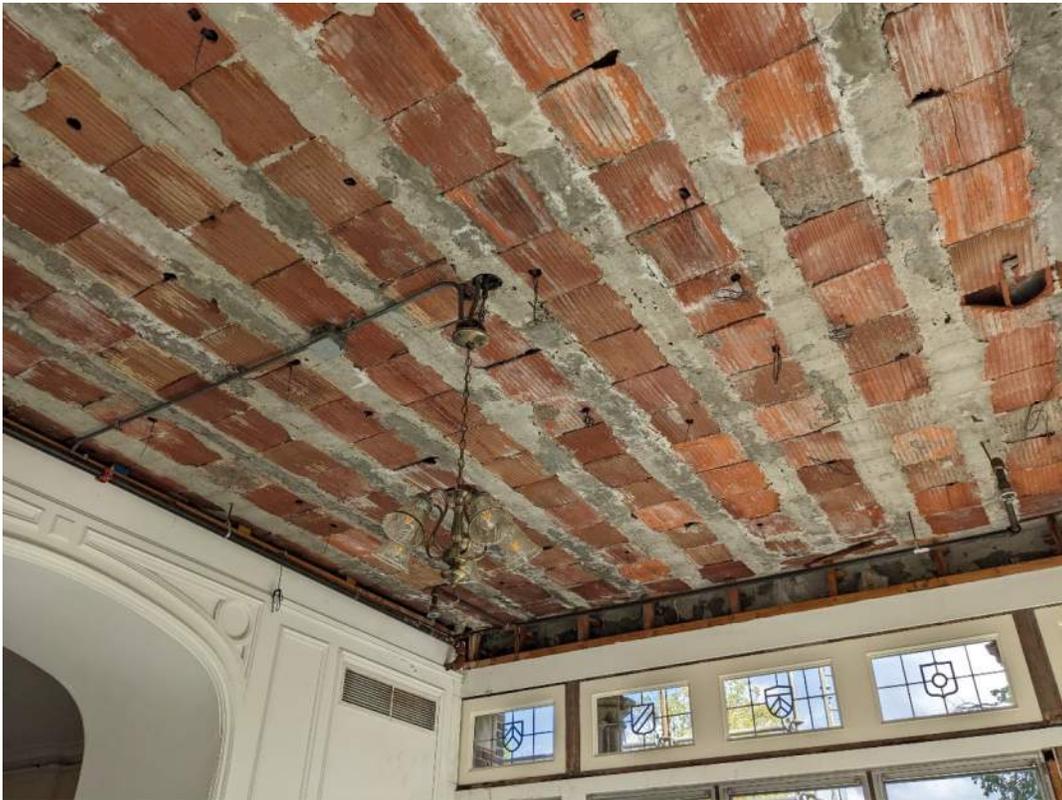
Figure 14 Mansion. Missing finish ceiling in Breakfast Porch.

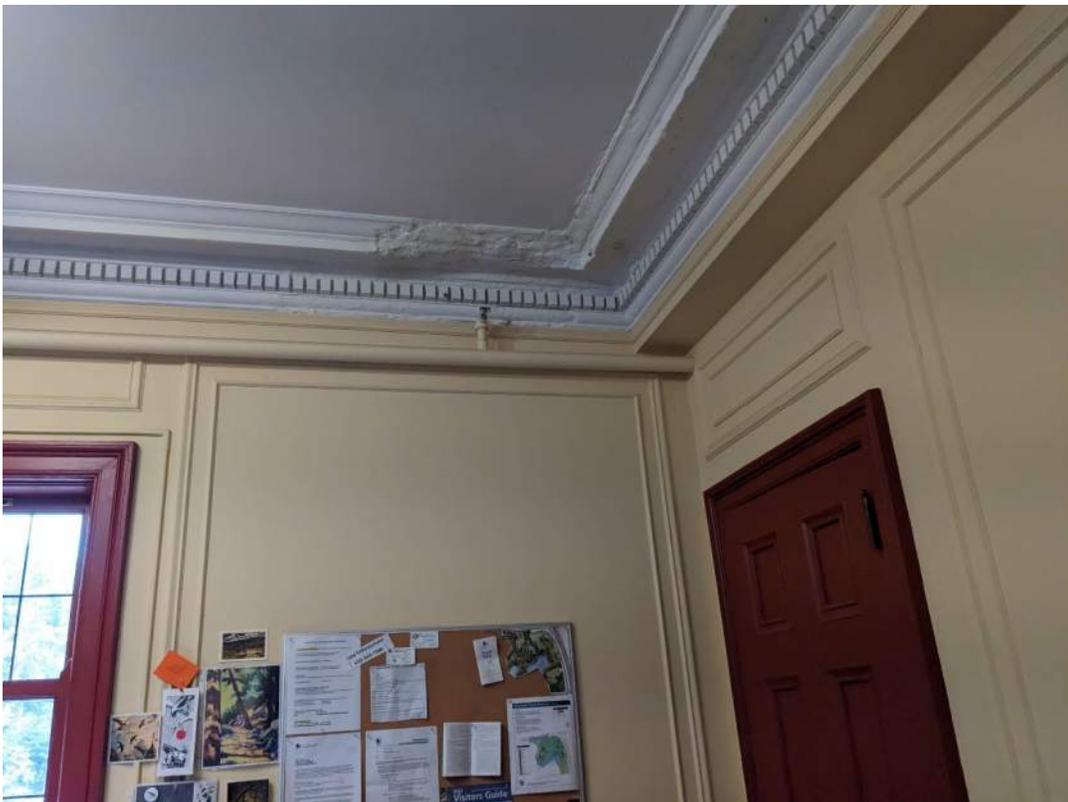
Figure 17 Mansion. Plaster deterioration in the Reception Room, east wall.

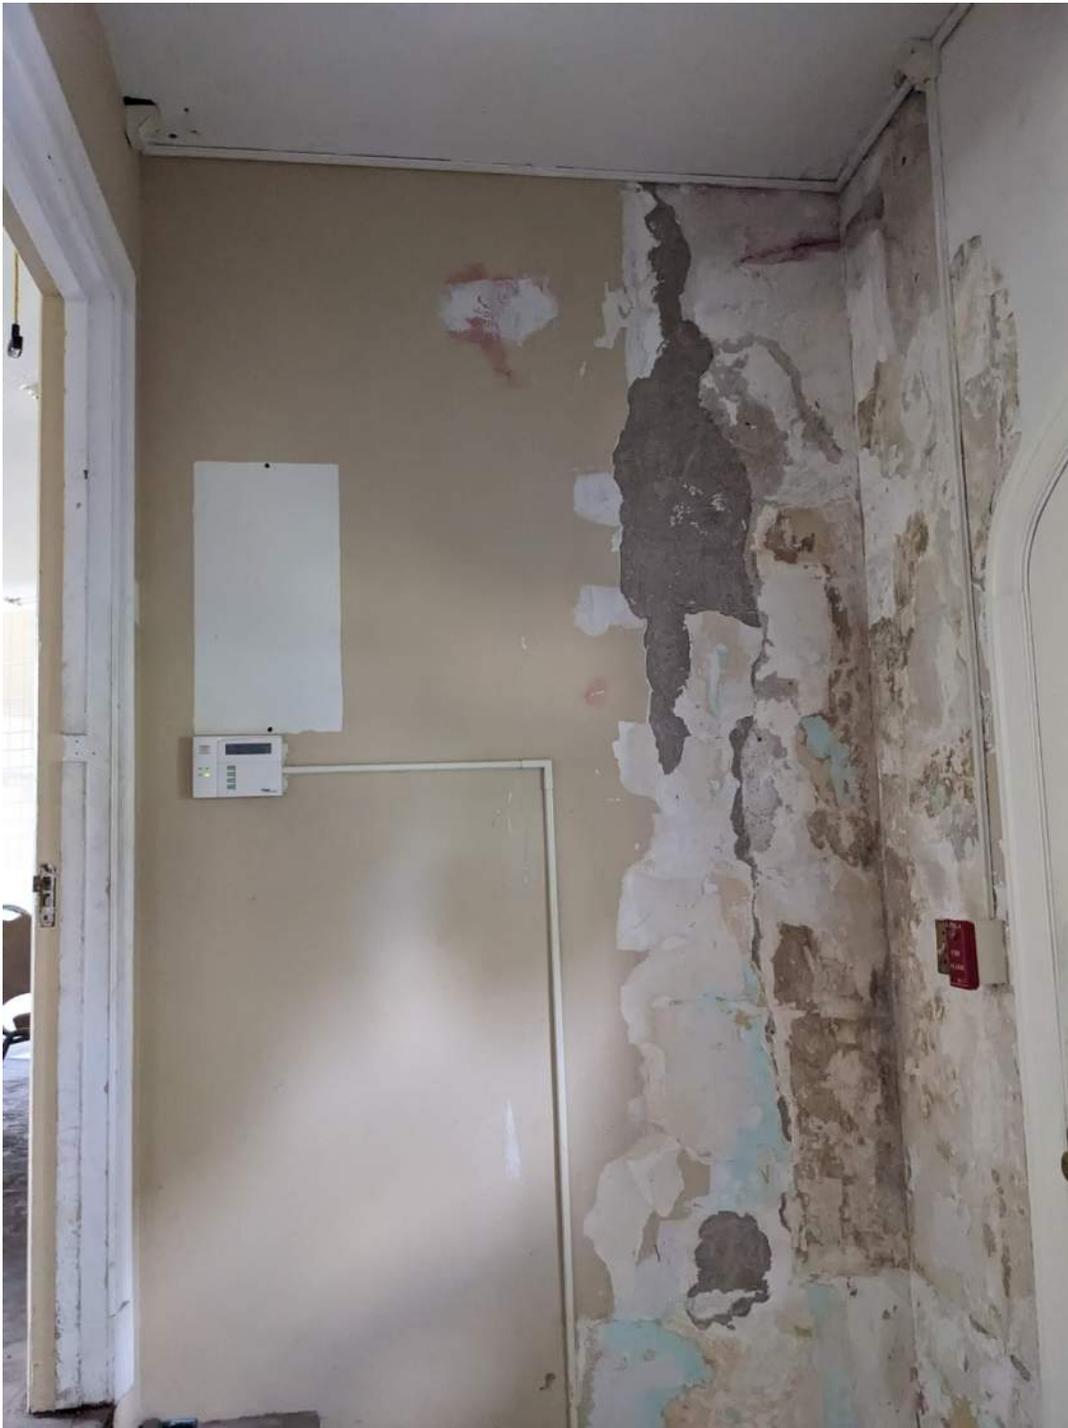
Figure 20 Plaster damage in Servant's Entry.

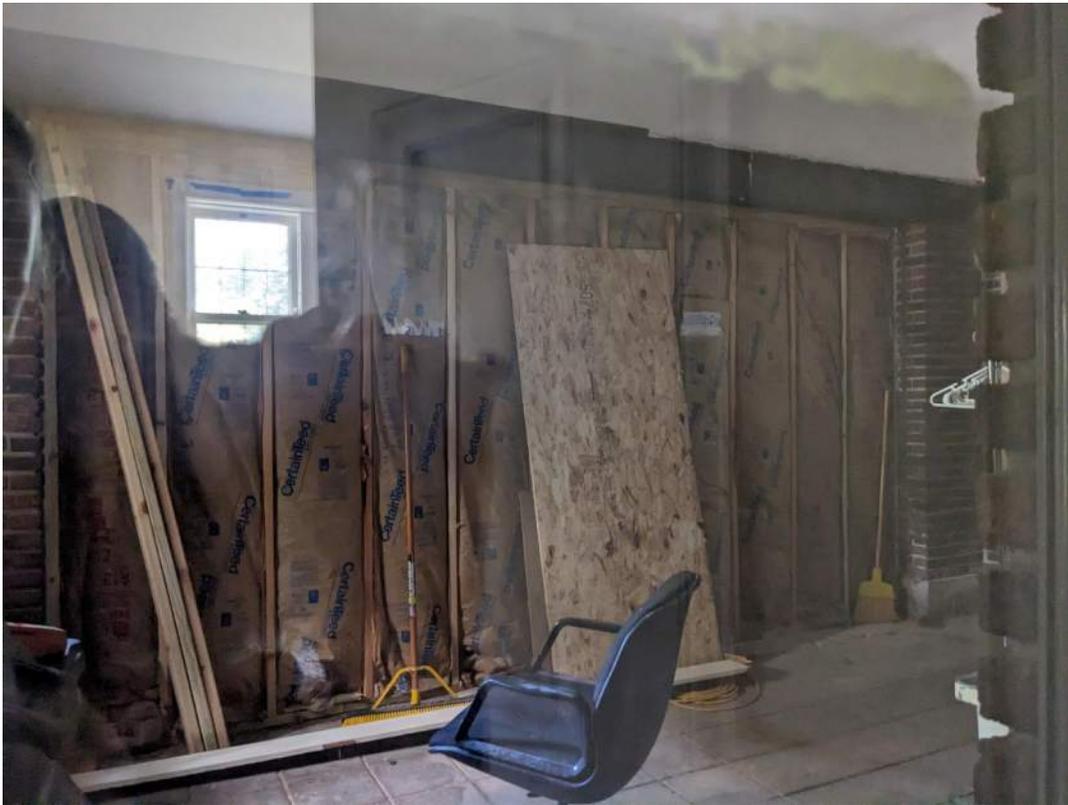
Figure 23 Mansion Service Wing. Porch with missing finishes.

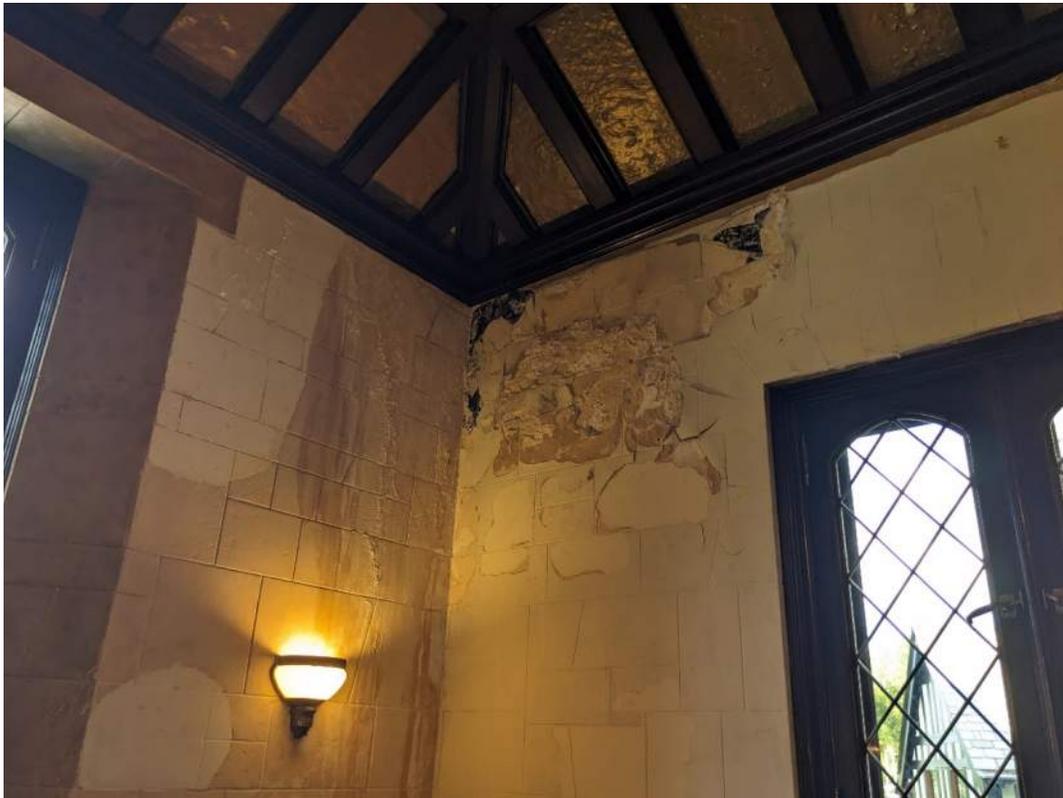
Figure 24 Mansion. Plaster damage on Entry Hall landing.

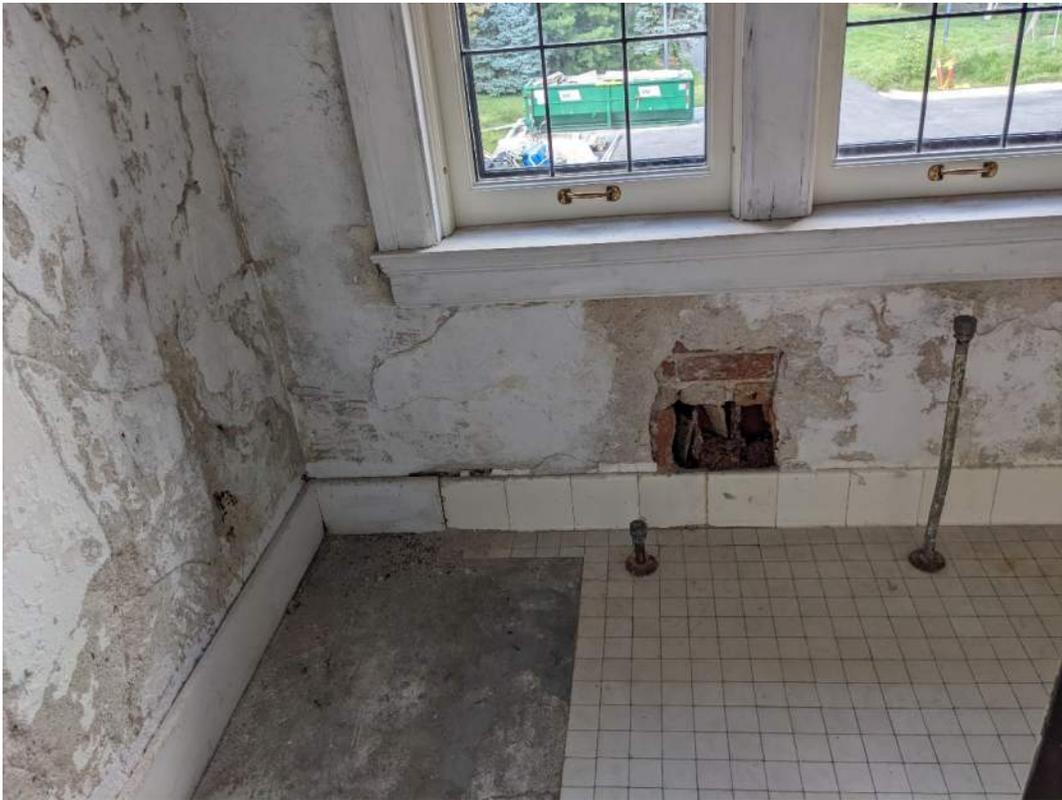
Figure 35 Mansion. Plaster damage in Flower Closet. Damaged masonry.

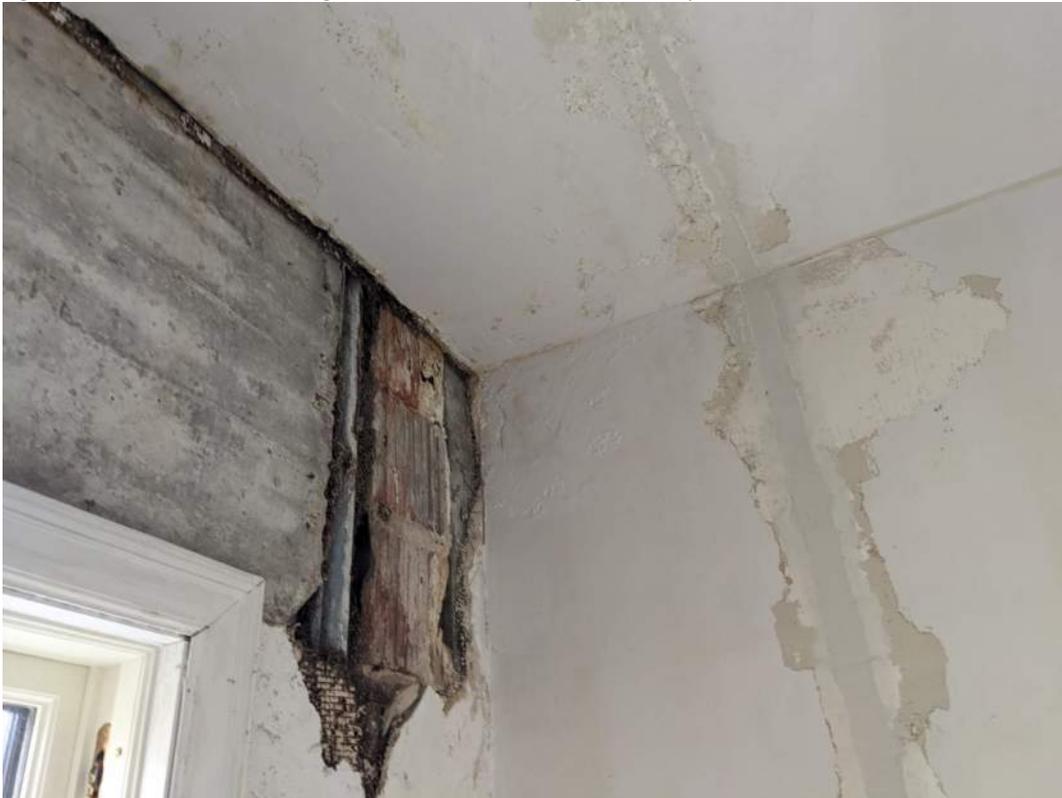
Figure 36 Mansion. Plaster damage in Flower Closet.

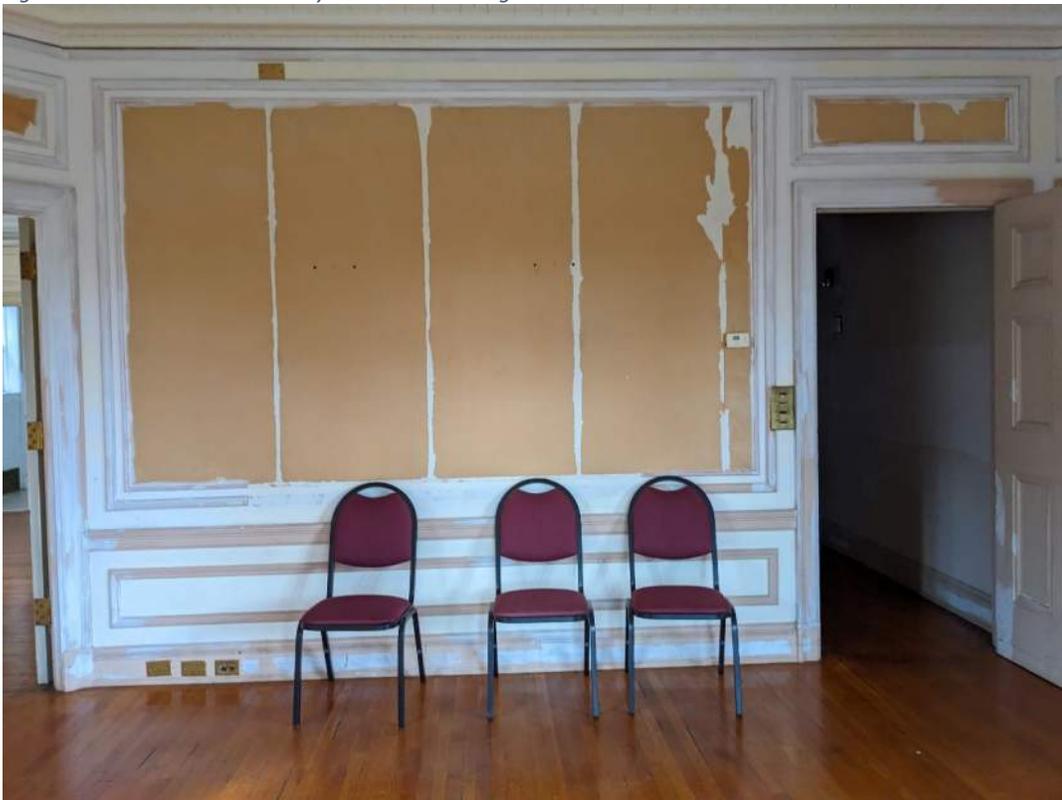
Figure 42 Mansion. Mrs. Peabody's Chamber looking north. Damaged/missing wood trim.

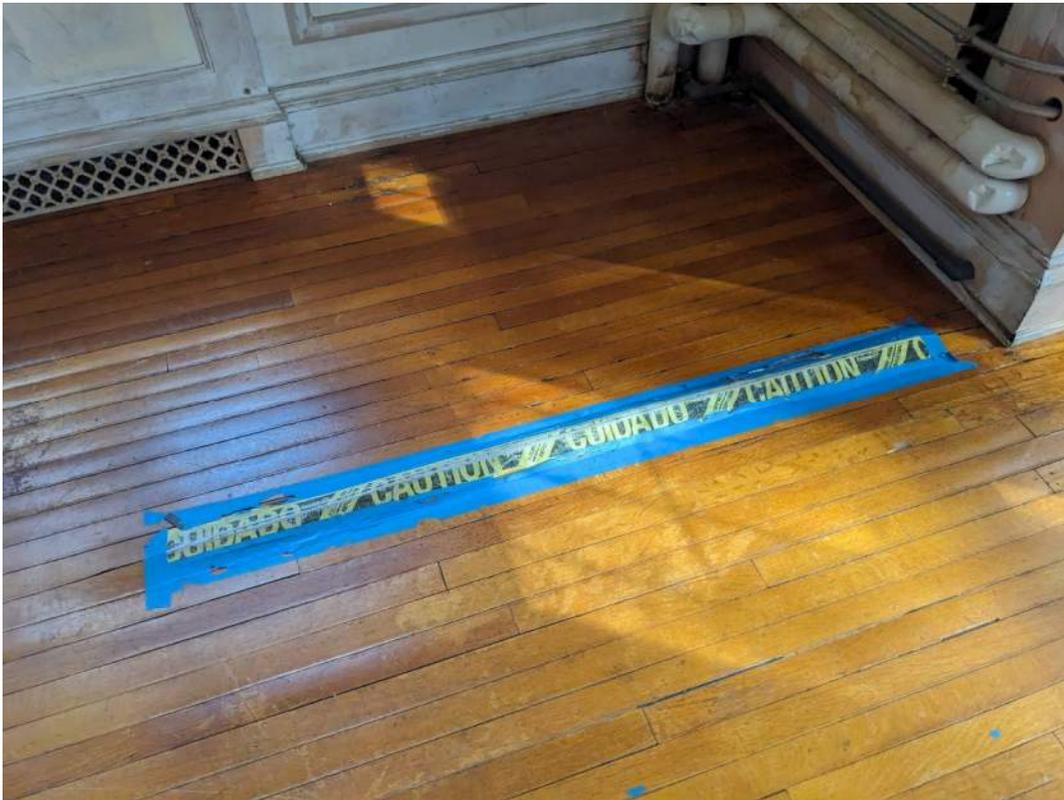
Figure 43 Mansion. Buckled flooring in Mrs. Peabody's Chamber.

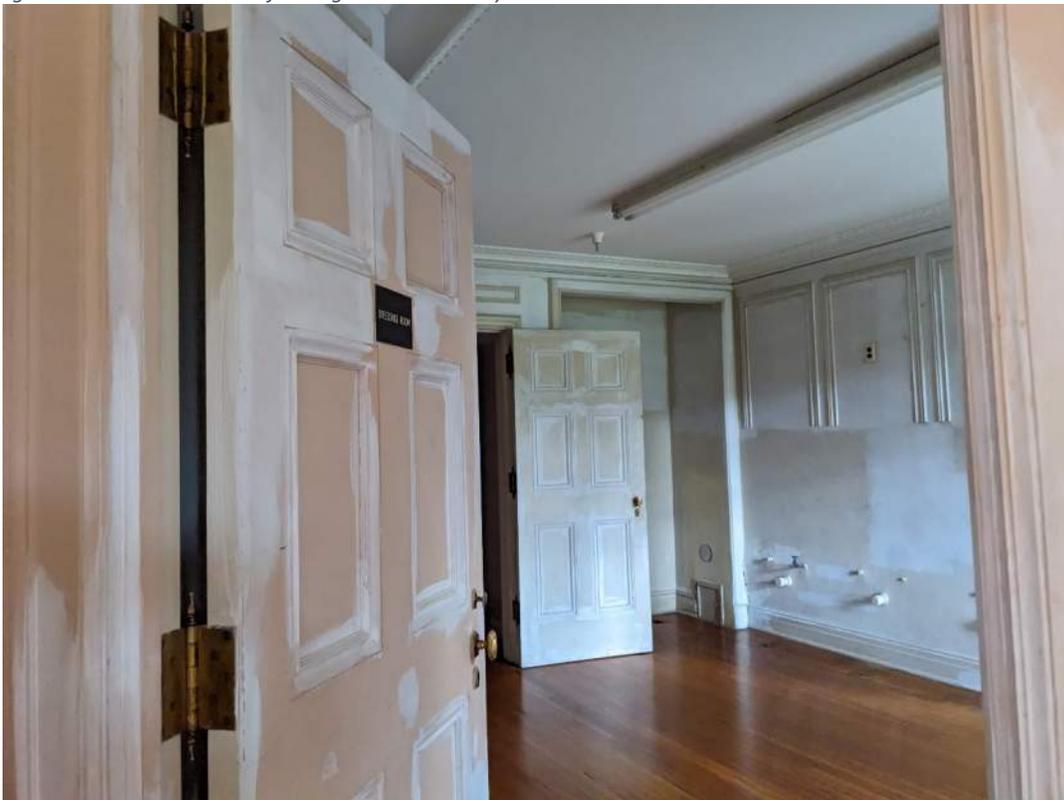
Figure 44 Mansion. Dressing room. Missing wood trim, capped plumbing.

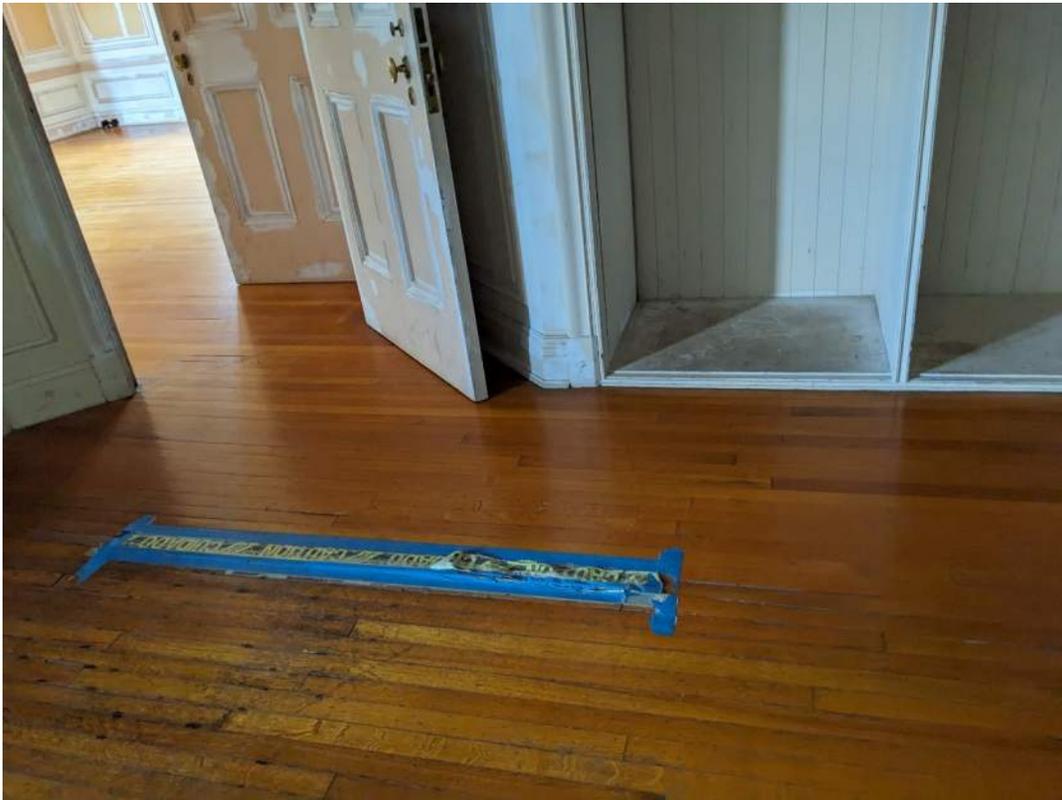
Figure 45 Mansion. Buckled flooring in Dressing Room.

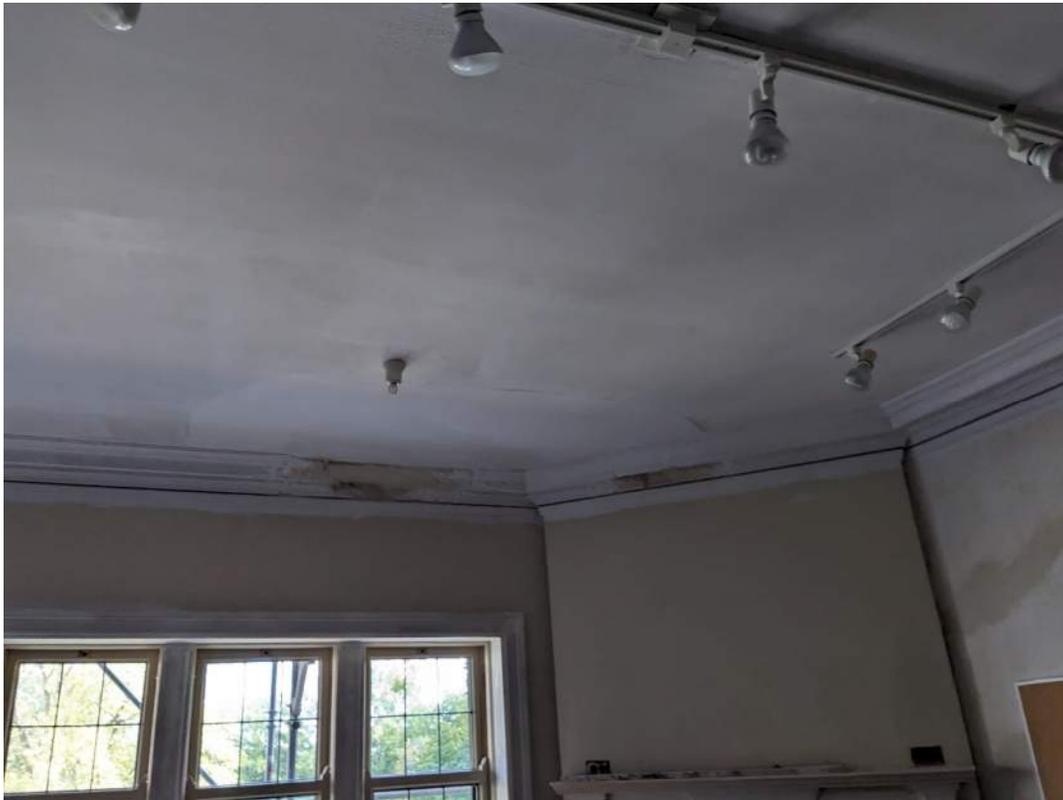
Figure 47 Mansion. Chamber 3 damaged plaster moulding.

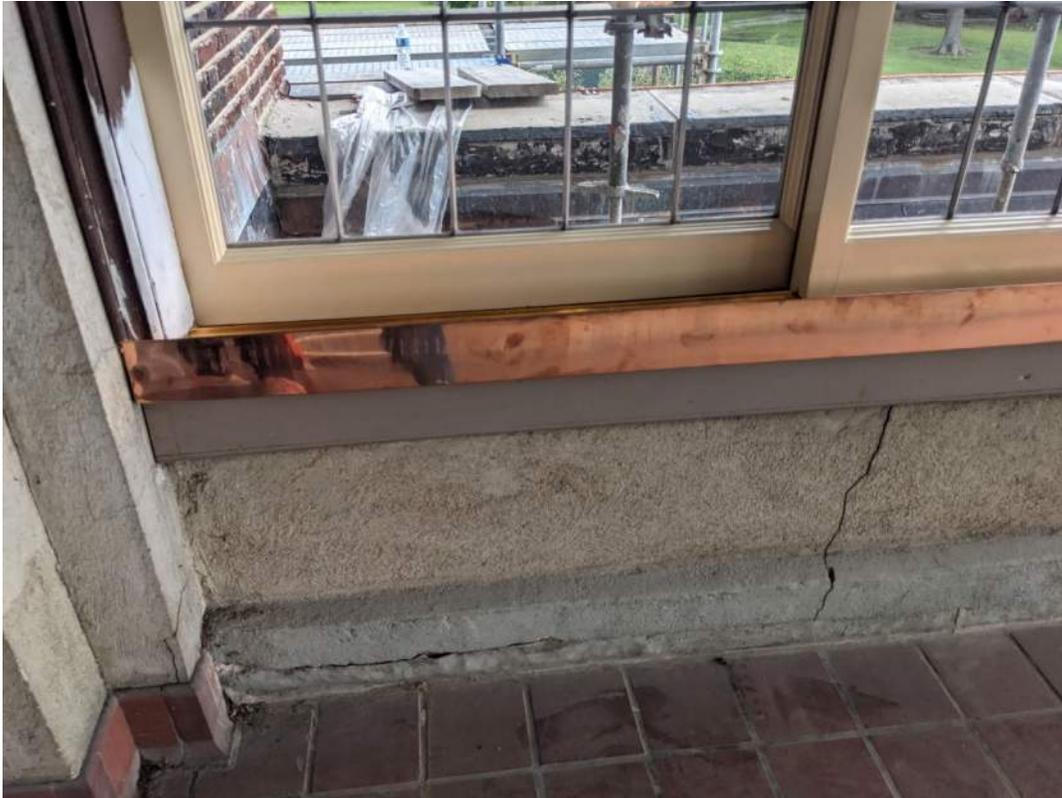
Figure 52 Mansion. Concrete cracking on sleeping porch.

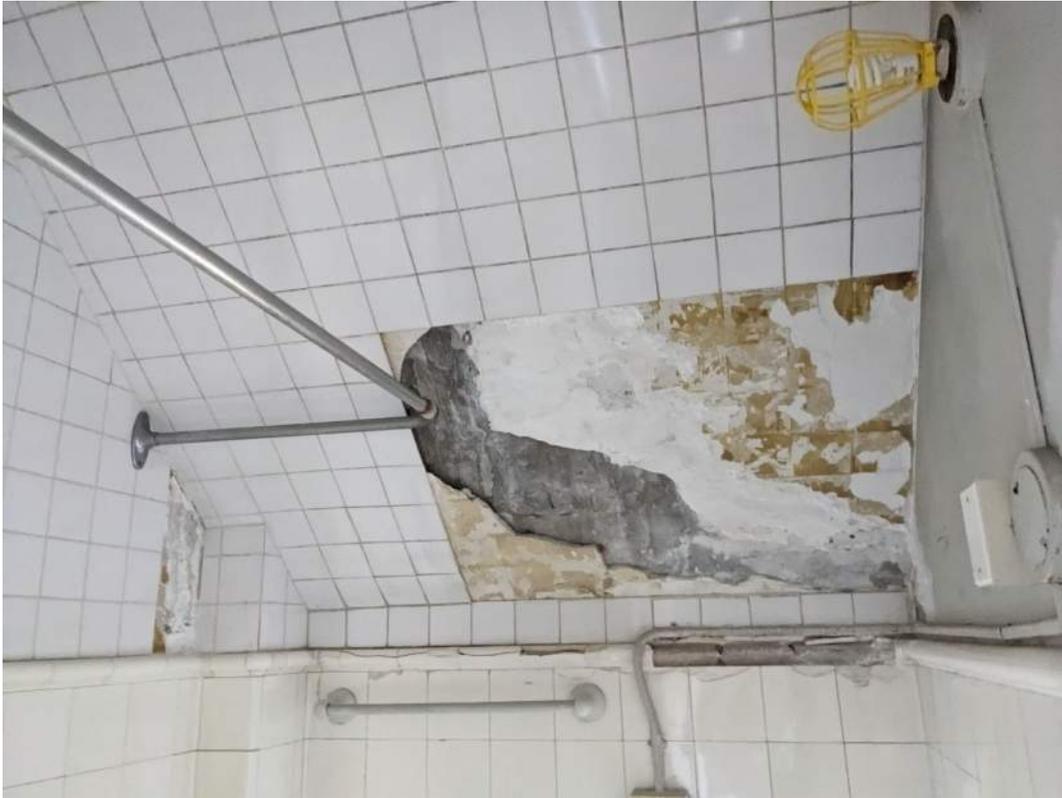
Figure 58 Mansion Service Wing. Damage modern tile above original tile wainscot.

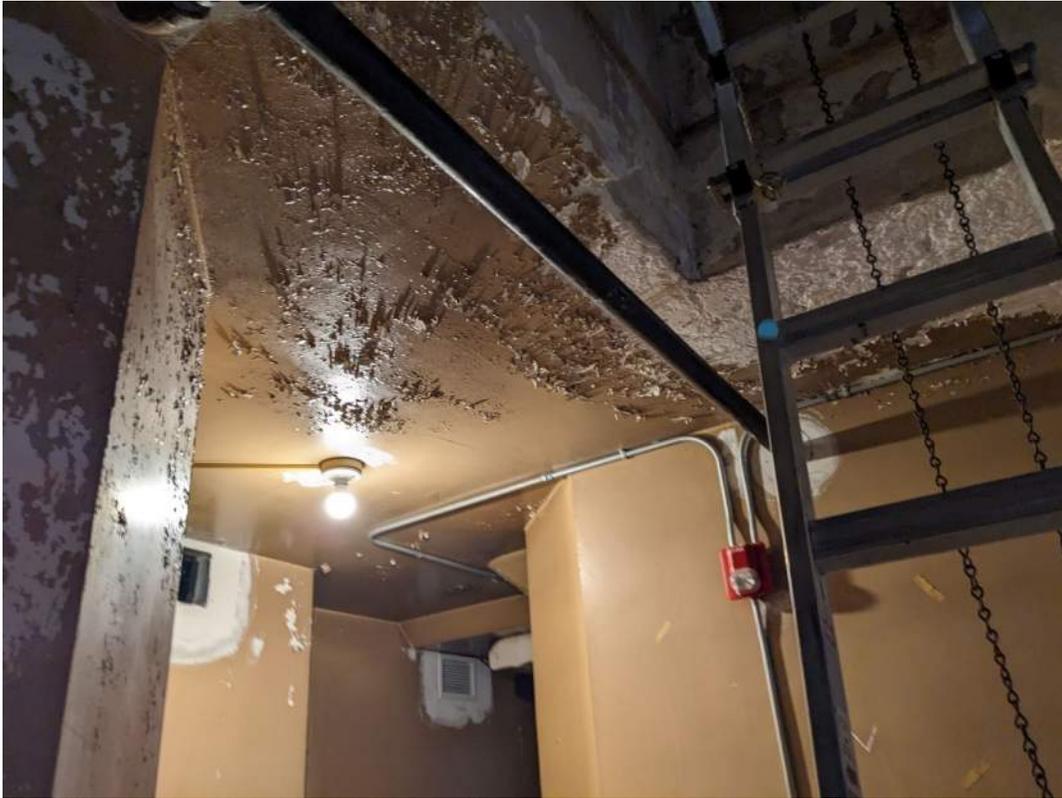
Figure 62 Mansion. Deteriorating paint in attic.

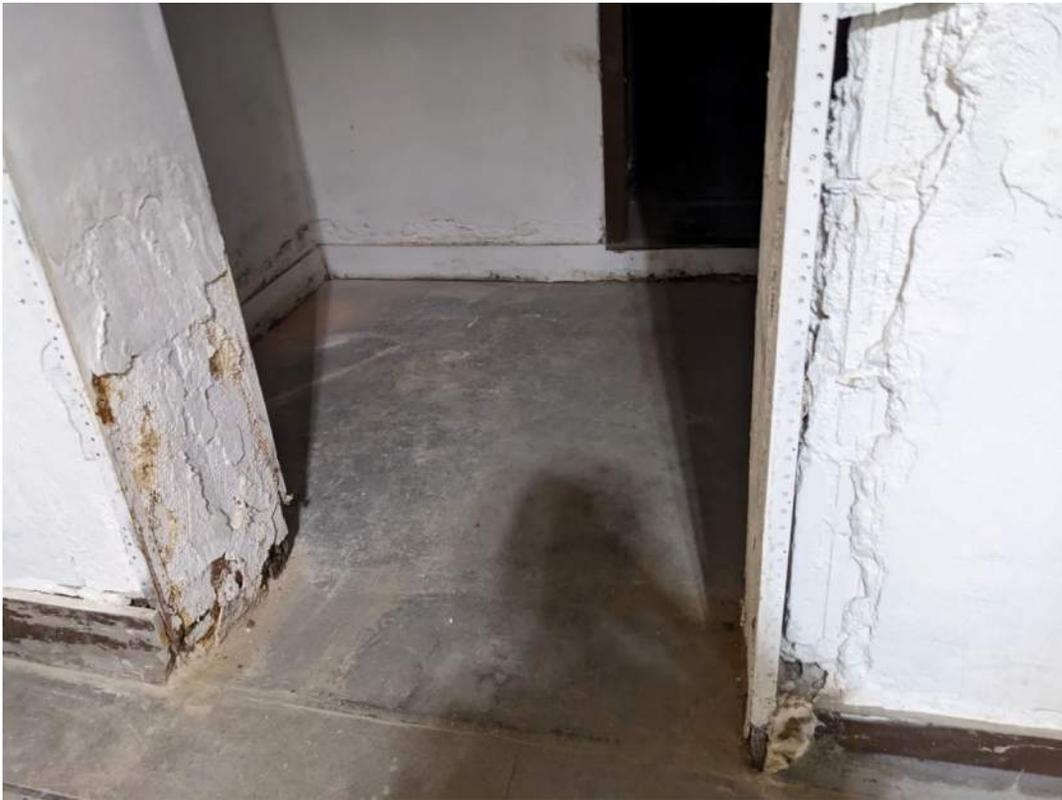
Figure 69 Mansion. Finished doorway in basement. Plaster damage.

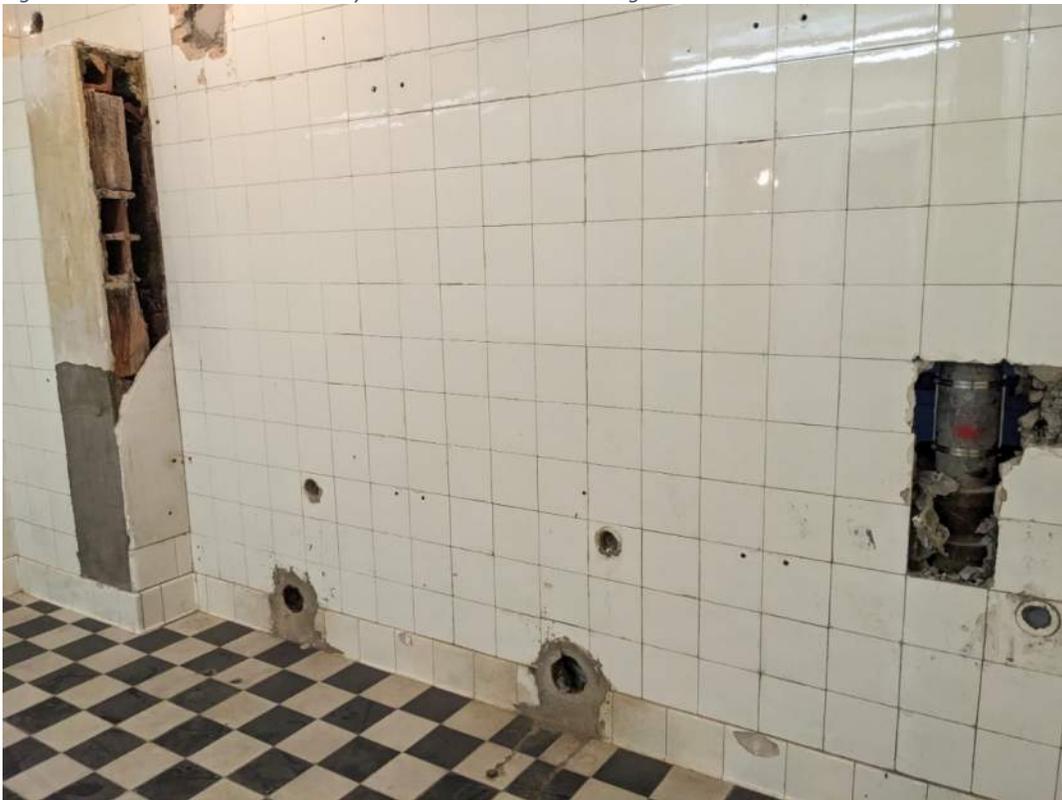
Figure 70 Mansion. Turkish Bath. Damaged original tiles.

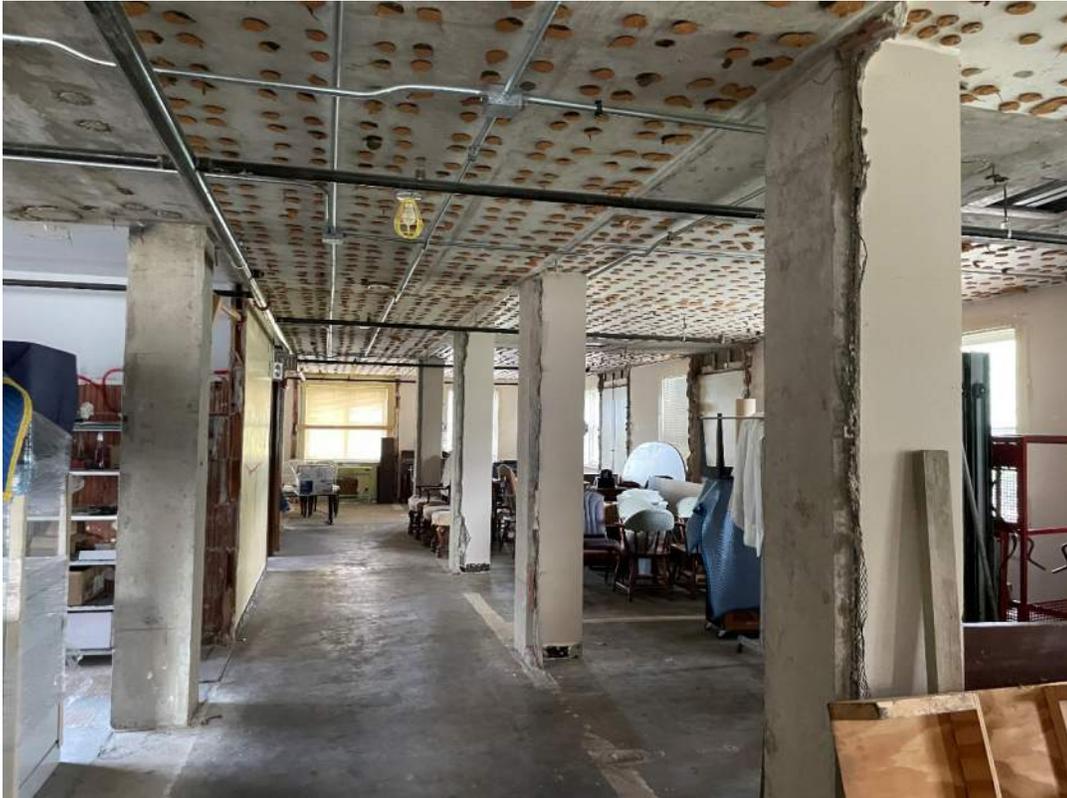
Figure 75 Retreat Building. First floor typical condition.

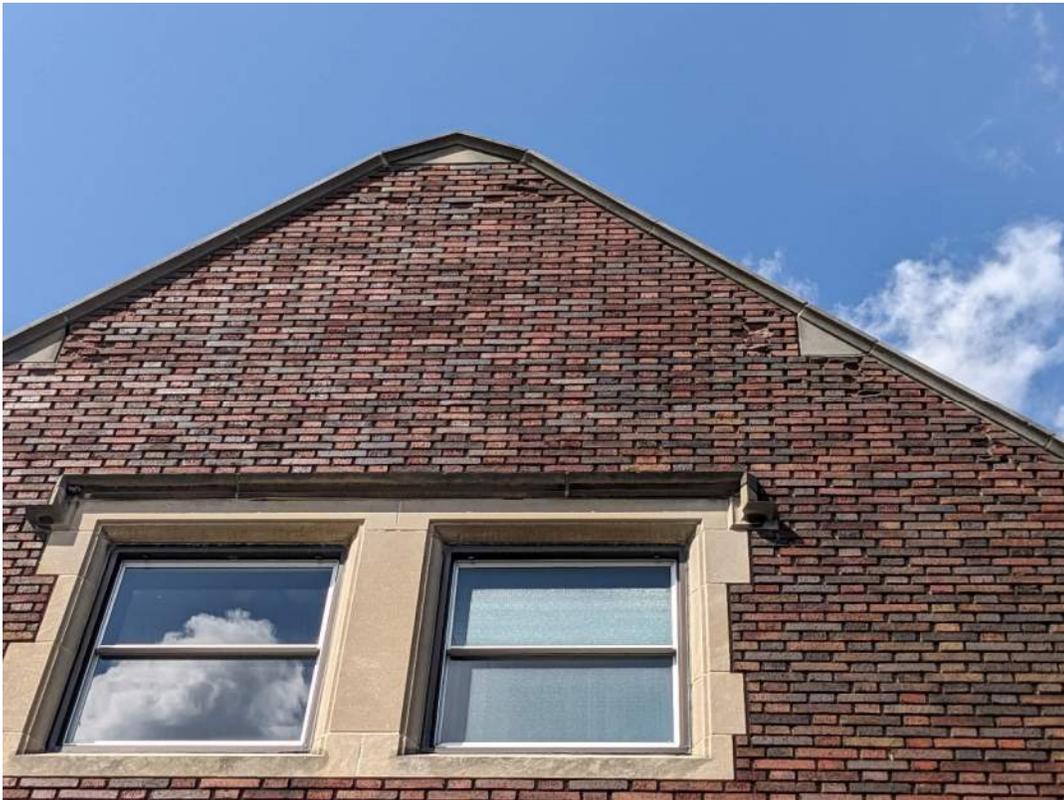
Figure 92 Retreat Building. East facade, spalling bricks on front face of parapet.
