Mayslake Peabody Estate
Forest Preserve District of DuPage County

Master Plan Report

November 1, 2024

Facility Condition Assessment Report

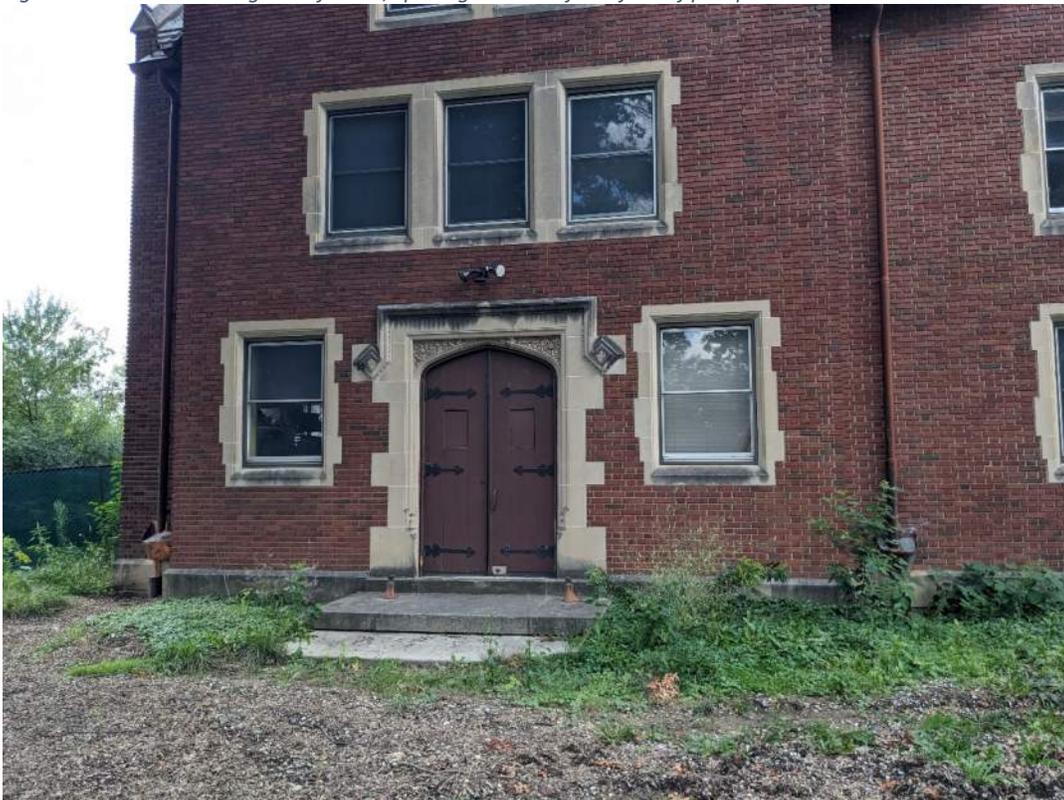
Figure 93 Retreat Building. South end of east facade. Note staining on limestone sills and door frame.

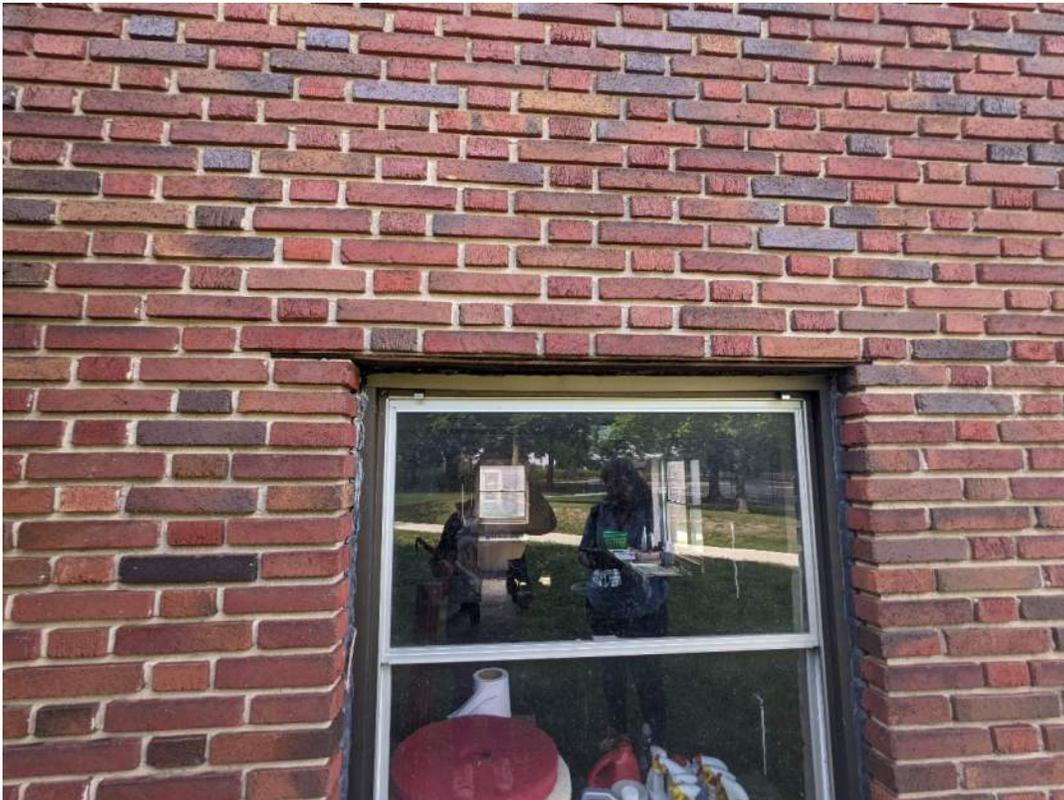
Figure 96 Retreat Building. North facade. Example of basement window. Note rust in lintel.

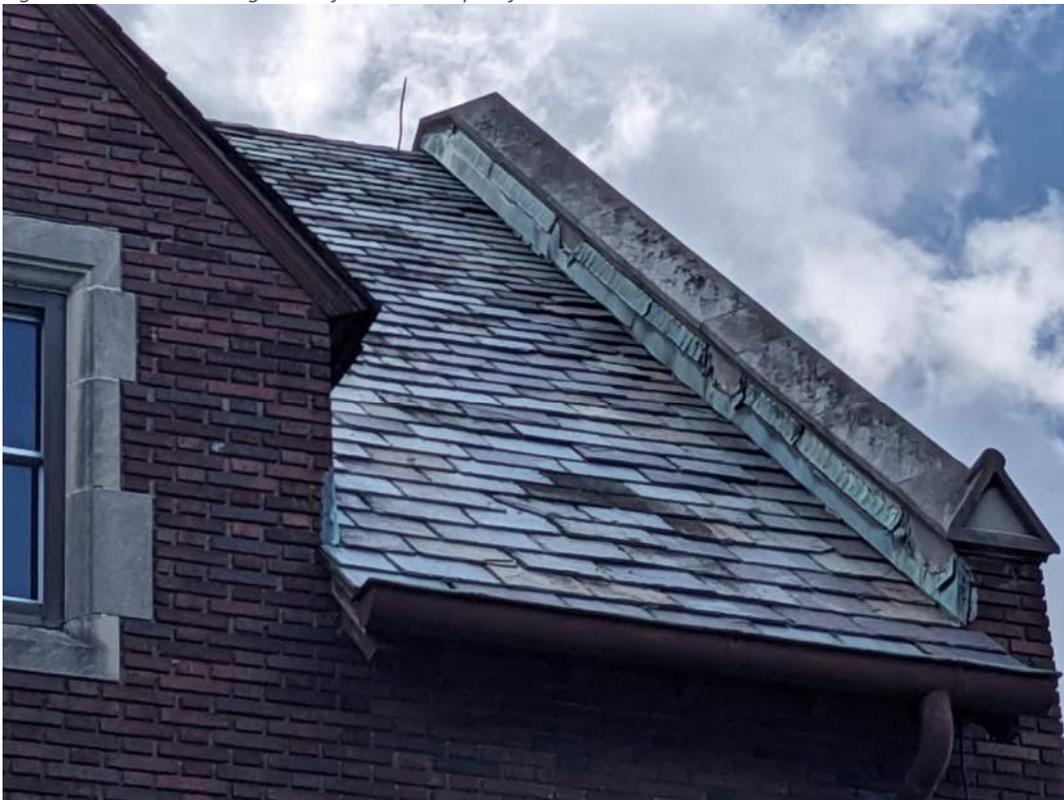
Figure 97 Retreat Building. Deteriorating copper flashing on back side of parapet.

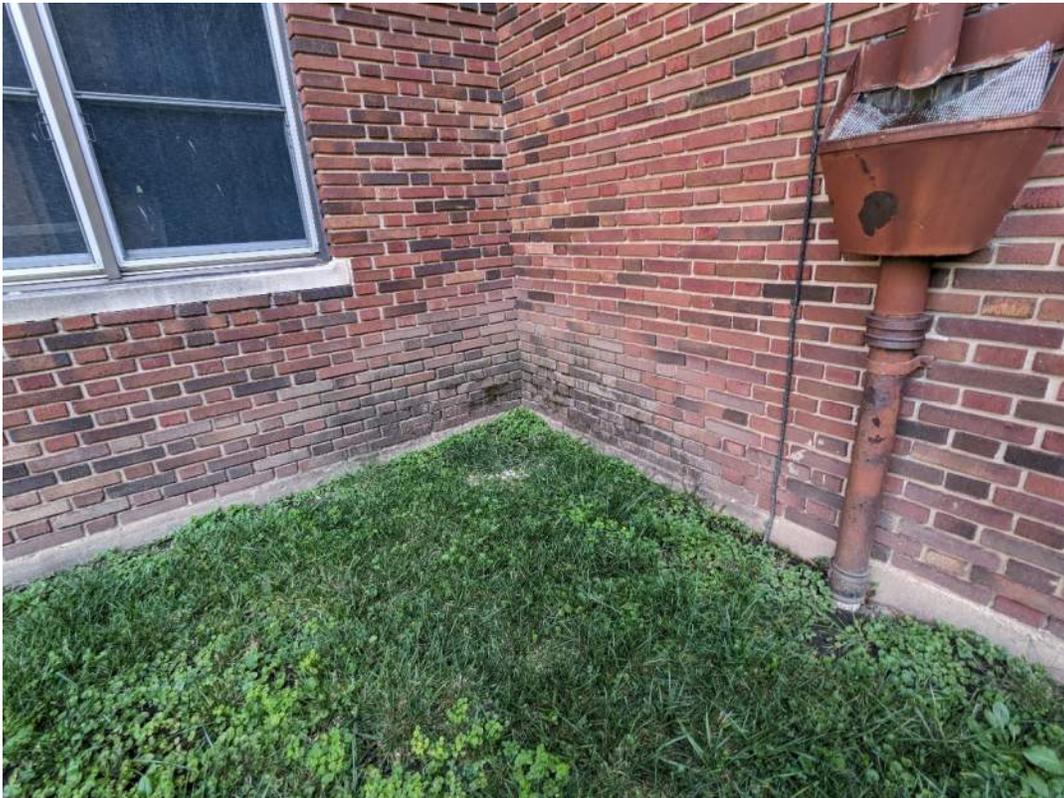
Figure 103 Retreat Building. West facade, brick deterioration due to water damage from broken gutter above.

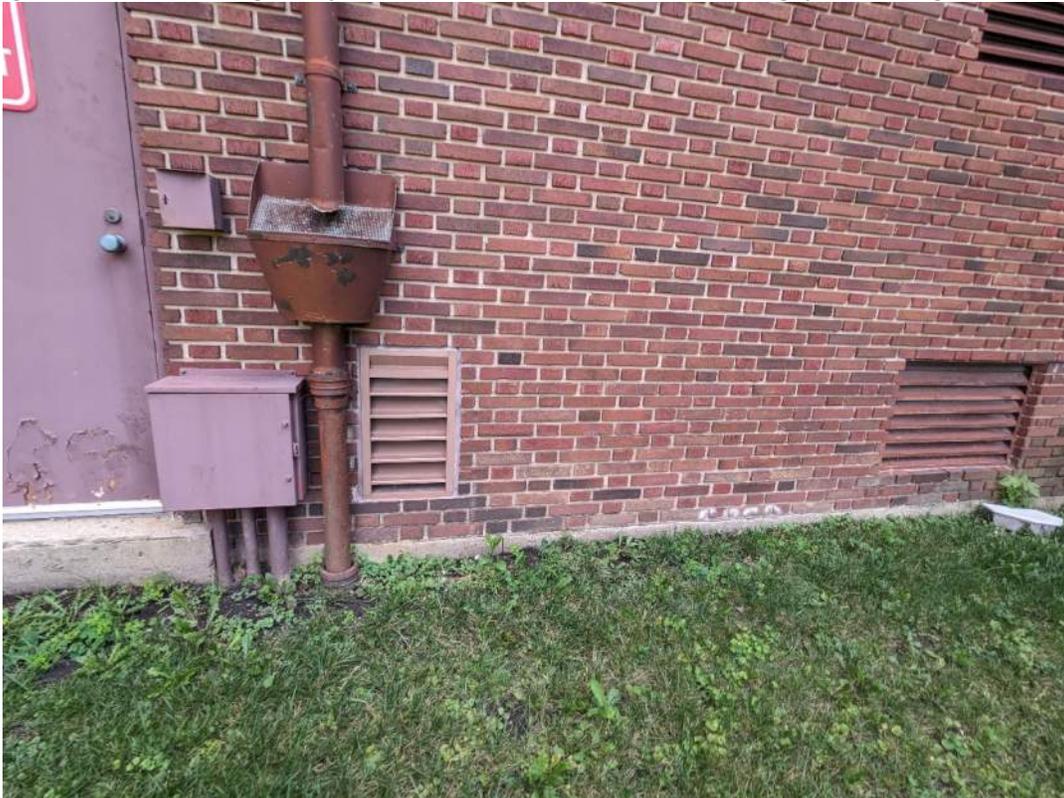
Figure 104 Retreat Building. West facade, peeling paint on door, conductor box.

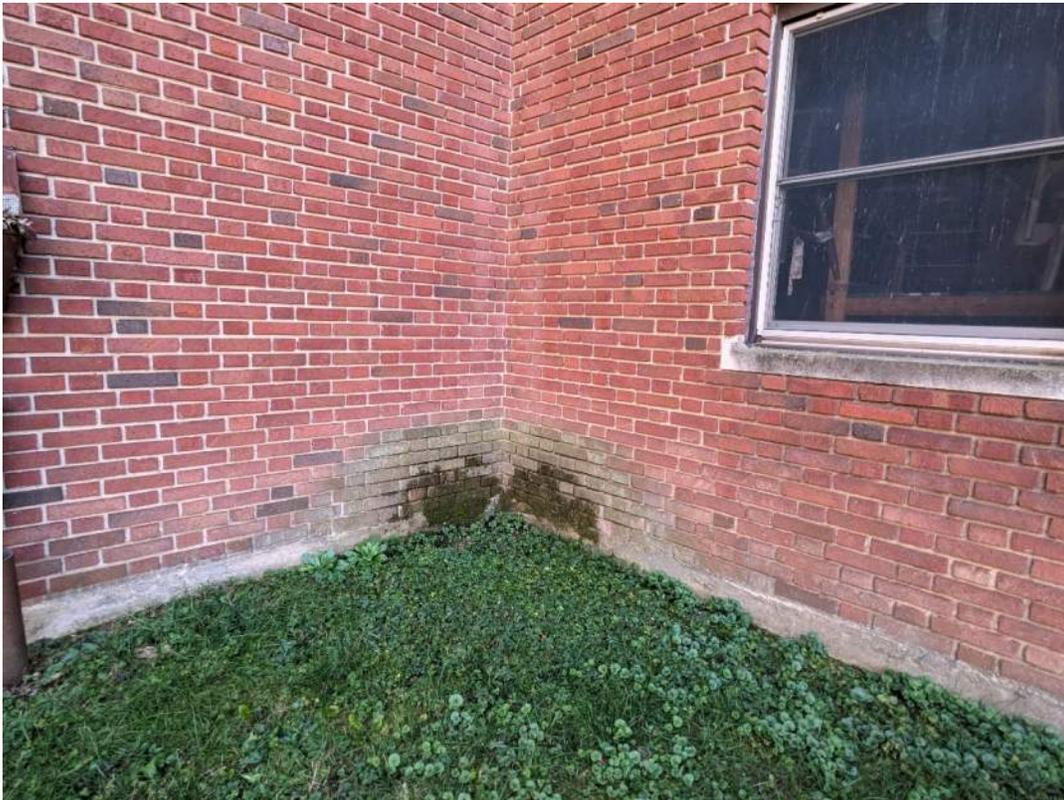
Figure 107 Retreat Building. West facade. Brick staining and deterioration due to water from broken gutter above.

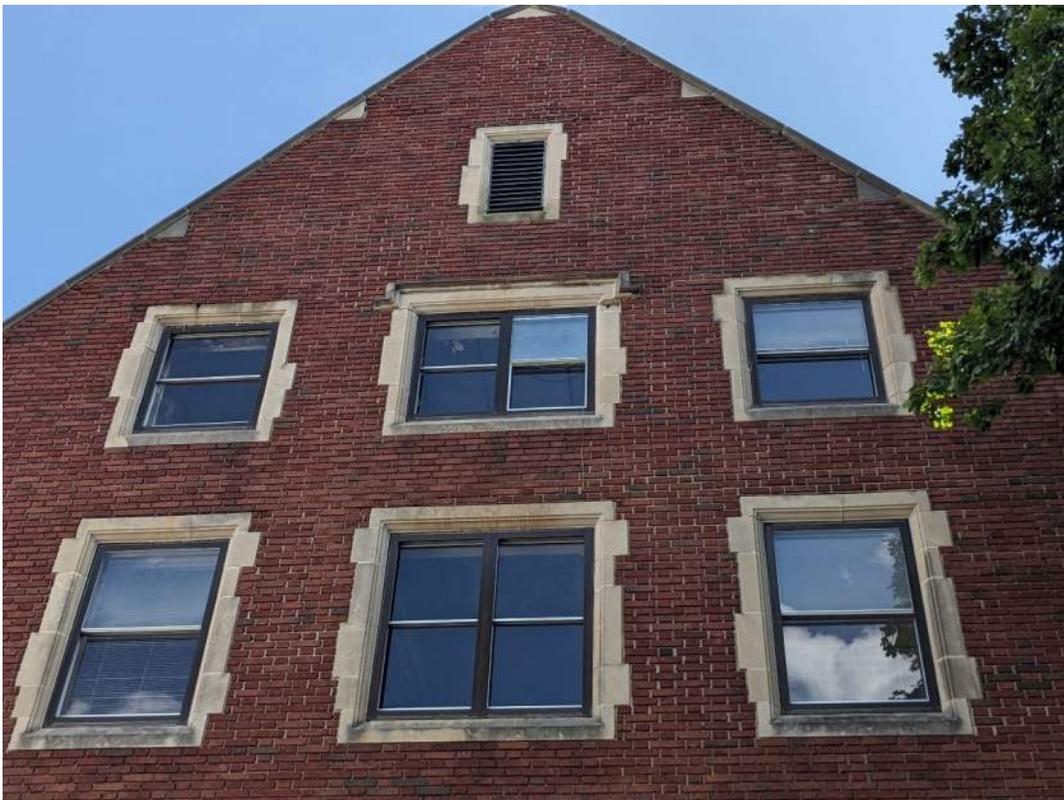
Figure 108 Retreat Building. West elevation. Note cracking in limestone window heads.

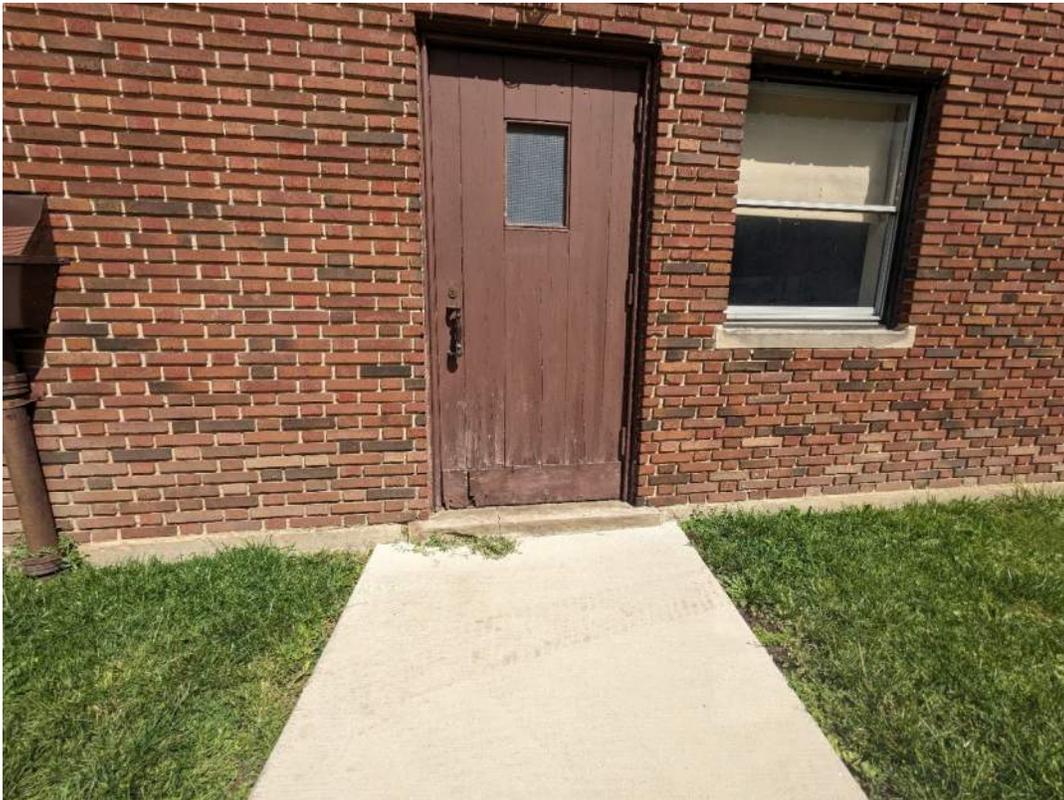
Figure 109 Retreat Building. West facade, deterioration of wood door.

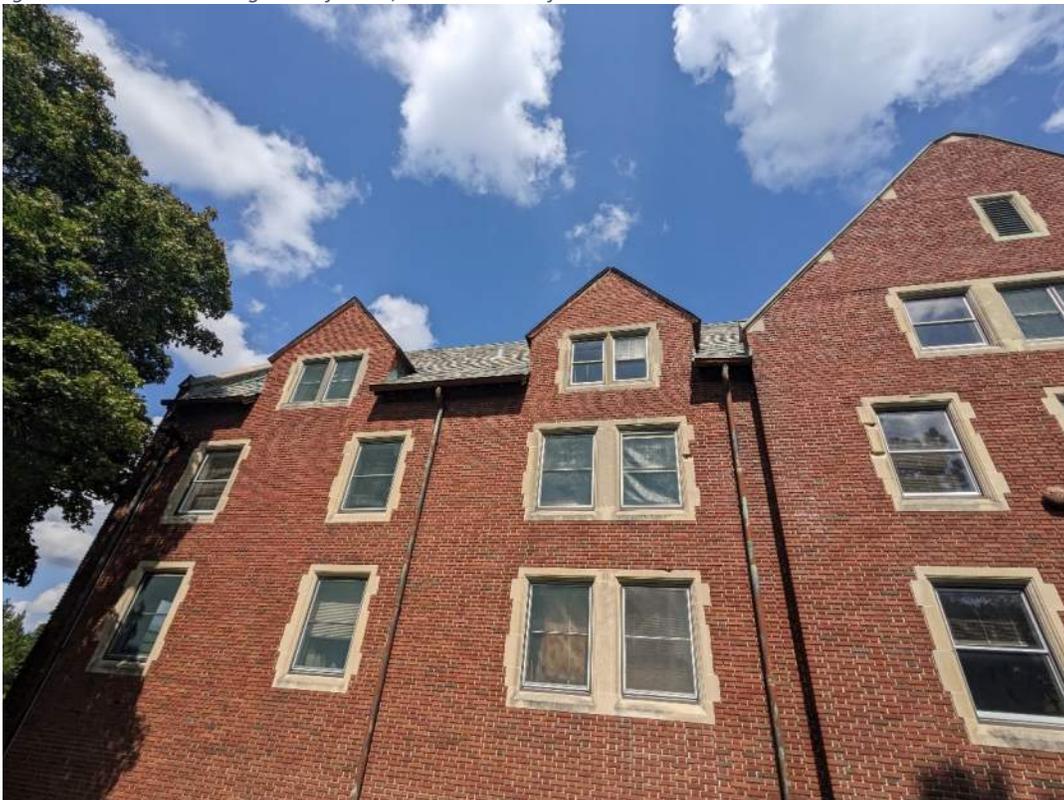
Figure 110 Retreat Building. South facade. Note spalls in limestone window heads.

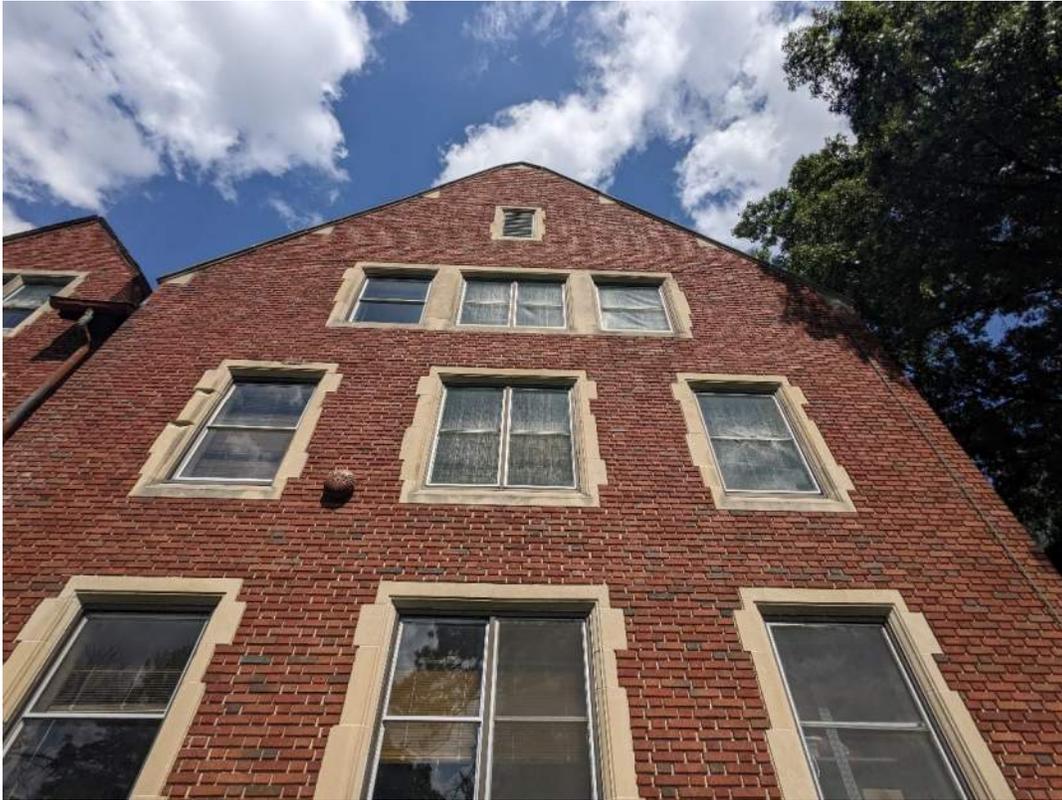
Figure 111 Retreat Building. South facade. Note spall at limestone window head and step cracking in brick.

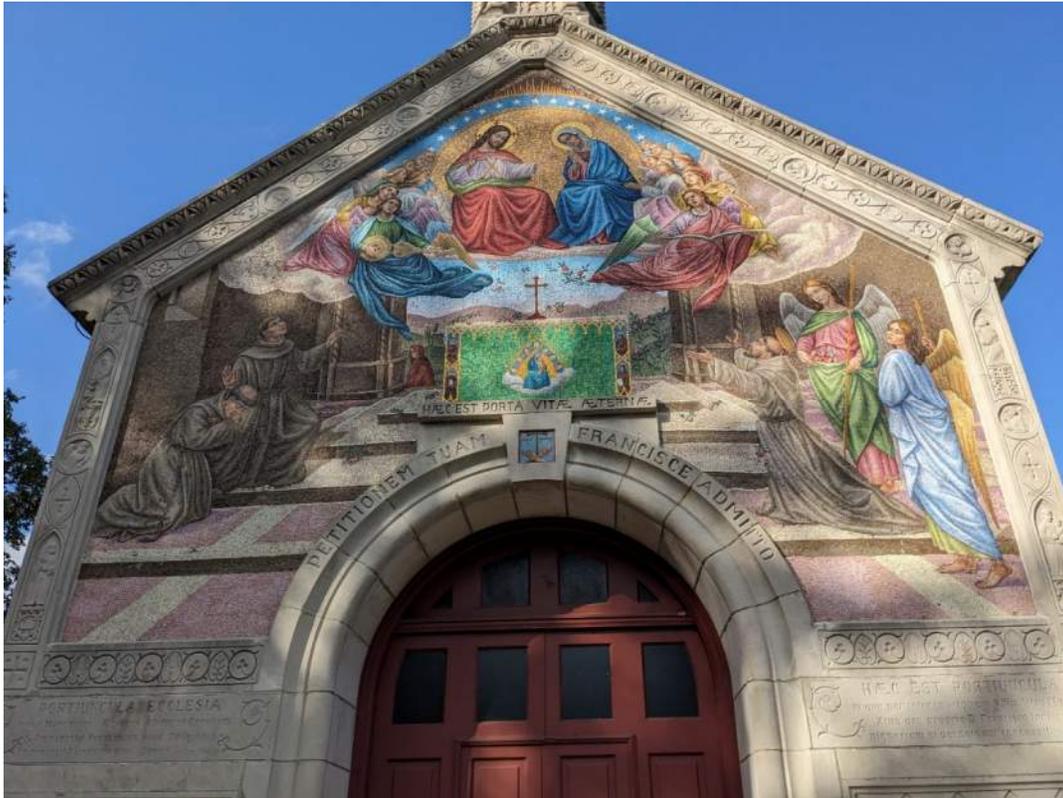
The Chapel is in good condition with limited mosaic tiles missing from the main elevation. A sealant material has been applied to all the limestone joints instead of a limestone compatible mortar. The wood entry doors require refinishing and limited wood replacement as well as the addition of door closers. The chapel is heated by electric wall heaters, there is no air conditioning or ventilation.

Figure 114 Chapel. Tile mosaic on front facade. Note missing tiles.

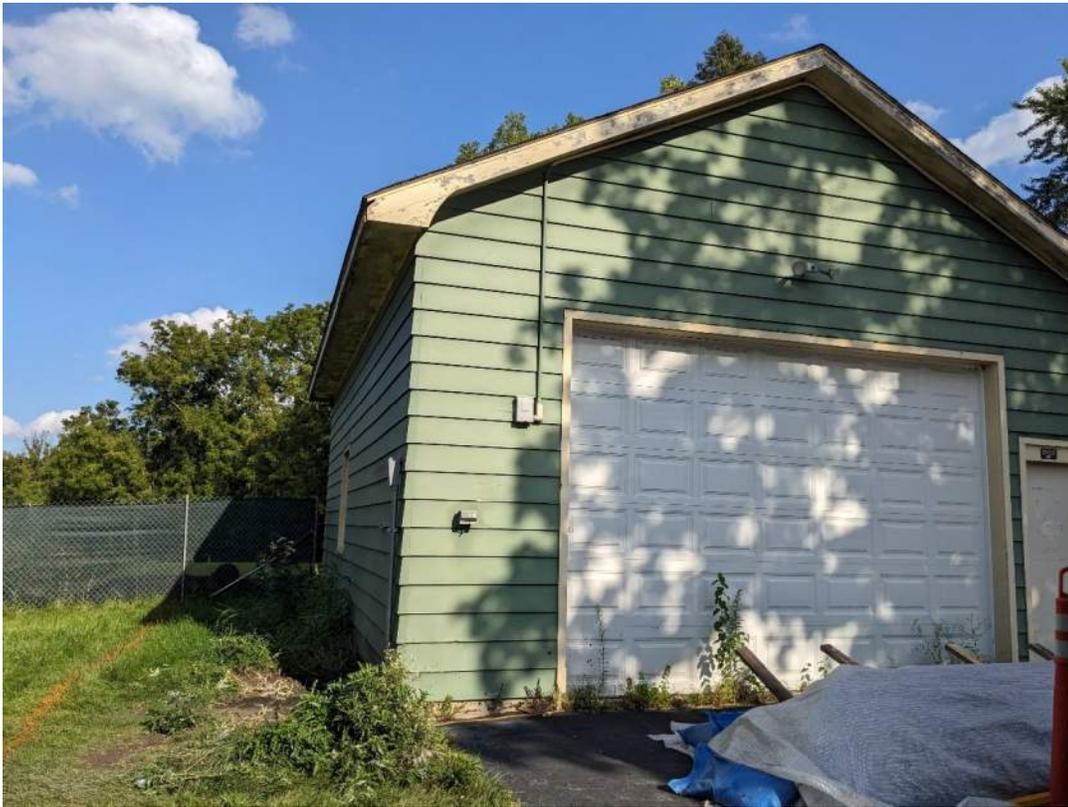
There is peeling paint and some minor damage along the wood eaves and trim. The interior of the building was not assessed.

Figure 118 Garage. Note peeling paint.

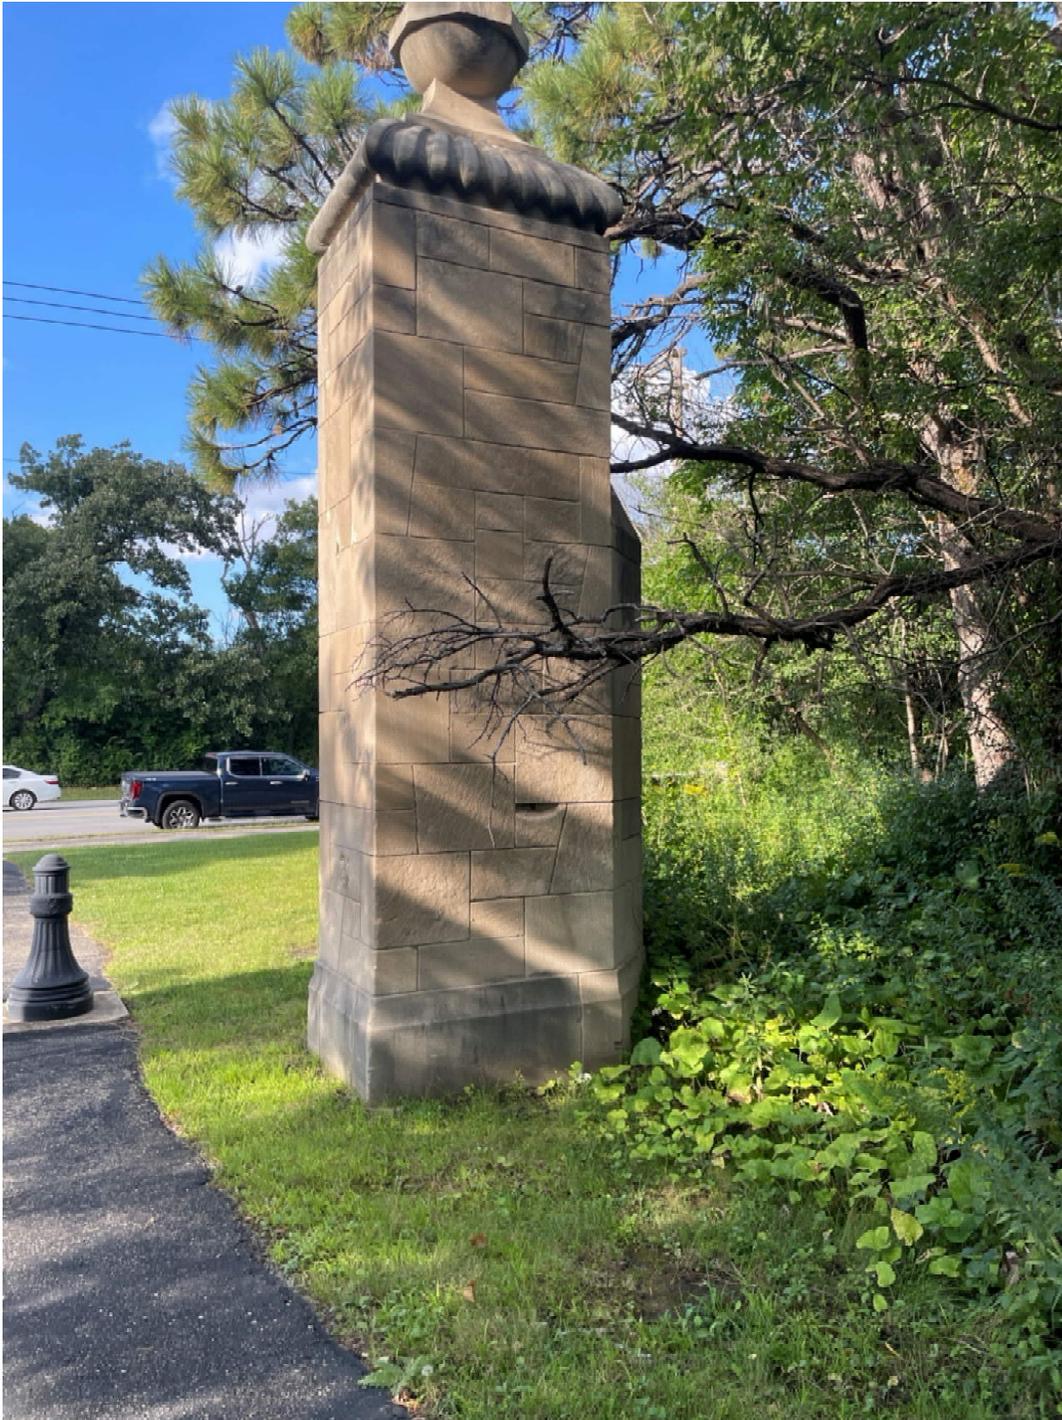
The limestone entry gate and its flanking walls adjacent to the modern street entrance are in poor to fair condition requiring targeted rebuilding and tuckpointing.

Figure 121 Gate. East pier, note spalled limestone.
