MAPLE GROVE BRIDGE AND SANITARY SEWER REPLACEMENT PROJECT – FEASIBILITY STUDY

FINAL REPORT

**SUBMITTED BY:
CHRISTOPHER B. BURKE ENGINEERING, LTD.
AUGUST 30, 2024**

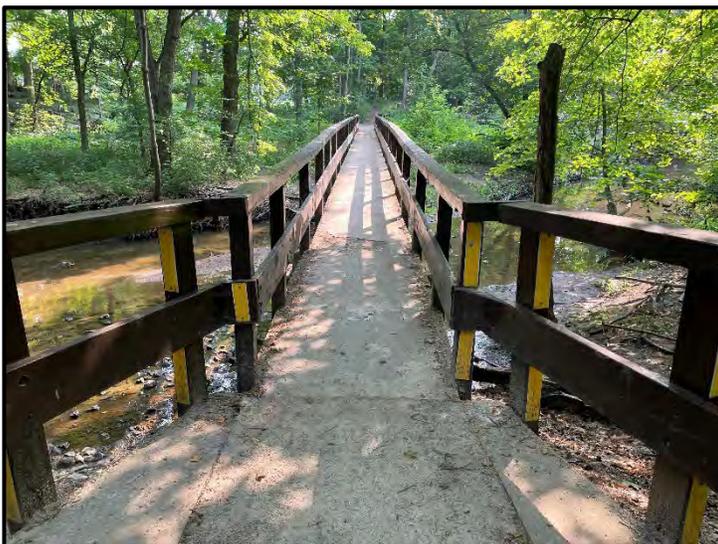
Photo – Bridge Looking East

The existing bridge was built in phases and consists of a nine-span reinforced concrete superstructure. The bottom half of the superstructure was constructed in the early 1900s, is u-shaped and supports a DGSD 24” sanitary sewer supported on reinforced concrete piers. The sewer was then encased in concrete in the 1980’s when the structure was modified to accommodate pedestrian traffic. The structure is approximately 122 feet long, has a clear width between railings of 3 ½ feet and has an overall structural depth of 43” from top of deck to bottom of superstructure. See photo and cross section below.

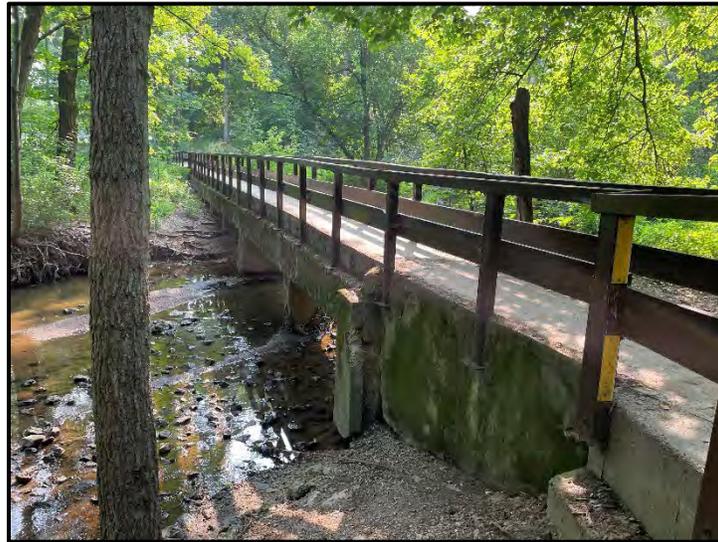
Photo – North Elevation of Bridge – Westernmost Span Closed Off, Two Easternmost Spans Obstructed

CBBEL performed a site survey of the structure in January of 2024. It is notable that the survey indicated that the piers are different widths and different orientations (some are parallel to the creek as opposed to orthogonal to the bridge). This could be an indication that the piers were not all constructed at the same time. Additionally, the survey shows that the two easternmost spans are nearly completely buried. A wall was constructed at some point in the westernmost span, and this span is completely obstructed. See photo below.

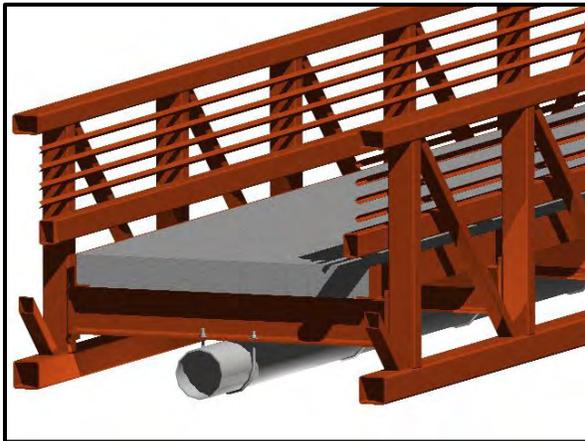
Sketch From Contech – Sample Pipe Hanger Connection to Floor Beam

For the prefabricated steel truss superstructure types, the pipes would most likely be connected to the floor beams of the structure. Per discussions with Contech, the proposed bridge deck will be 6" thick at the edge and approximately 7.25" thick at the crown. The pipe, running full, will weigh roughly 400 pounds per foot, depending on the material type selected. The proposed floor beams can be made as shallow as 12" tall for this bridge width. The pipe will not be flush against the bottom of the floor beam but will likely be several inches lower to accommodate insulation. The pipe will likely have an outside diameter of 25.8", plus insulation. Keeping the invert of the pipe at 694.7 places the crown of the deck at approximately 698.65, approximately 9" higher than the top of deck elevation of the existing bridge.

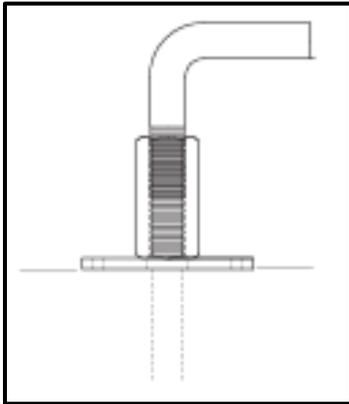
Sample Cast-In Threaded Insert for Pipe Hanger System

Utilizing a 33" tub girder, a 7" thick reinforced concrete deck and allowing for two inches for formwork will place the low chord of the structure at 694.3±. The pipe will be hung from the bridge deck. Threaded inserts will be cast into the deck at intervals to be determined. The proposed sewer invert would remain at 694.7. The pipe would not be visible from the side of the structure, and the tub girders would offer some shielding protection for the pipe from debris (see Drawings D-1 and D-2).

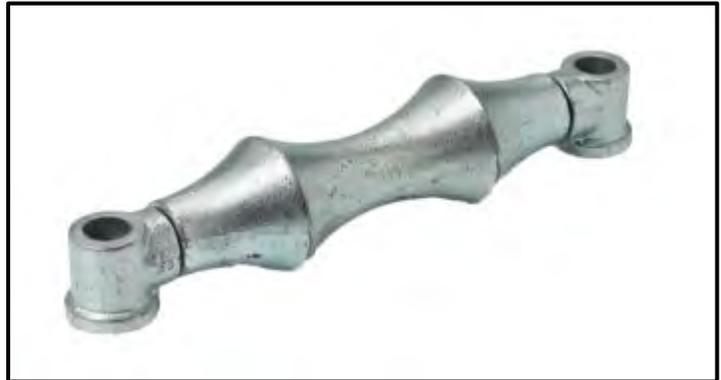
Sample – Pipe Roller Support

For both the truss and the tub girder alternates, pipe roller supports will most likely be utilized (see above). The roller supports will allow for longitudinal movement due to expansion and contraction of the bridge. Bracing on the top of the pipe would also likely be required to resist buoyancy forces.

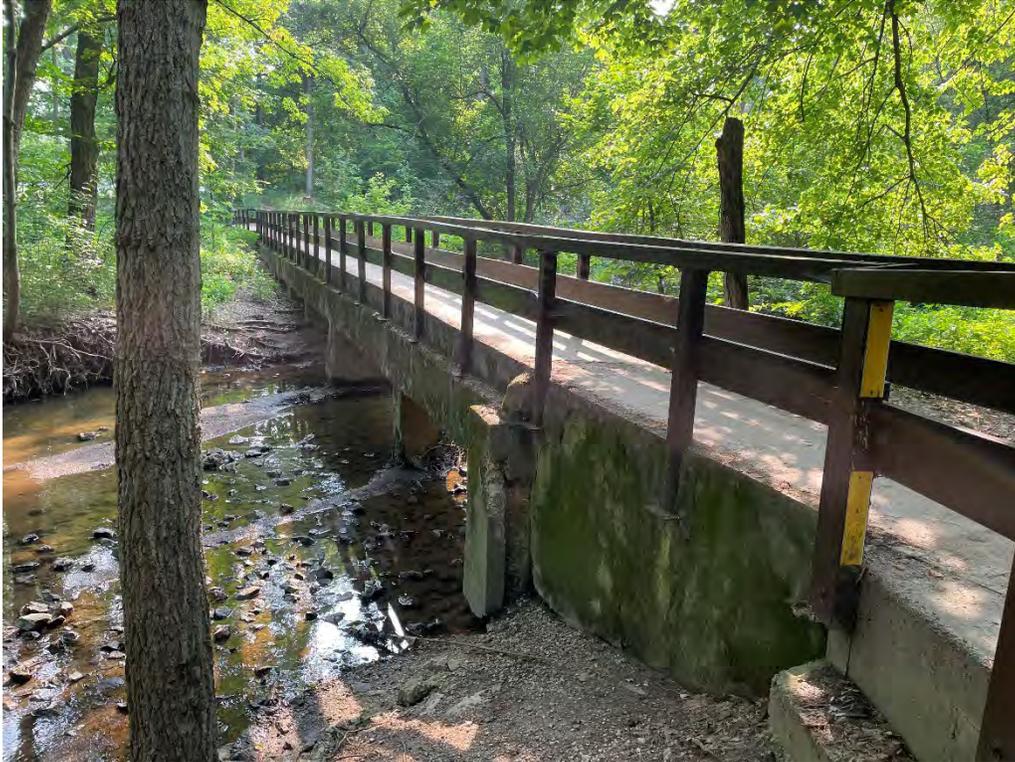
North Elevation (Upstream) of Structure – Note that wall has been placed in easternmost span and two westernmost spans are completely obstructed

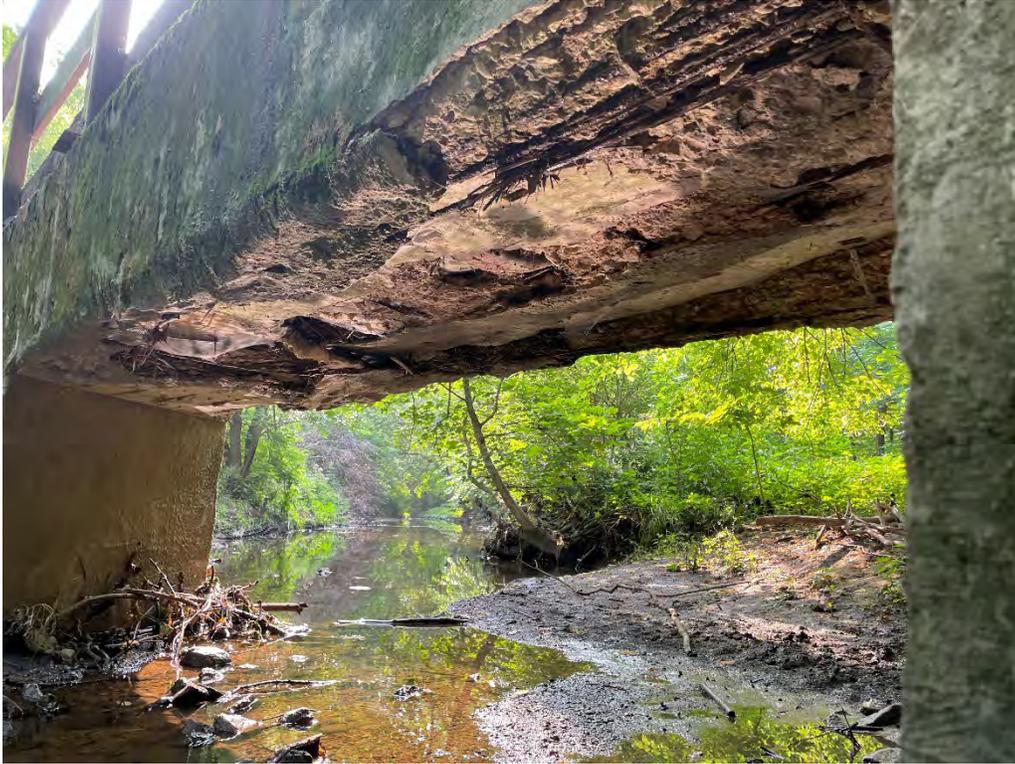
Typical Underside Condition – Bridge superstructure is in serious condition

The structure was last inspected on August 22, 2022, by Lochner. The inspection report indicates that the superstructure is in serious condition with significant spalling and with up to 50% section loss of the primary reinforcing steel. The substructure is in poor condition with moderate spalling and between 10% to 30% section loss in the piers. The bridge has a 39 inch tall wooden railing on both sides of the structure, which does not meet current American Association of State Highway and Transportation Officials (AASHTO) guidelines. Additionally, the spacing between the horizontal rail elements does not comply with current AASHTO guidelines. CBBEL concurs with the assessments in the bridge inspection report.

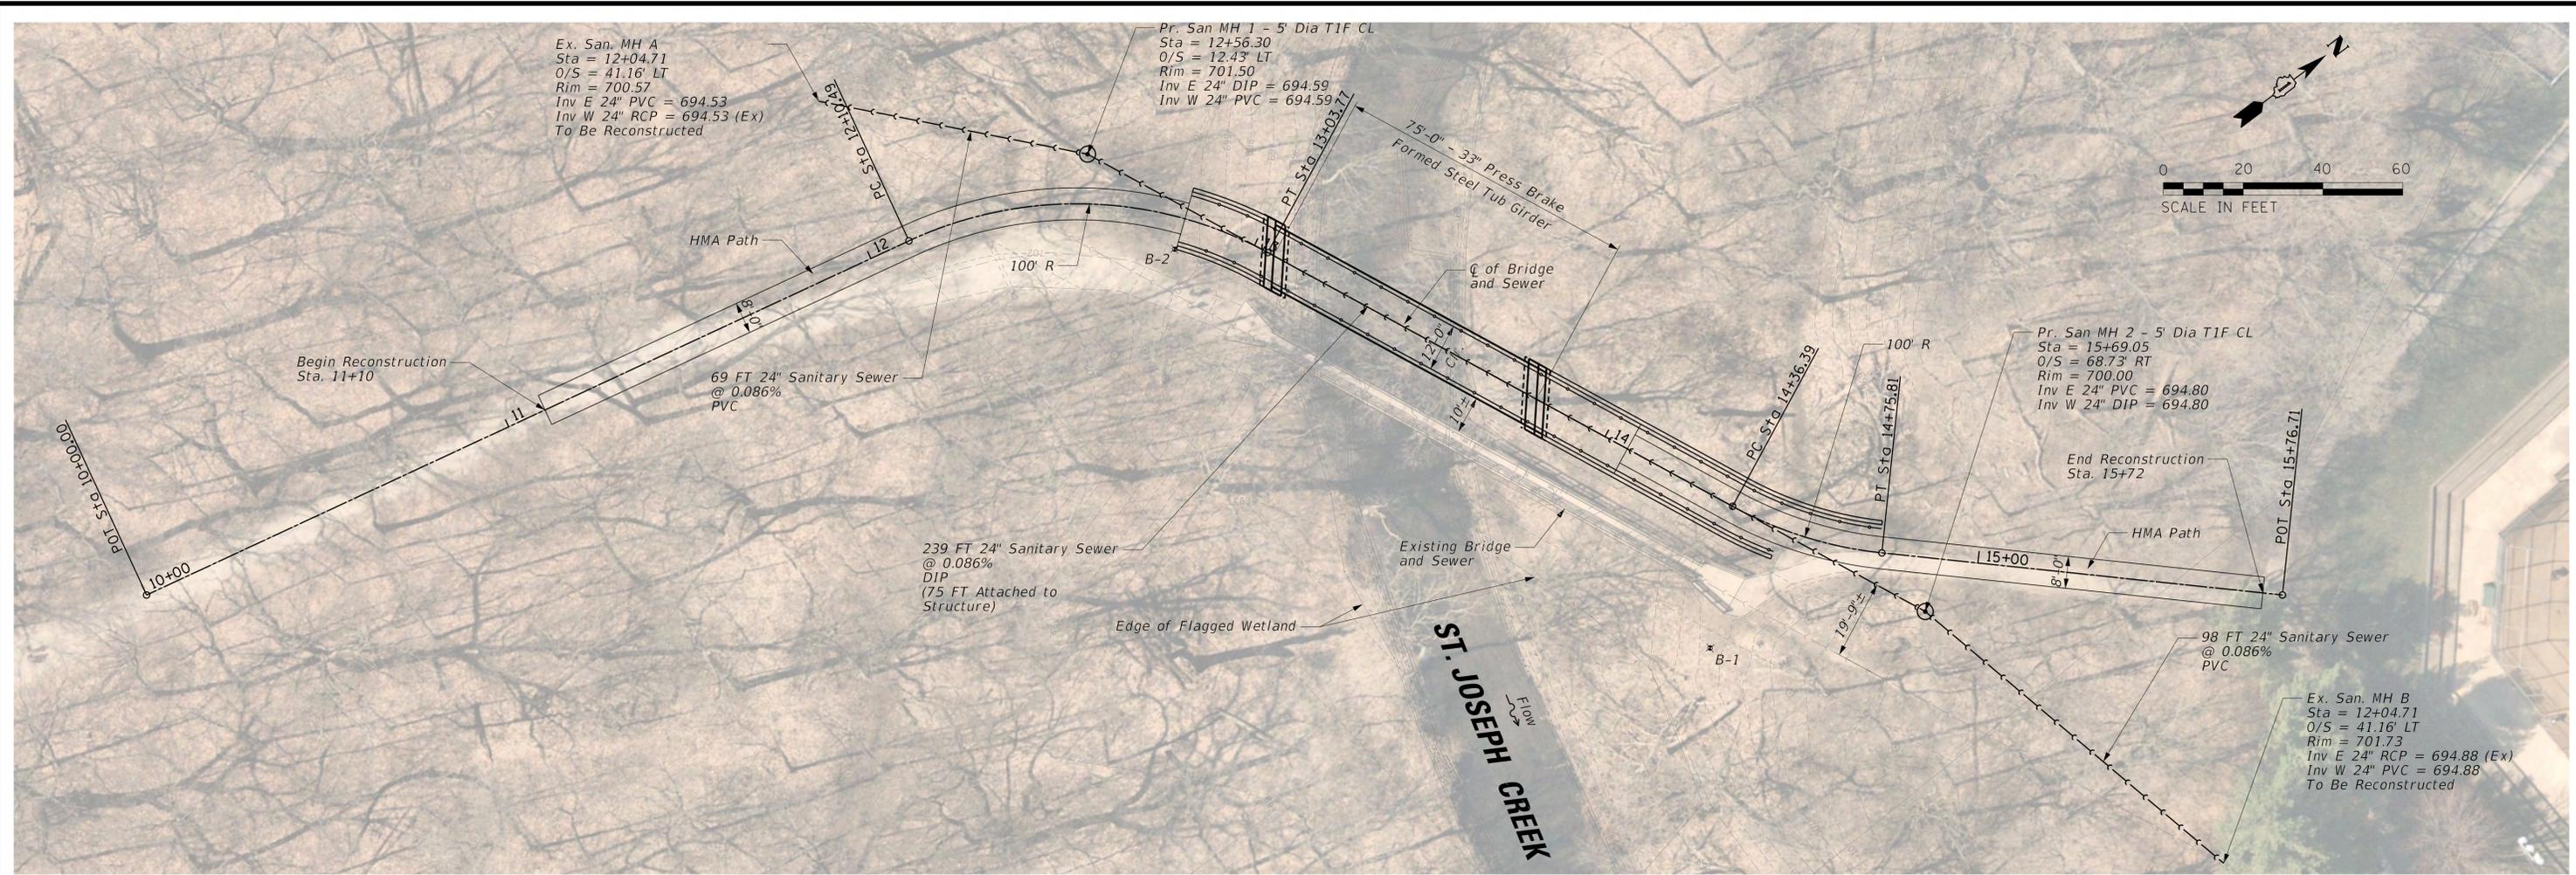
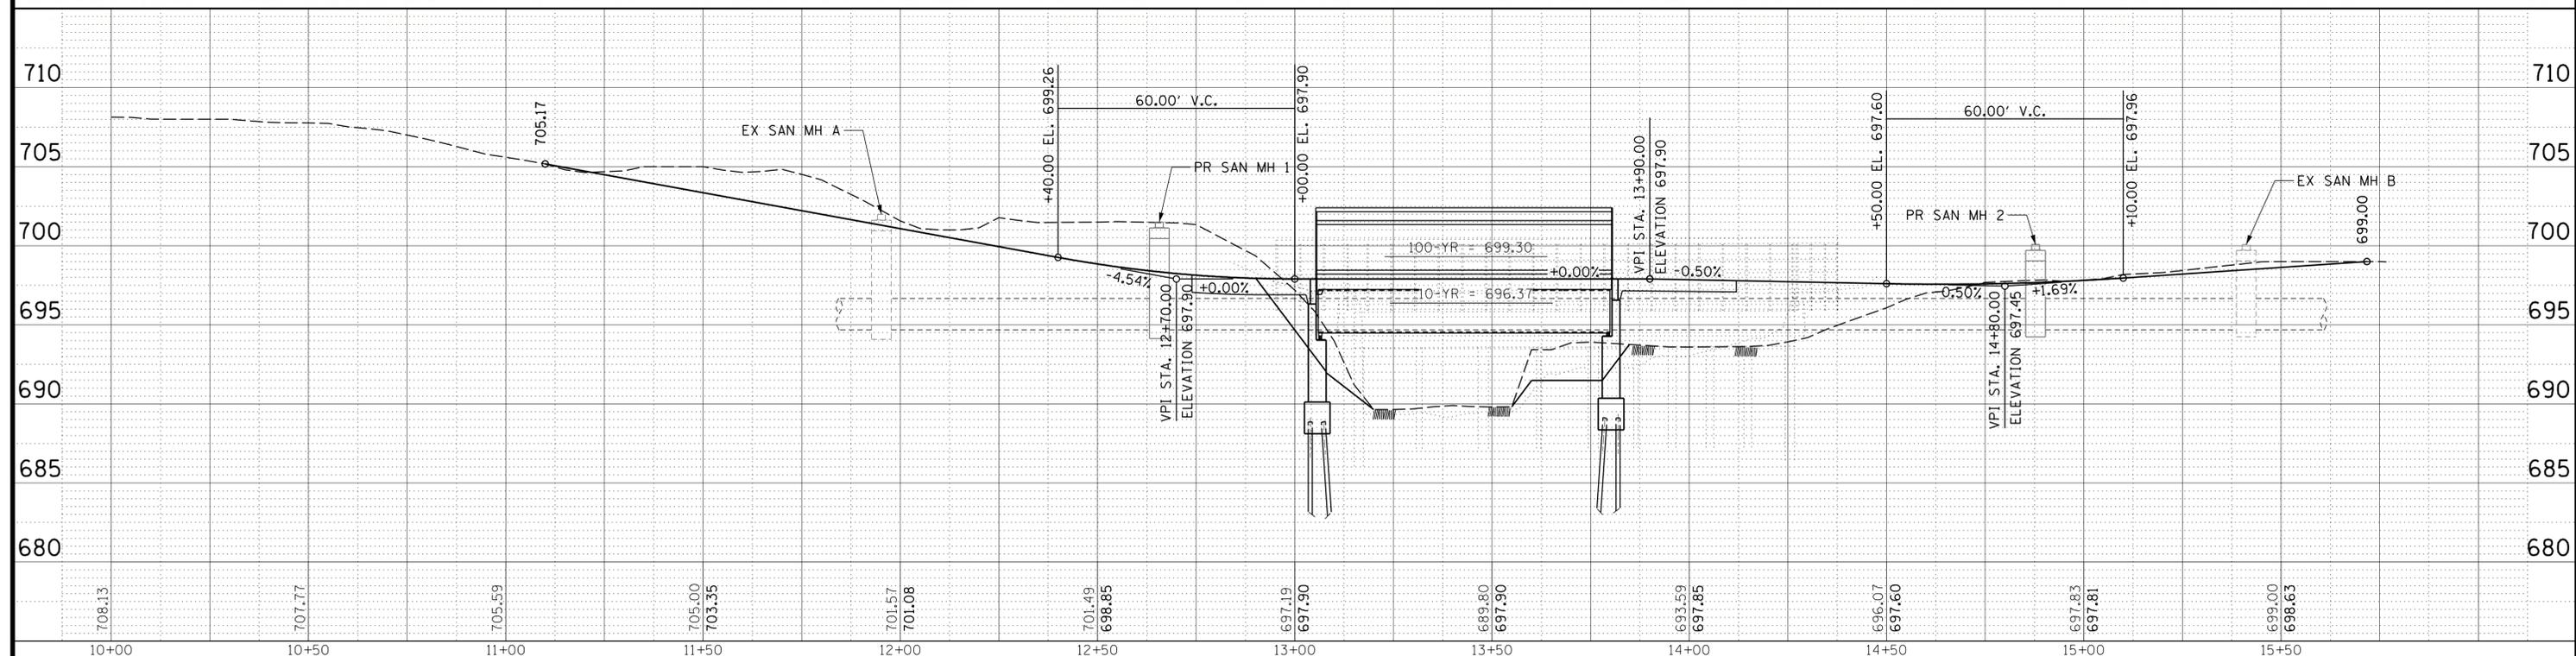
PROJ. NO. 230312
DATE: 8/28/2024
SHEET OF
DRAWING NO.
B-3

Ex. San. MH A
Sta = 12+04.71
O/S = 41.16' LT
Rim = 700.57
Inv E 24" PVC = 694.53
Inv W 24" RCP = 694.53 (Ex)
To Be Reconstructed

Pr. San MH 1 - 5' Dia T1F CL
Sta = 12+56.30
O/S = 12.43' LT
Rim = 701.50
Inv E 24" DIP = 694.59
Inv W 24" PVC = 694.59

Pr. San MH 2 - 5' Dia T1F CL
Sta = 15+69.05
O/S = 68.73' RT
Rim = 700.00
Inv E 24" PVC = 694.80
Inv W 24" DIP = 694.80

Ex. San. MH B
Sta = 12+04.71
O/S = 41.16' LT
Rim = 701.73
Inv E 24" RCP = 694.88 (Ex)
Inv W 24" PVC = 694.88
To Be Reconstructed

Per the request of the DGSD, the pipe will be PVC from the existing manholes to the proposed manholes, and the segment between proposed manholes and attached to the bridge will be ductile iron pipe (DIP) with flexible joints. These materials will allow for flexibility in the pipe in order to accommodate bridge movements. The connection of the proposed sewer to the bridge is dependent on the superstructure type. Regardless of bridge type selected, the proposed sewer must also remain at its current elevation across the bridge. The average invert of the sewer is 694.7 across the bridge, and the proposed sewer will have a slope of approximately 0.086%.

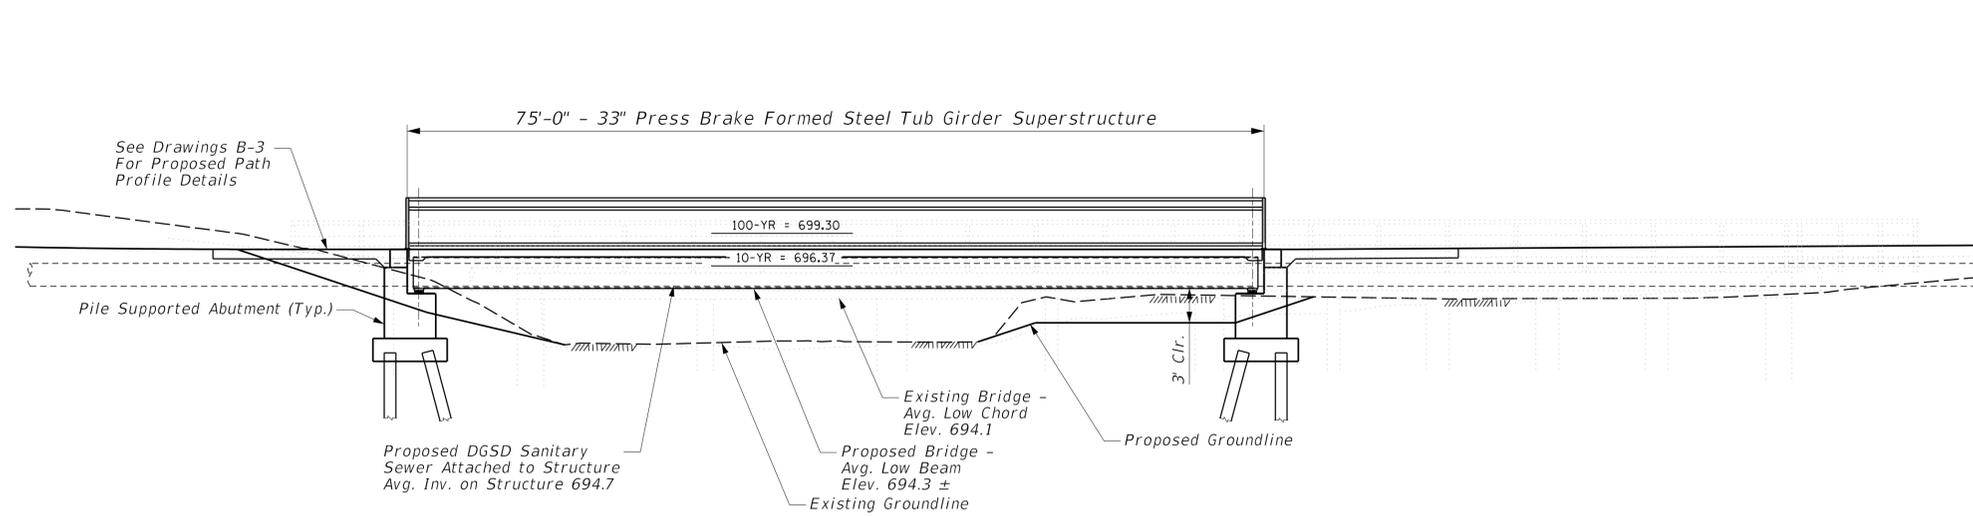
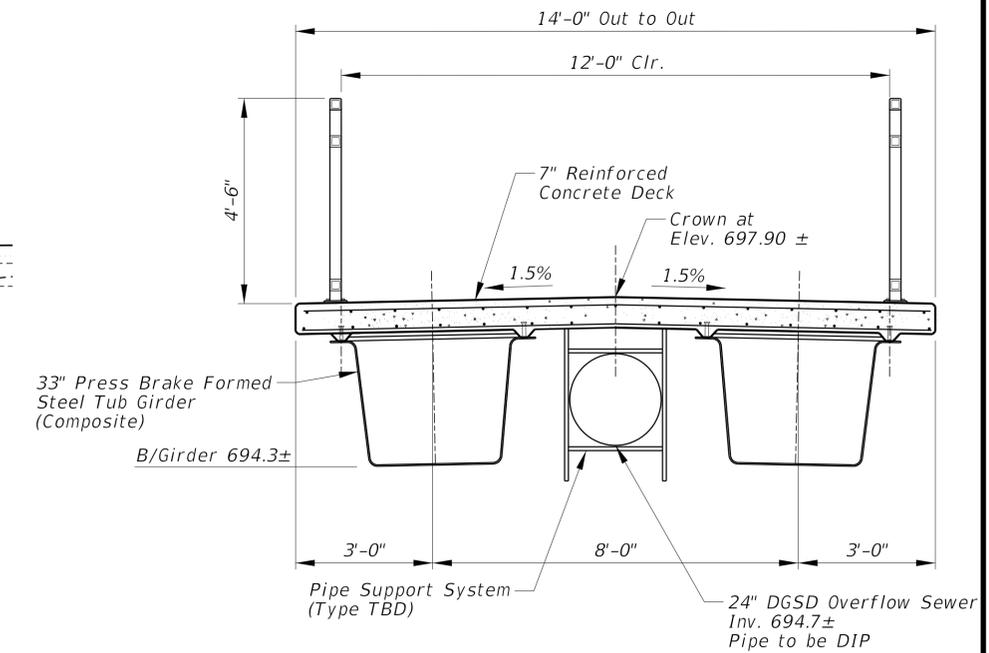
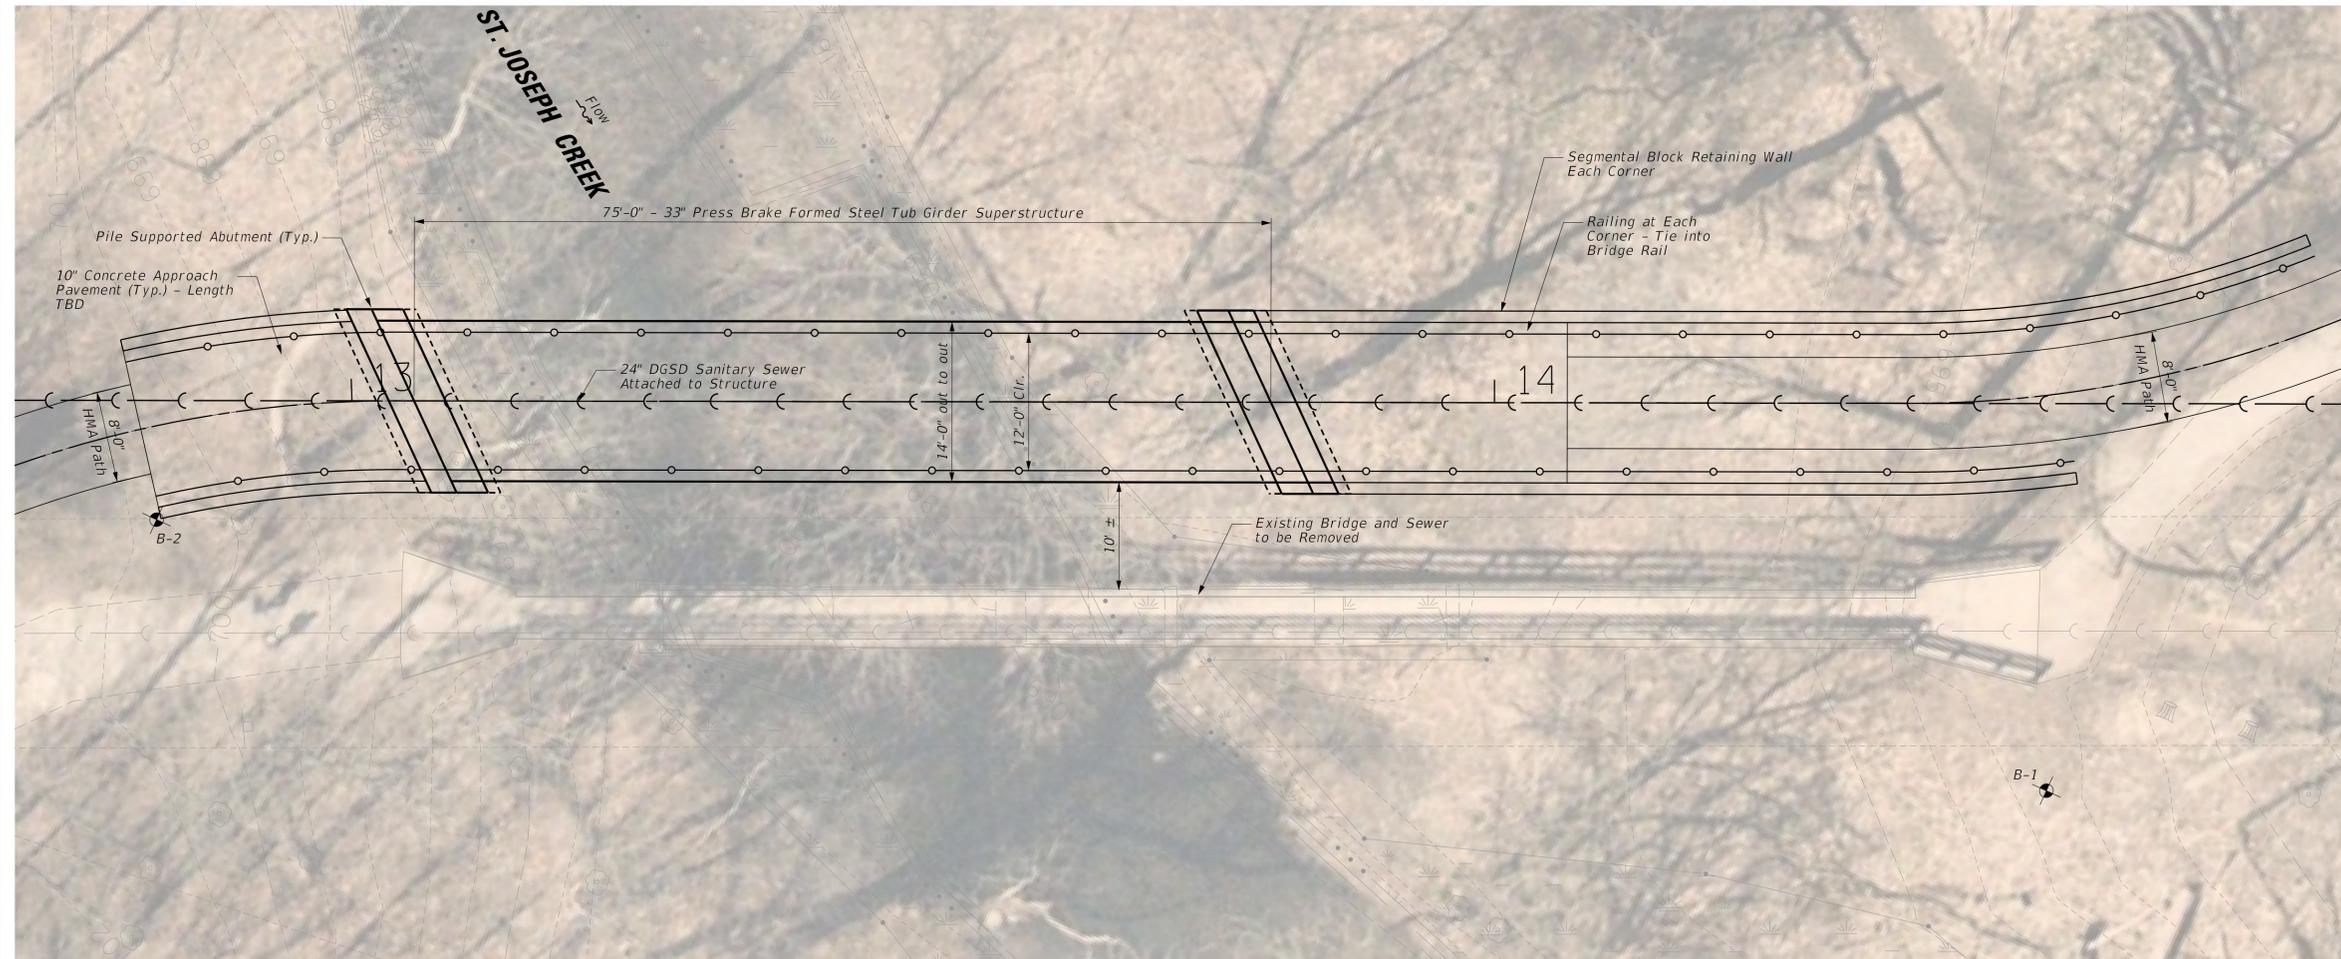
PROJ. NO. 230312
 DATE: 8/28/2024
 SHEET OF
 DRAWING NO.
D-3

ELEVATION

Approximate Opening Under Proposed Bridge - 276 sf

TYPICAL SECTION

PLAN

This refined alternative has all of the advantages noted above, including an increase in the opening under the structure. The opening will increase to 276 sf (vs. 206 sf existing), or roughly a 34% increase. Further analysis shows that a pier is not required for strength or serviceability requirements. Per correspondence with Valmont, live load deflection with a 75 ft span will be well below the AASHTO requirement of $L/360$. While the west approach to the bridge is steeper for the tub girder options than the truss options, all code requirements are still satisfied.
