Grounds and Natural Resource Management Operational Assessment and Logistics Plan Evaluation Report

May 10, 2022

Prepared By:

KNIGHT

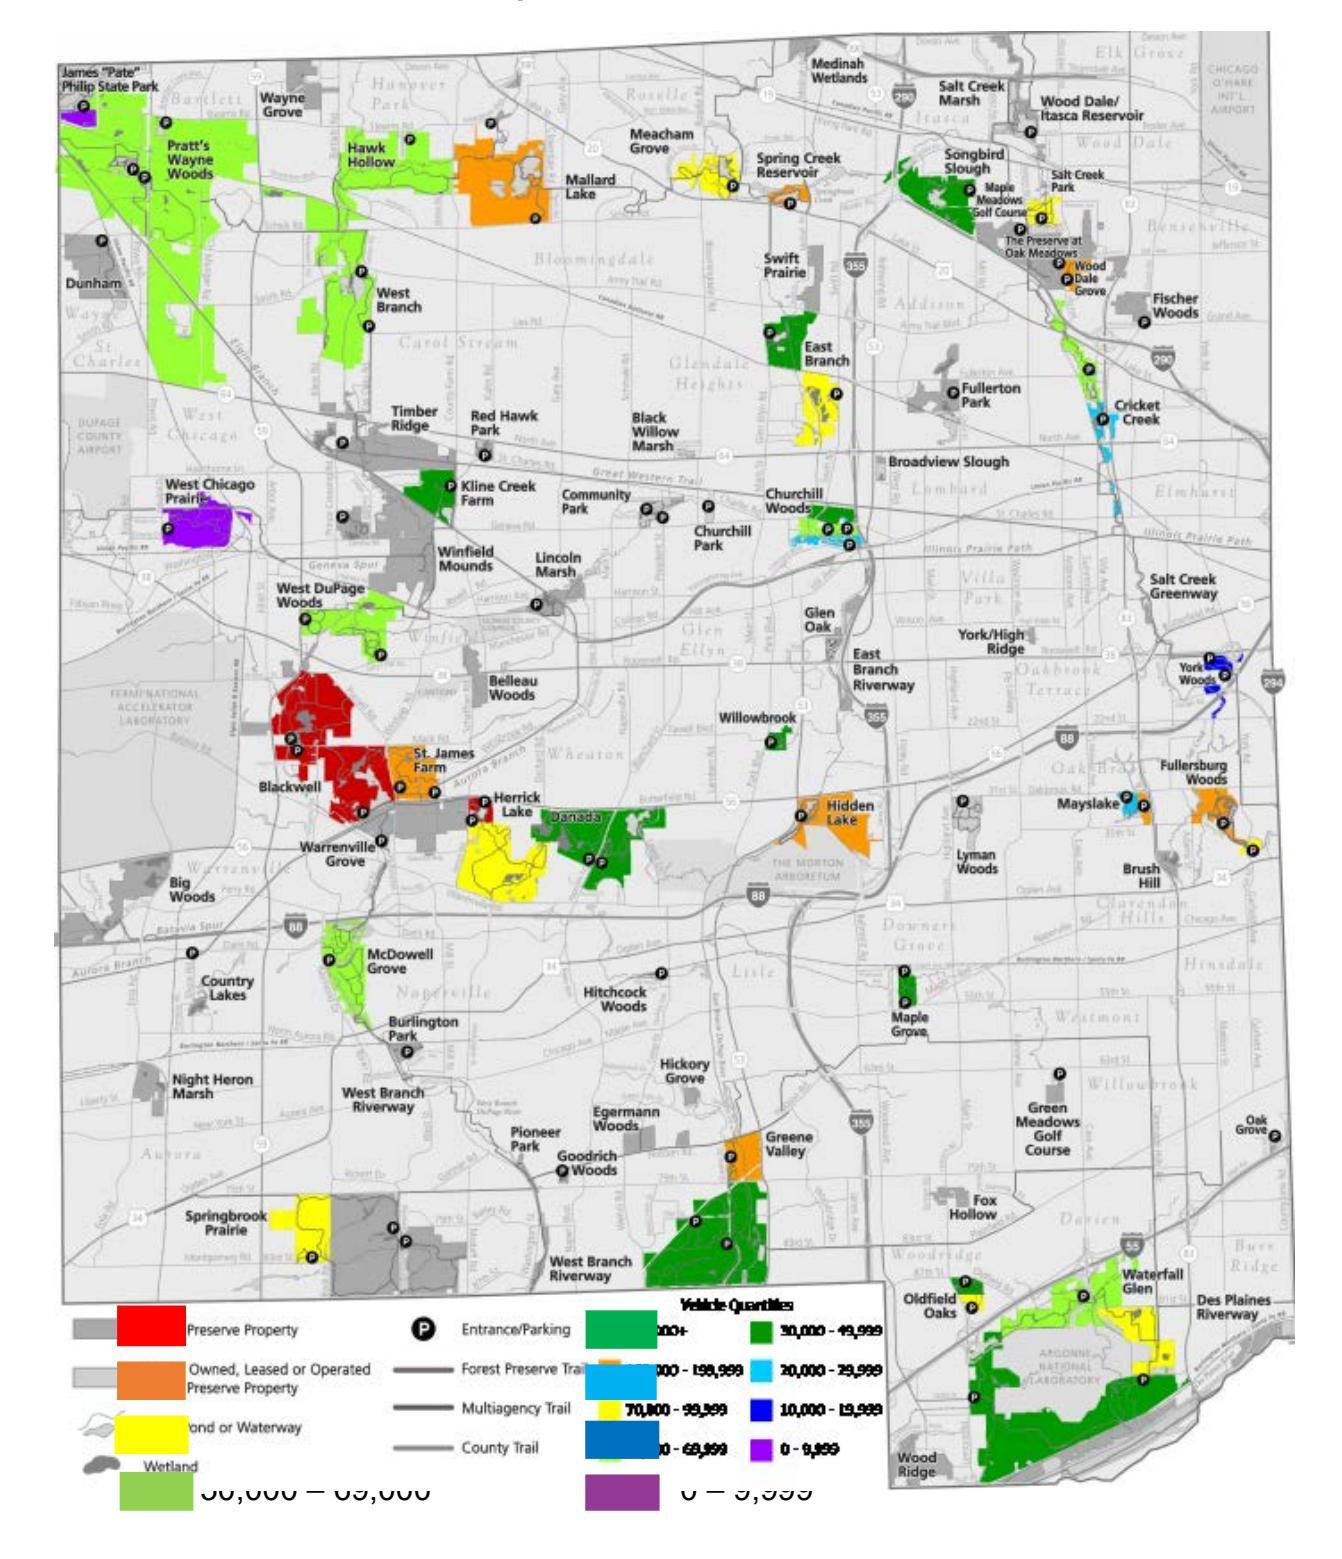
2.1 Preserve Heat Map

Ons	Preserve	2016	2017	% Change	2018	% Change	2019	% Change	2020	% Change	Grounds Crew Total Labor Hours
0 0 3		(1)	(1)	2016 to 2017	(1)(2)	2017 to 2018	(1)	2018 to 2019	(1)(2)	2019 to 2020	2016 thru 2020 (3)
BSO	Blackwell - Main	160,480	164,915	3%	151,894	-8%	147,027	-3%	254,357	73%	42,806.28
BSO	Danada	61,420	58,288	-5%	44,592	-23%	30,855	-31%	45,806	48%	22,947.08
BSO	Elsen's Hill	11,620	11,372	-2%	10,581	-7%	9,692	-8%	18,576	92%	
BSO	Hawk Hallow – Off Leash Dog	39,217	44,174	13%	39,378	-11%	44,902	14%	53,722	20%	4,020.44
BSO	Herrick Lake - Main	87,681	94,992	8%	83,443	-12%	85,094	2%	207,417	144%	0 258 25
BSO	Herrick Lake – South	67,636	70,940	5%	65,745	-7%	67,197	2%	82,087	22%	9,338.23
BSO	Klein Creek Farms	31,947	32,532	2%	30,699	-6%	31,772	3%	43,268	36%	
BSO	Mallard Lake	64,254	83,424	30%	77,453	-7%	81,229	5%	158,976	96%	4,881.85
BSO	McDowell Grove	53,968	34,005	-37%	28,708	-16%	37,796	32%	51,981	38%	3,670.50

2. Both the 2018 and 2020 data tend to skew any pattern in the limited amount of data available. The 2018 data indicates a decrease in vehicular activity at the Forest Preserves; the cause of this decline is unknown. The significant increase in the vehicular activity indicated in the 2020 data more than likely represents Forest Preserve usage due the Covid 19 pandemic.

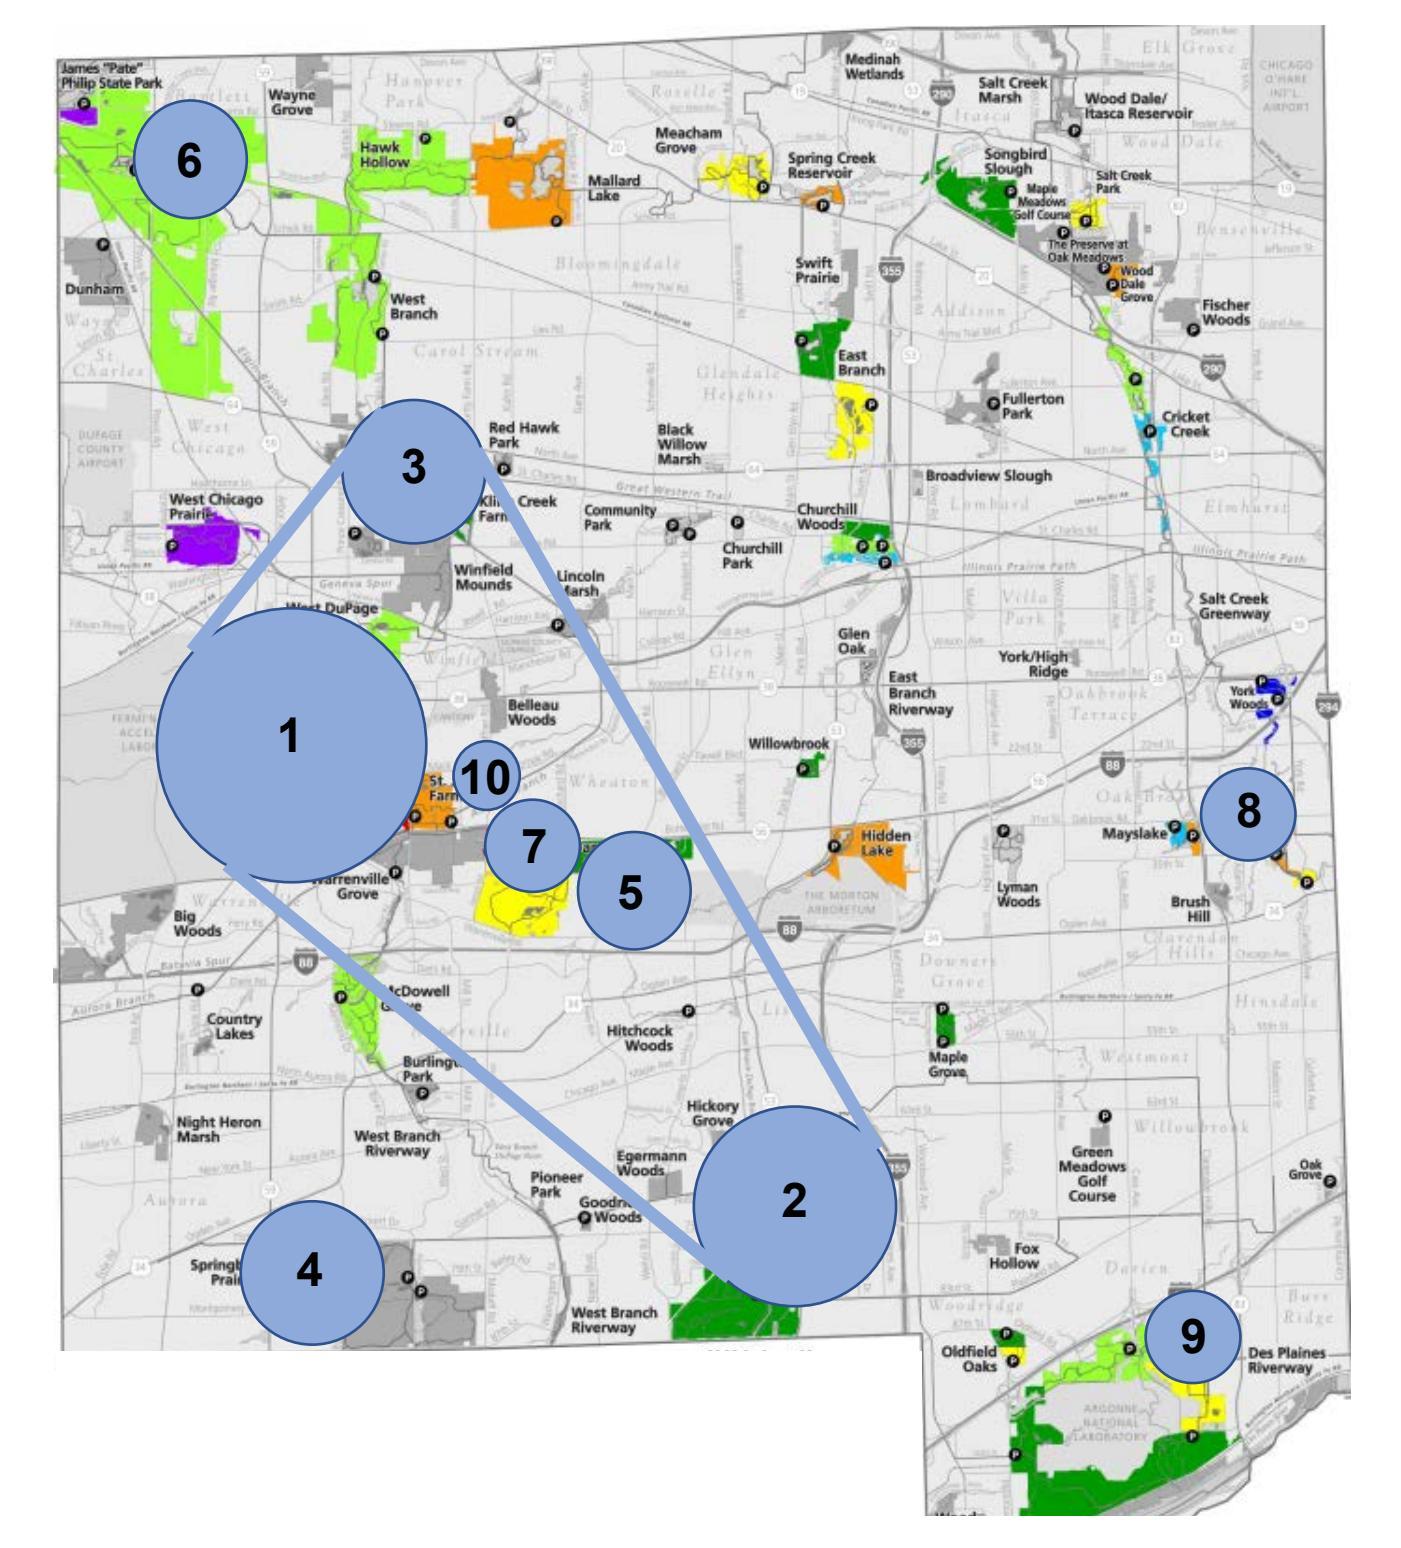
This map represents the top 10 locations that contain the most Trail Systems that are required to be maintained by Forest Preserve Crews. As a result, they in turn represent the top 10 locations where these Crews spend the most time throughout the year. It is anticipated that the best location to support these services would be centrally within the area they contain.

1.	Blackwell	9,171 Hours
2.	Greene Valley	4,548 Hours
3.	Timber Ridge	3,174 Hours
4.	Springbrook Prairie	3,031 Hours
5.	Danada	2,604 Hours

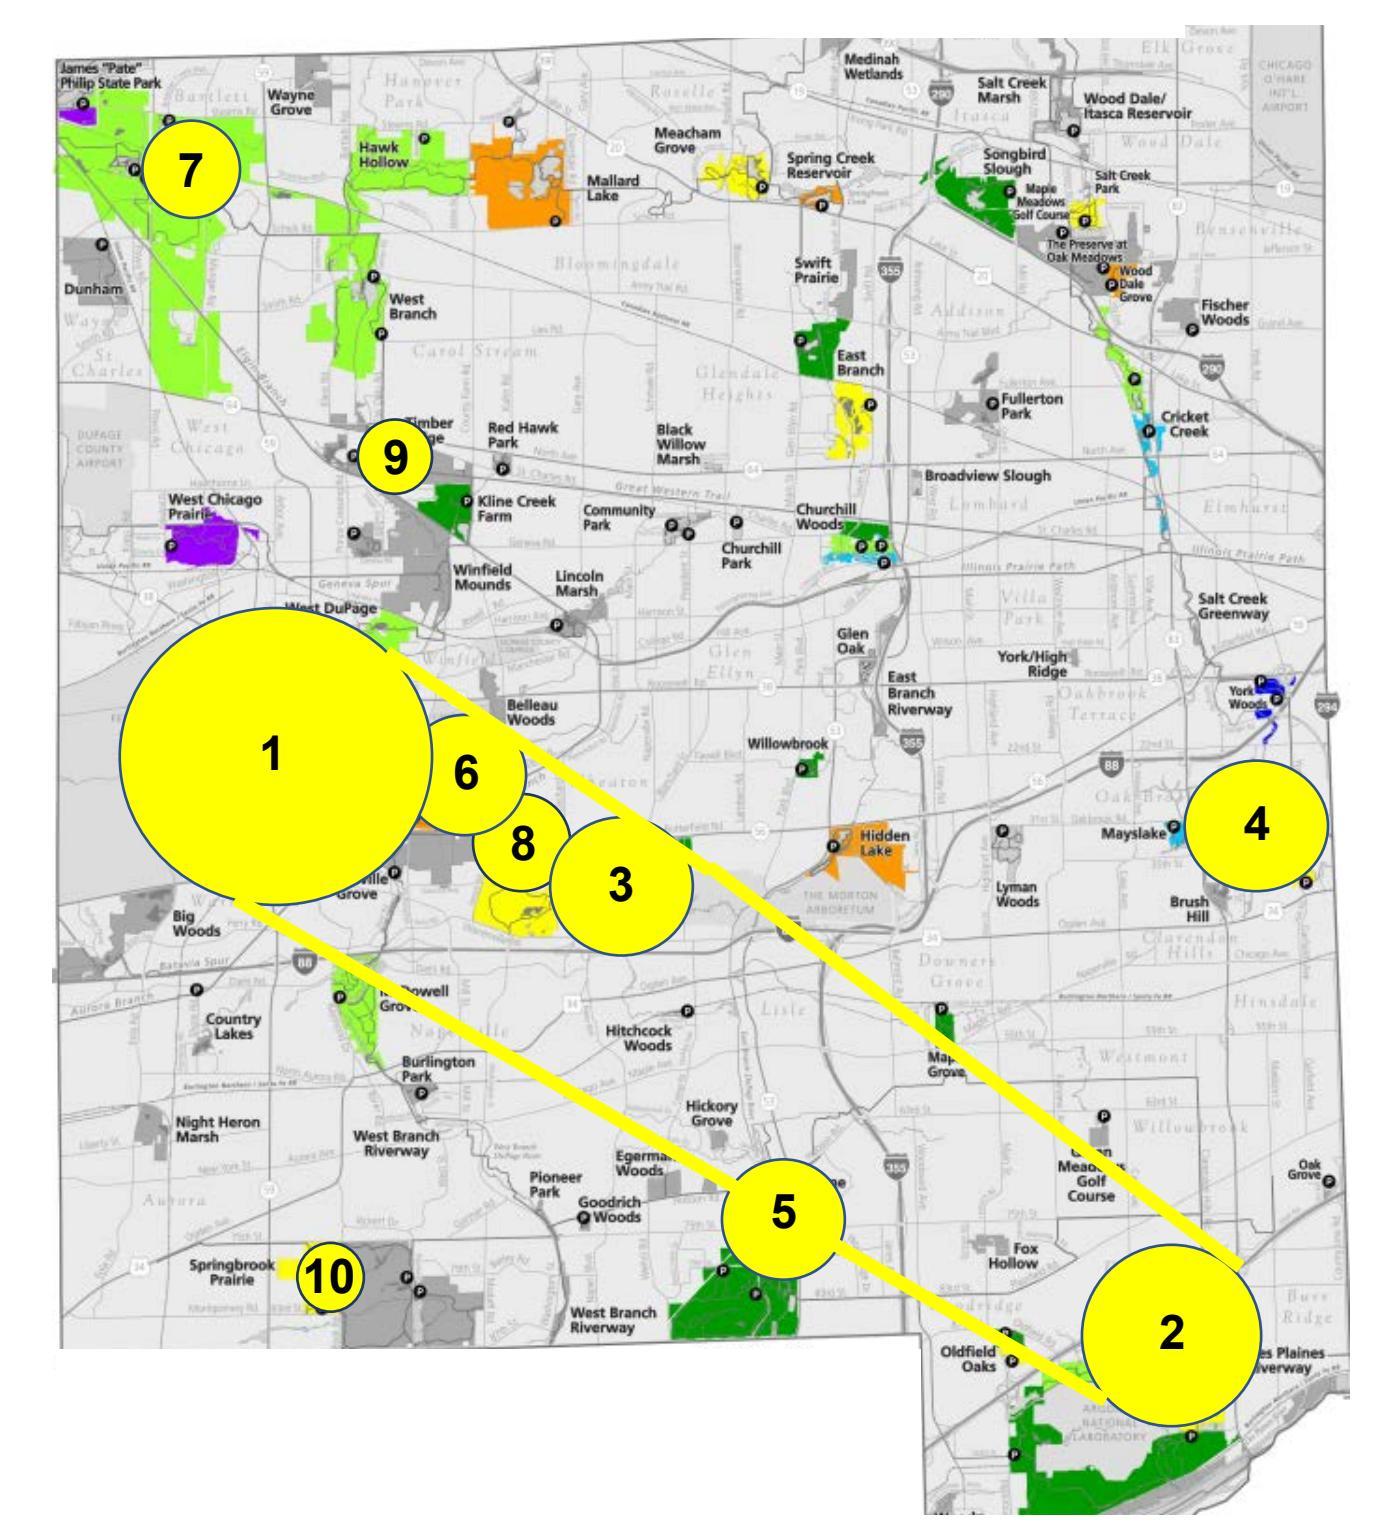
Roadways and Parking Lots – Crew Access Analysis 2.3

This map represents the top 10 locations that contain the most Roadways and Parking Lots that are required to be maintained by Forest Preserve Crews. As a result, they in turn represent the top 10 locations where these Crews spend the most time throughout the year. It is anticipated that the best location to support these services would be centrally within the area they contain.

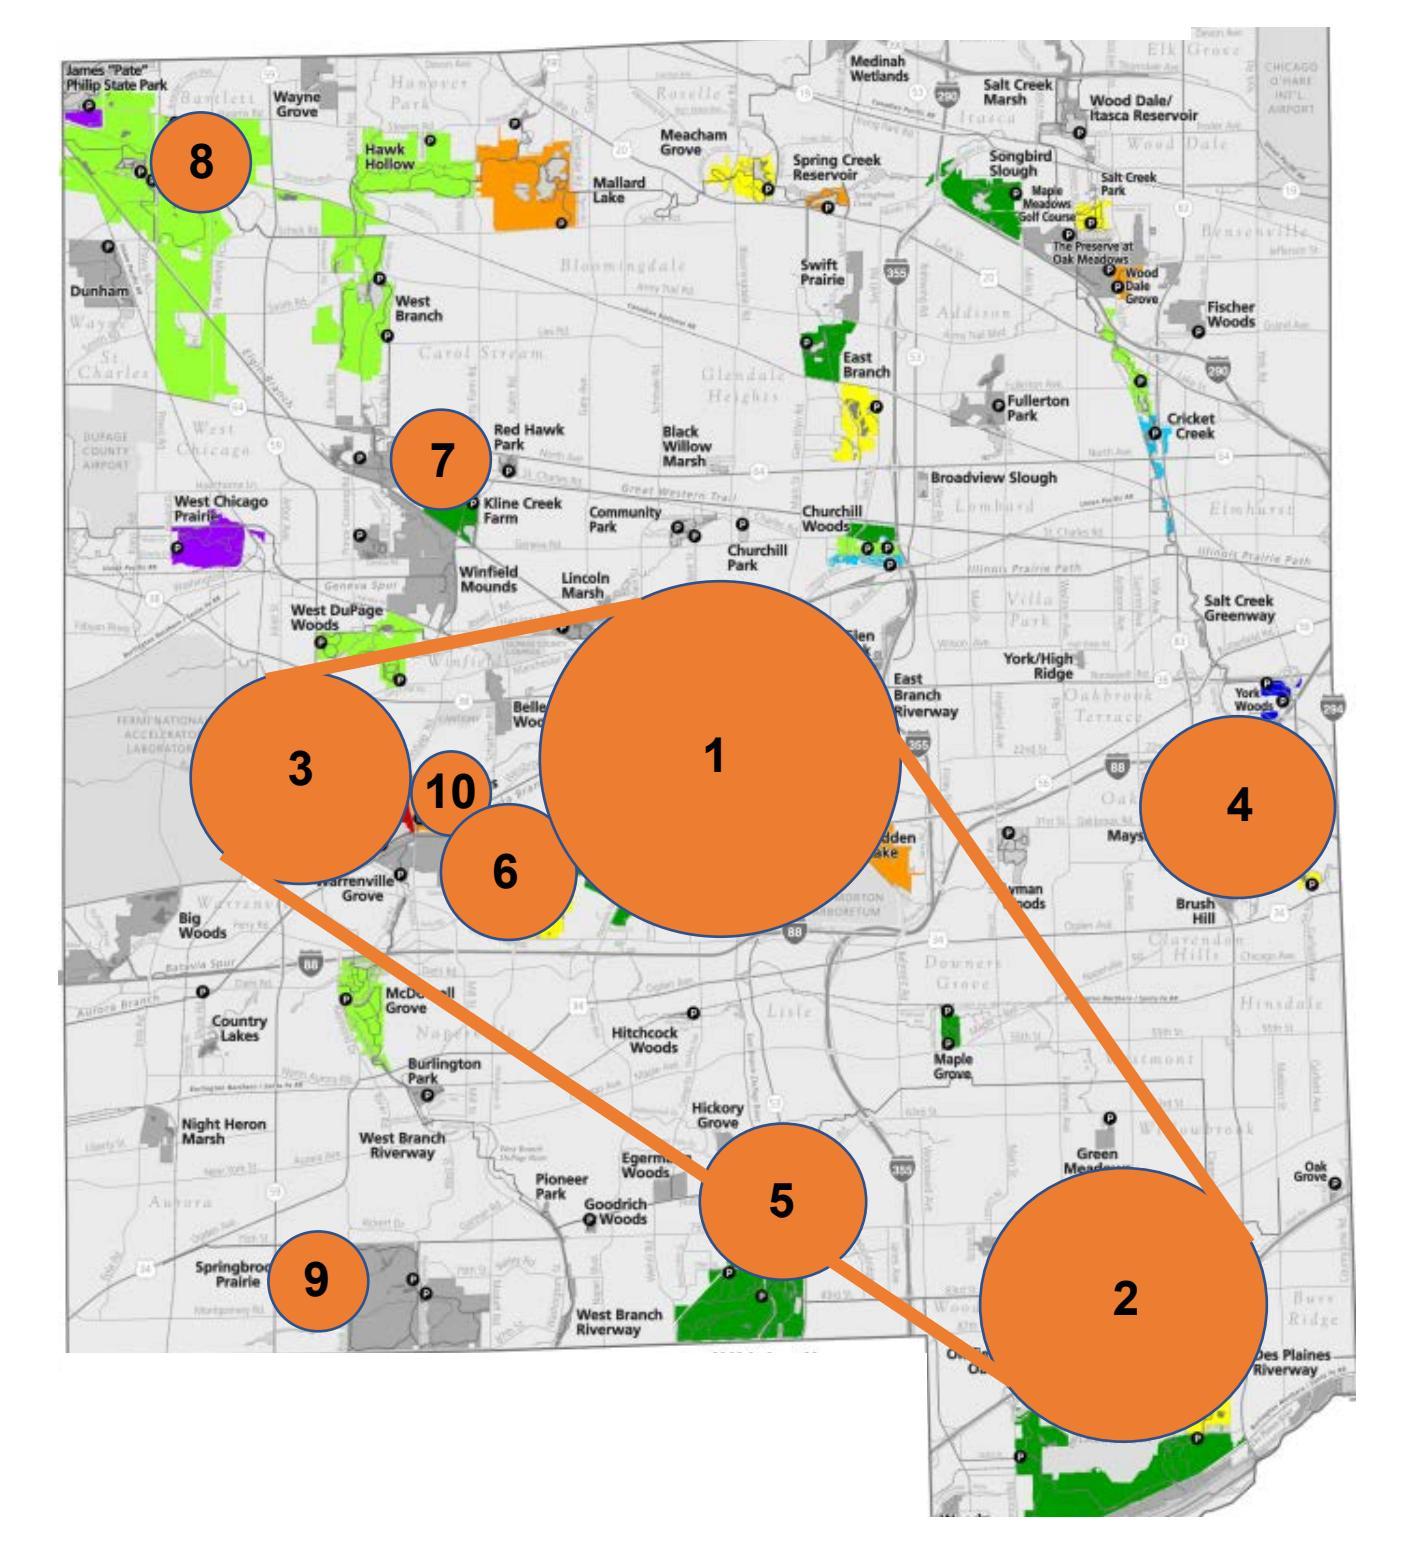
Landscape – Crew Access Analysis 2.4

This map represents the top 10 locations that contain the most Landscaping Areas that are required to be maintained by Forest Preserve Crews. As a result, they in turn represent the top 10 locations where these Crews spend the most time throughout the year. It is anticipated that the best location to support these services would be centrally within the area they contain.

1.	Danada	12,359 Hours
2.	Waterfall Glen	9,816 Hours
3.	Blackwell	7,553 Hours
4.	Fullersburg Woods	5,753 Hours
5.	Greene Valley	4,553 Hours

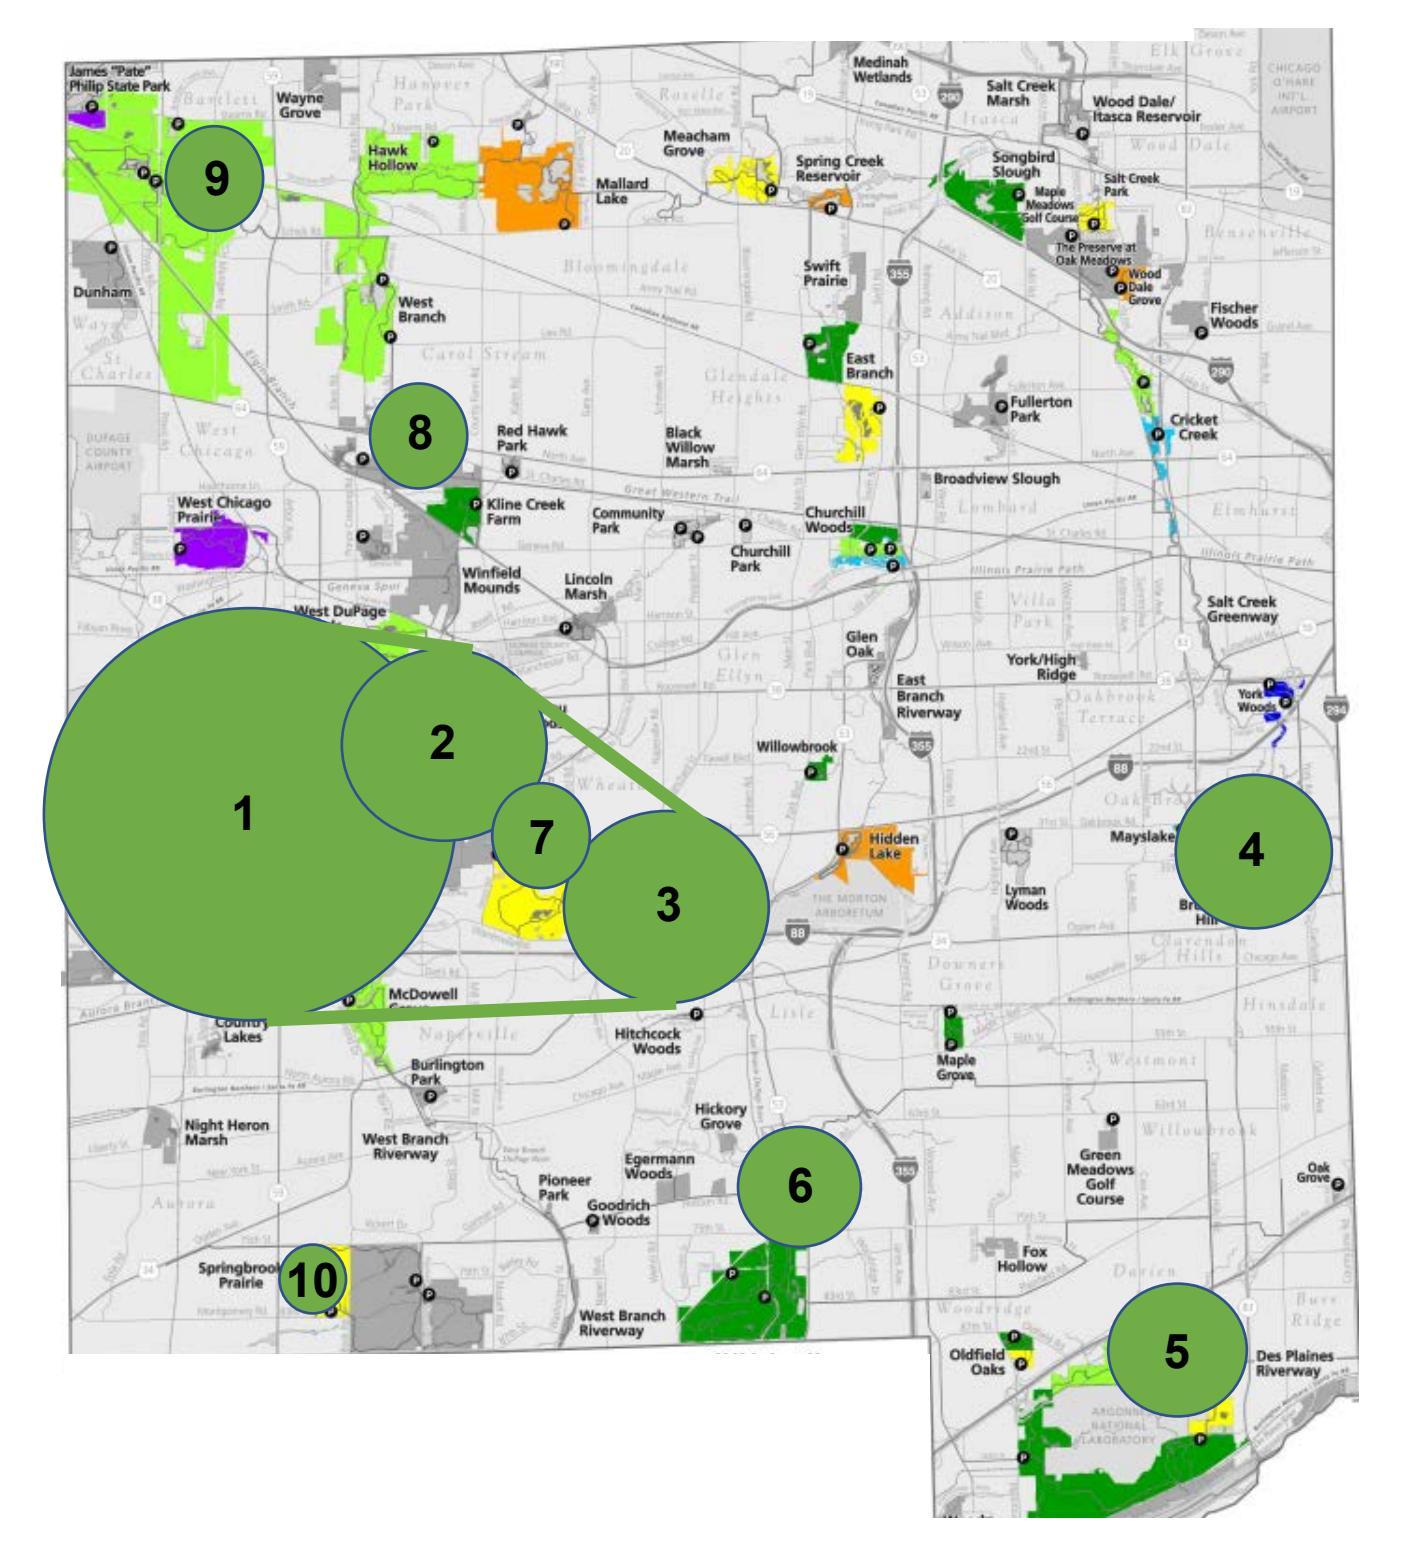
Forestry – Crew Access Analysis 2.5

This map represents the top 10 locations that contain the most Forestry Areas that are required to be maintained by Forest Preserve Crews. As a result, they in turn represent the top 10 locations where these Crews spend the most time throughout the year. It is anticipated that the best location to support these services would be centrally within the area they contain.

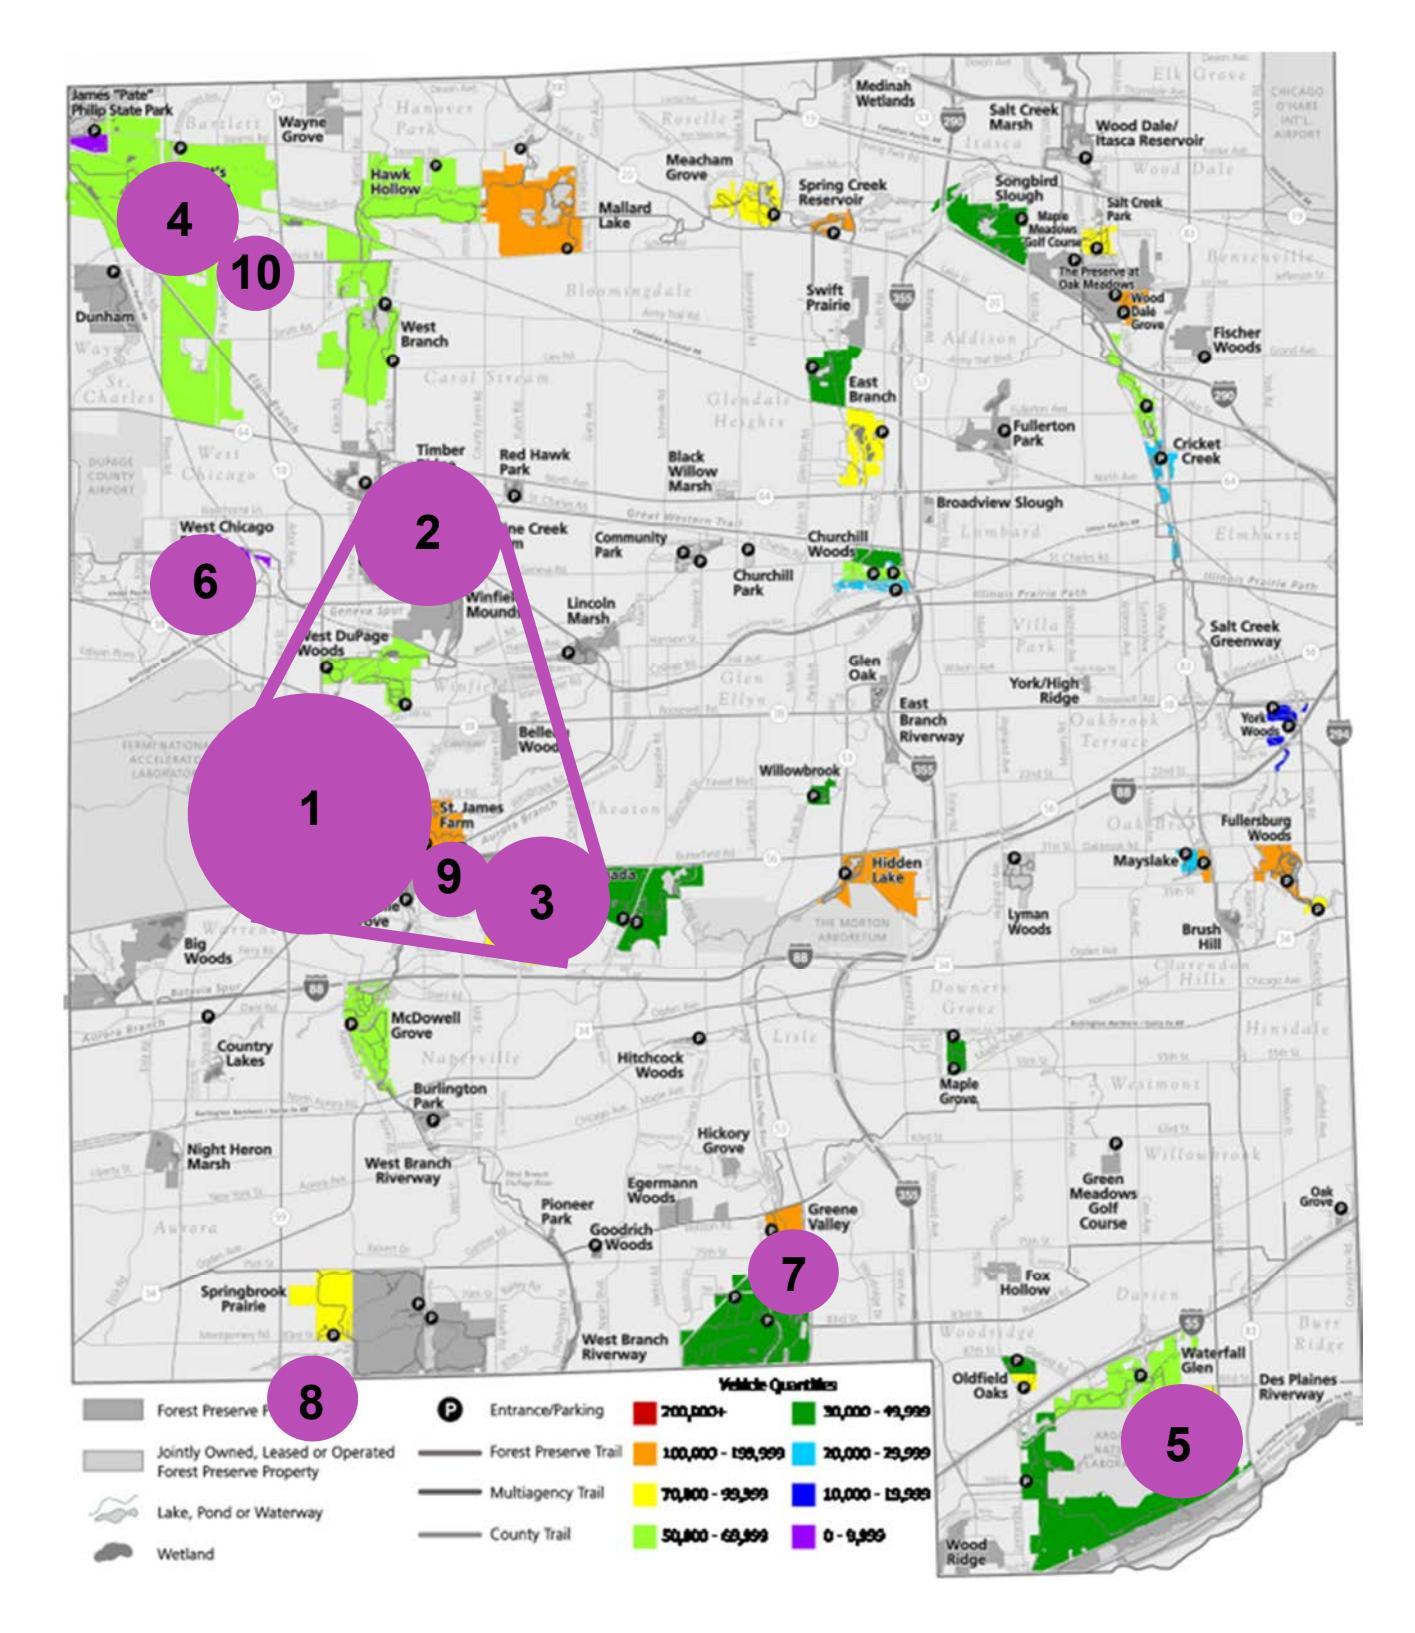
2.6 Natural Resources – Crew Access Analysis

This map represents the top 10 locations that contain the most Natural Resource Areas that are required to be maintained by Forest Preserve Crews. As a result, they in turn represent the top 10 locations where these Crews spend the most time throughout the year. It is anticipated that the best location to support these services would be centrally within the area they contain.

6.	West Chicago Prairie	2,376
7.	Green Valley	1,728
8.	Springbrook Prairie	1,703
9.	St James Farm	1,197
10.	Dunham	1,124

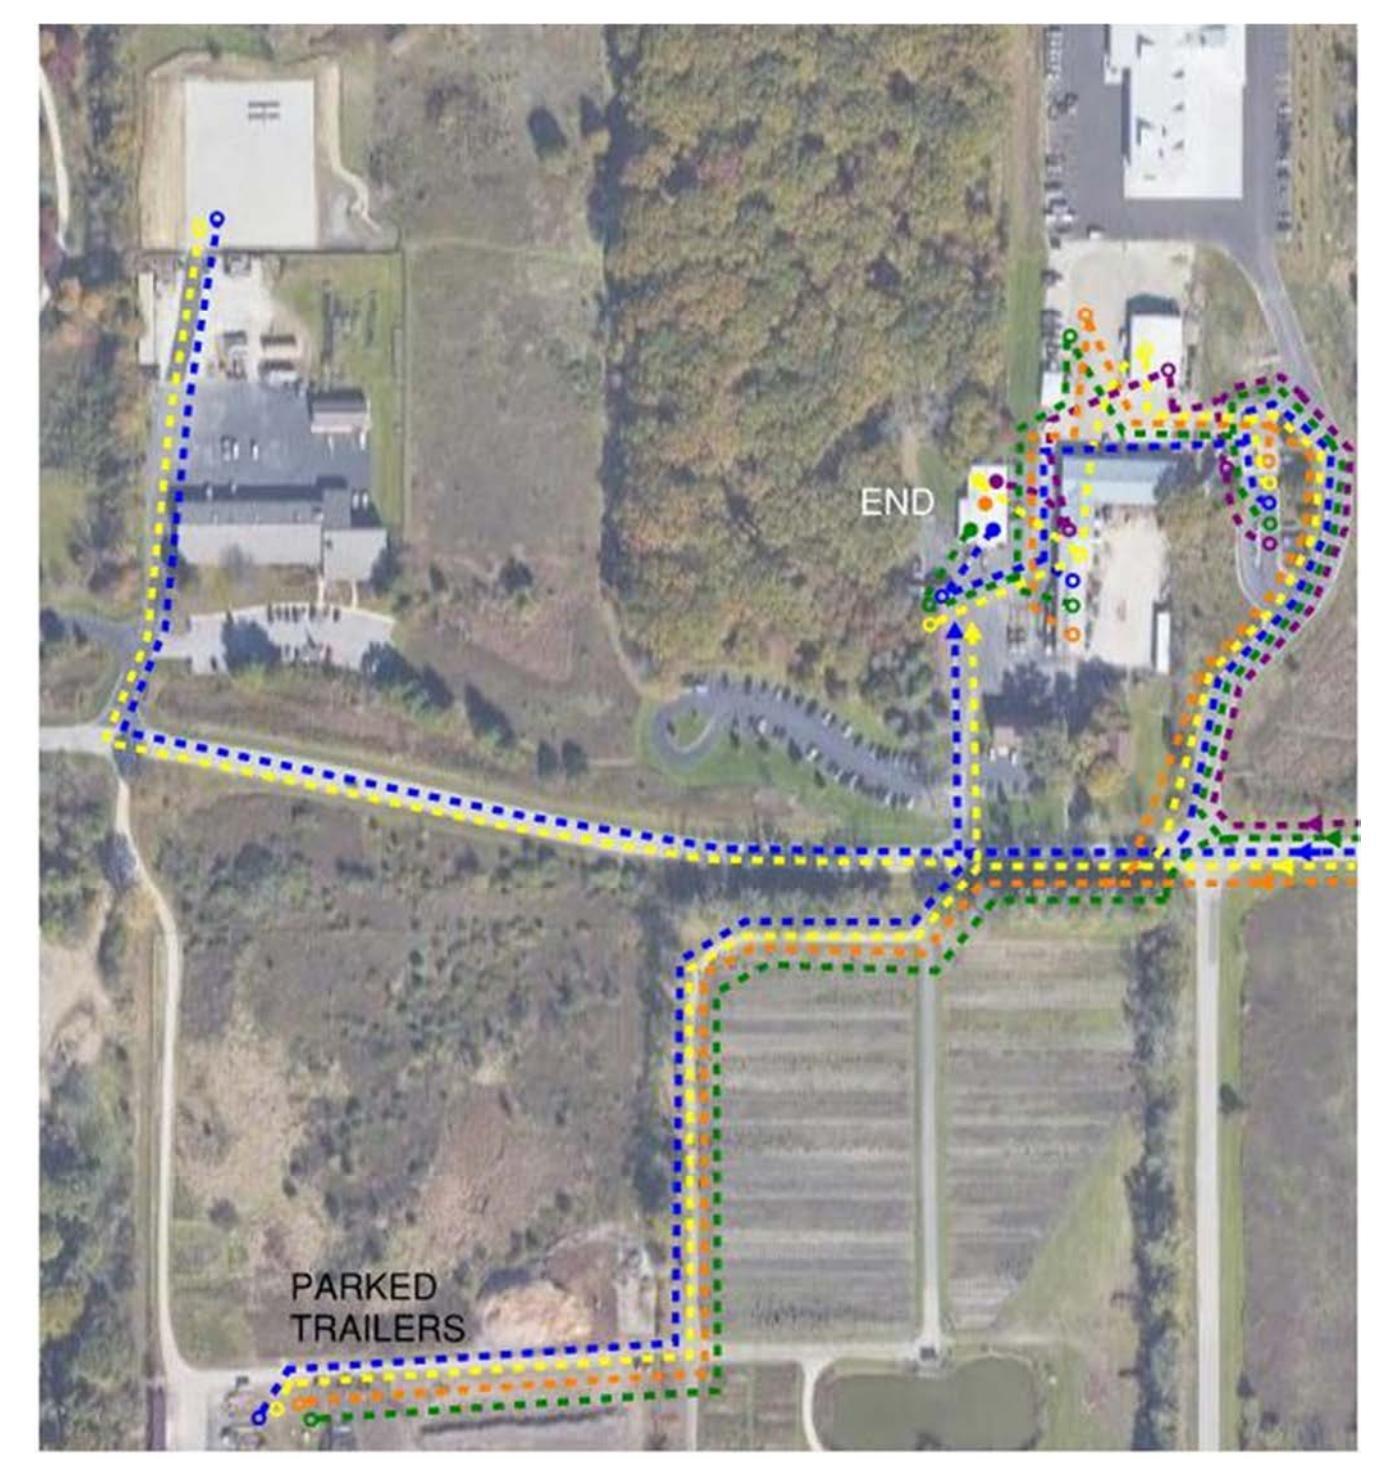
All crews end their day at the refueling station located on the east end of the Blackwell Site – this is cause for lengthy waits and inefficiencies. This may add up to 15 minutes per vehicle per refueling instance. On some occasions, refueling is done in the morning whenever possible to offset the afternoon delays.

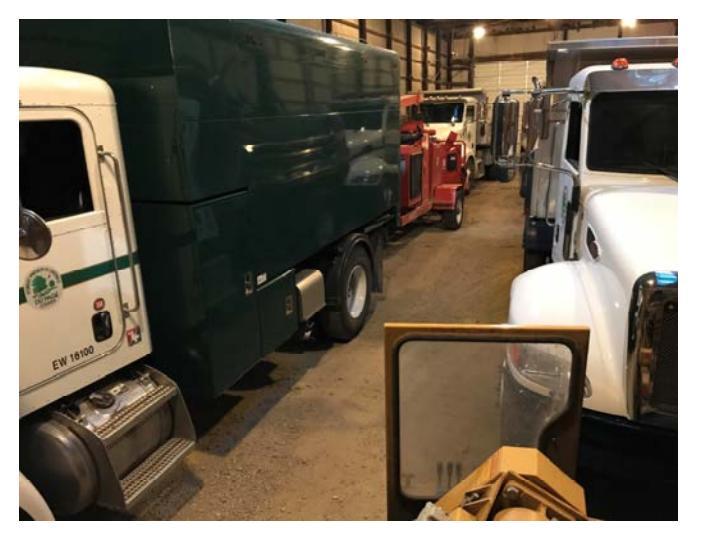
- Constructed in 1980.
- Approximately 1,536 square feet. ٠
- The construction consists of a wood framed pole barn with corrugated metal roof and wall panels, space, accessed with a wood framed stair.
- electric exhaust fan is mounted on the East wall.

The building has inadequate thermal and moisture protection of the wall and roof assemblies lead-

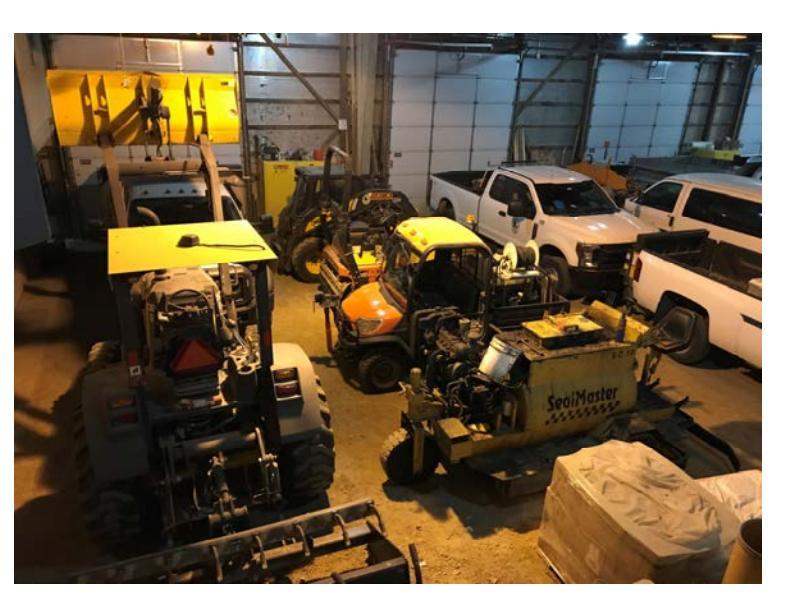
This insulation product is exposed to the interior of the building and can pose a fire and smoke de-

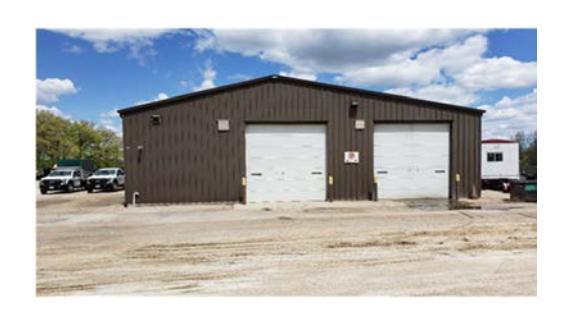
Building BW-026 Chemical Mixing & Vehicle Wash – 2 Bays

• Approximately 4,680 square feet. • The construction consists of a pre-engineered metal frame with corrugated metal roof and wall panels, interior concrete masonry (CMU) partitions, and a concrete floor.

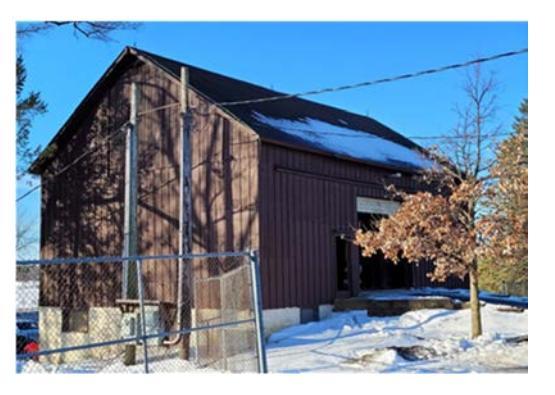
We were informed that roof leaks are present and in need of repair. The current condition has led

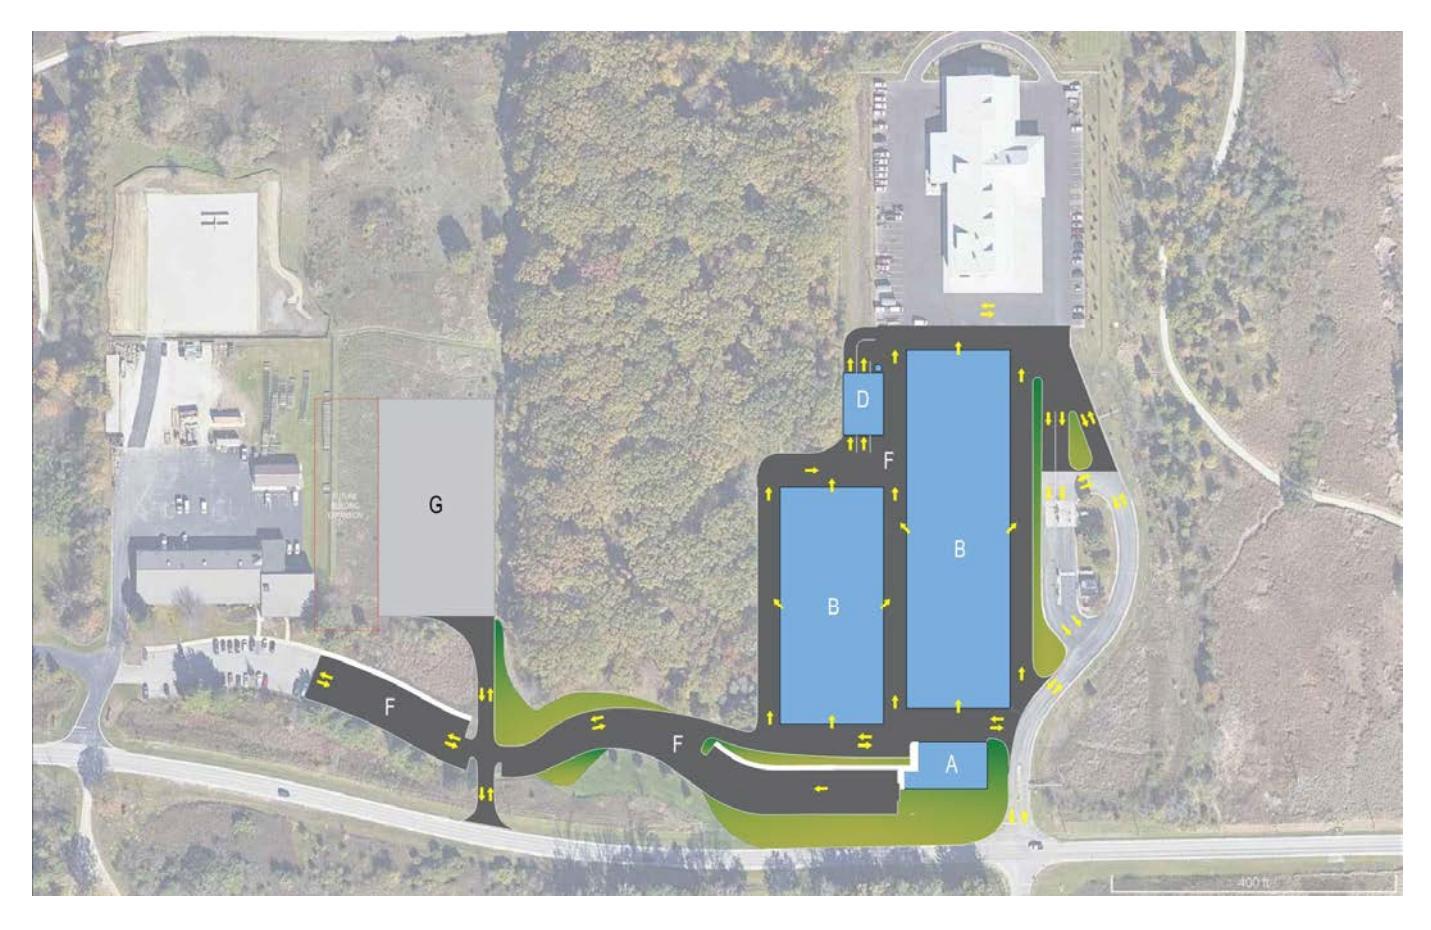
FPDDC- Grounds and Natural Resources – Scheme A.1 6.1

- A ADMINISTRATIVE OFFICES AND LOCKER ROOMS
- **B GARAGES, EQUIPMENT STORAGE & SHOP AREAS**
- C GARAGES (UNHEATED) NOT USED
- **D VEHICLE WASH AND CHEMICAL MIXING**
- **E SEED PROCESSING & GREENHOUSE**
- F NEW PAVED PARKING AREA FOR TEMPORARY OF
- G NEW GRAVEL PAVING FOR TEMPORARY VEHICLE
- H EXISTING CONSTRUCTION DEMOLITION

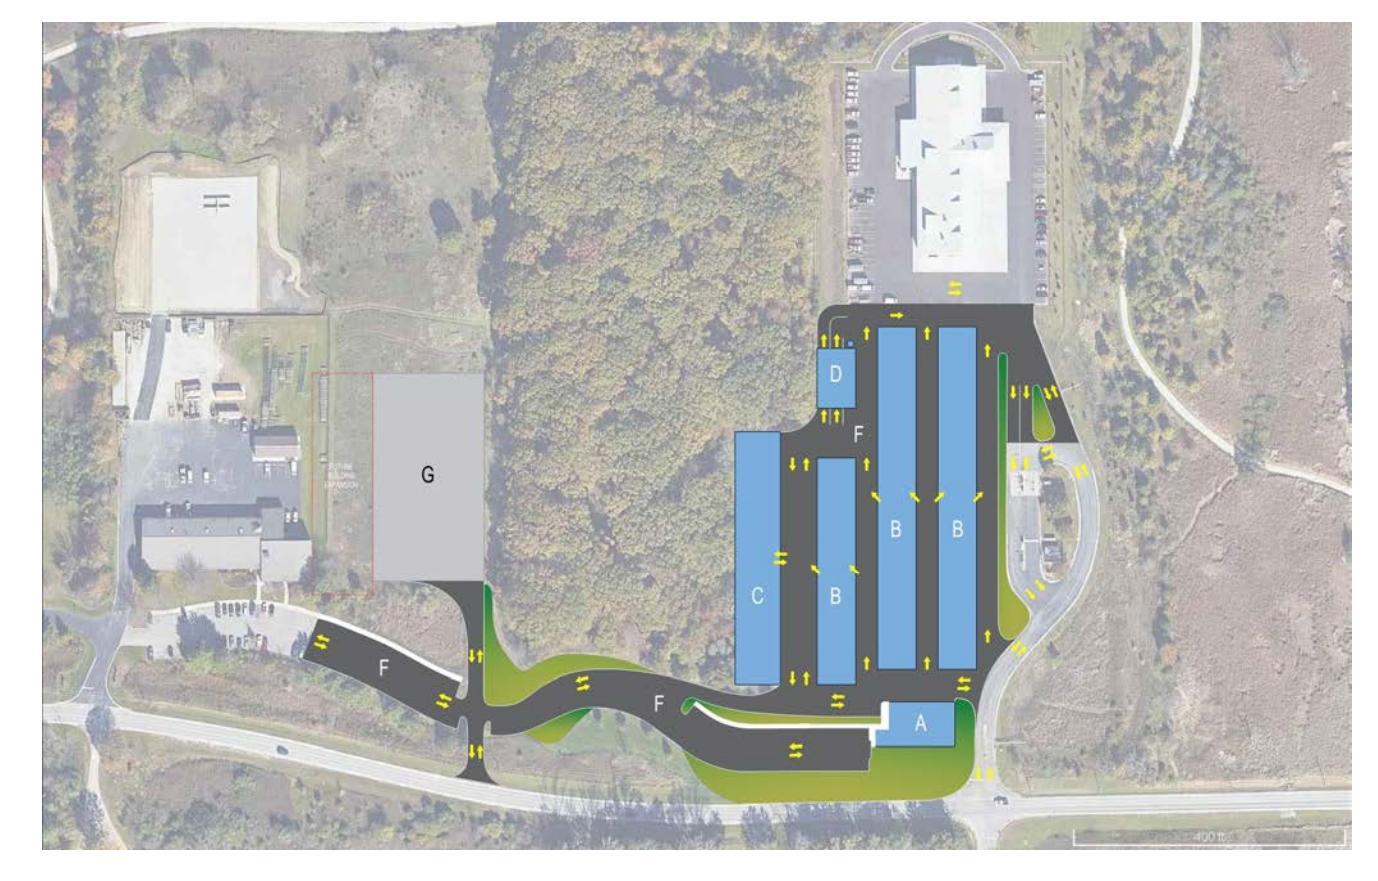
6.2 FPDDC- Grounds and Natural Resources – Scheme A.2

SCHEME A.2 – TOTAL	\$19,070,630
J – UNDERGROUND DETENTION & STORM WATER	\$ 726,335
H – EXISTING CONSTRUCTION DEMOLITION	\$ 372,767
G – NEW GRAVEL PAVING FOR TEMPORARY VEHICLE STAGING	\$ 871,602
F – NEW PAVED PARKING AREA FOR TEMPORARY OFFICE TRAILER STAGING	\$ 479,381
E – SEED PROCESSING & GREENHOUSE	\$ 345,558
D – VEHICLE WASH AND CHEMICAL MIXING	\$ 866,660
C – GARAGES (UNHEATED)	\$ 3,108,315
B – GARAGES, EQUIPMENT STORAGE & SHOP AREAS (HEATED)	\$ 10,346,108
A – ADMINISTRATIVE OFFICES AND LOCKER ROOMS	\$ 1,953,905

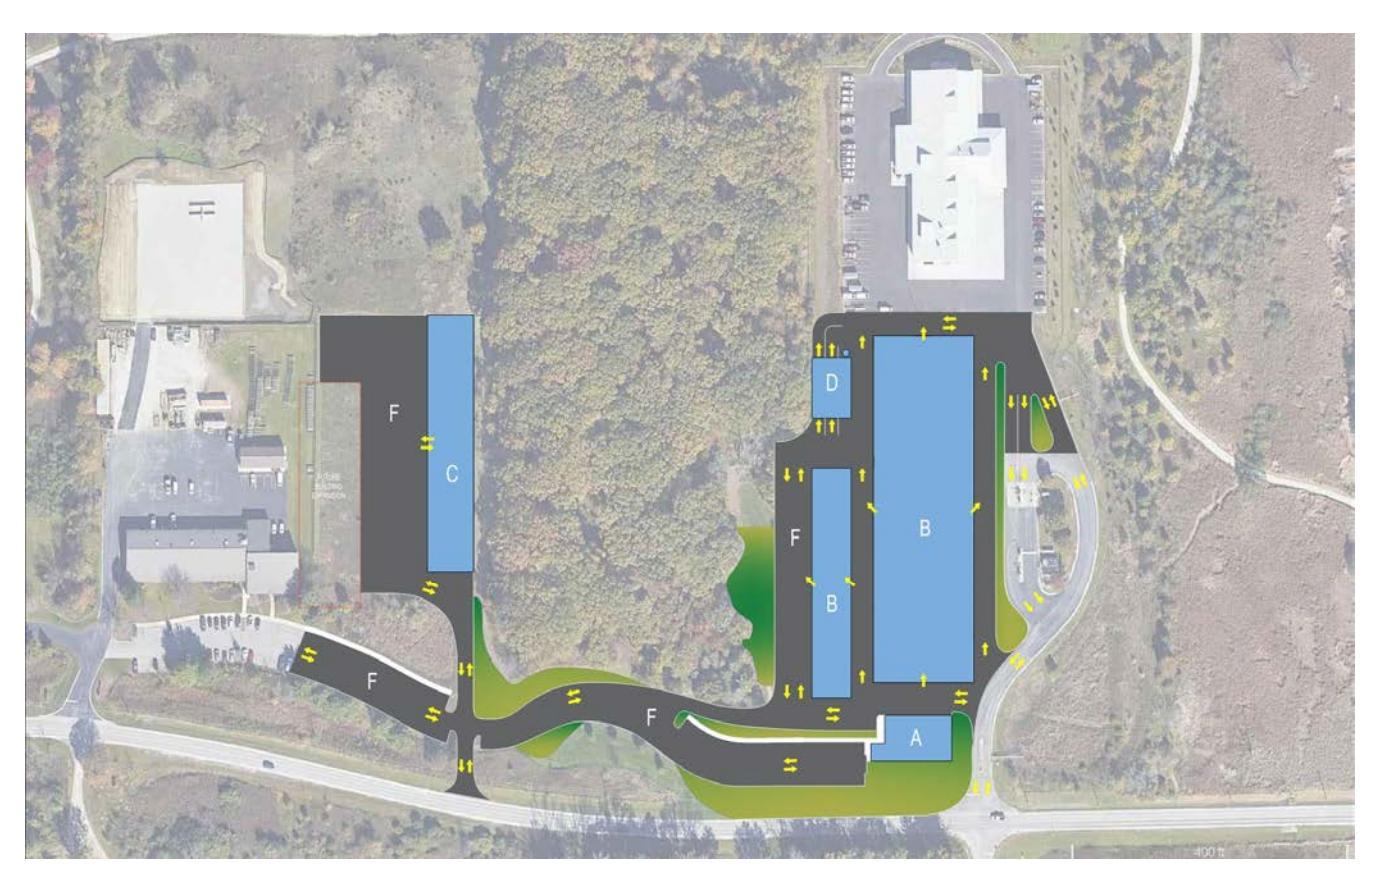
6.3 FPDDC- Grounds and Natural Resources – Scheme A.3

- A ADMINISTRATIVE OFFICES AND LOCKER ROOMS
- B GARAGES, EQUIPMENT STORAGE & SHOP AREAS (H
- C GARAGES (UNHEATED)
- D VEHICLE WASH AND CHEMICAL MIXING
- **E SEED PROCESSING & GREENHOUSE**
- F NEW PAVED PARKING AREA FOR TEMPORARY OFFI
- G NEW GRAVEL PAVING FOR TEMPORARY VEHICLE ST
- H EXISTING CONSTRUCTION DEMOLITION
- J UNDERGROUND DETENTION & STORM WATER
