Mayslake Peabody Estate
Forest Preserve District of DuPage County

Master Plan Report

November 1, 2024

Facility Condition Assessment Report

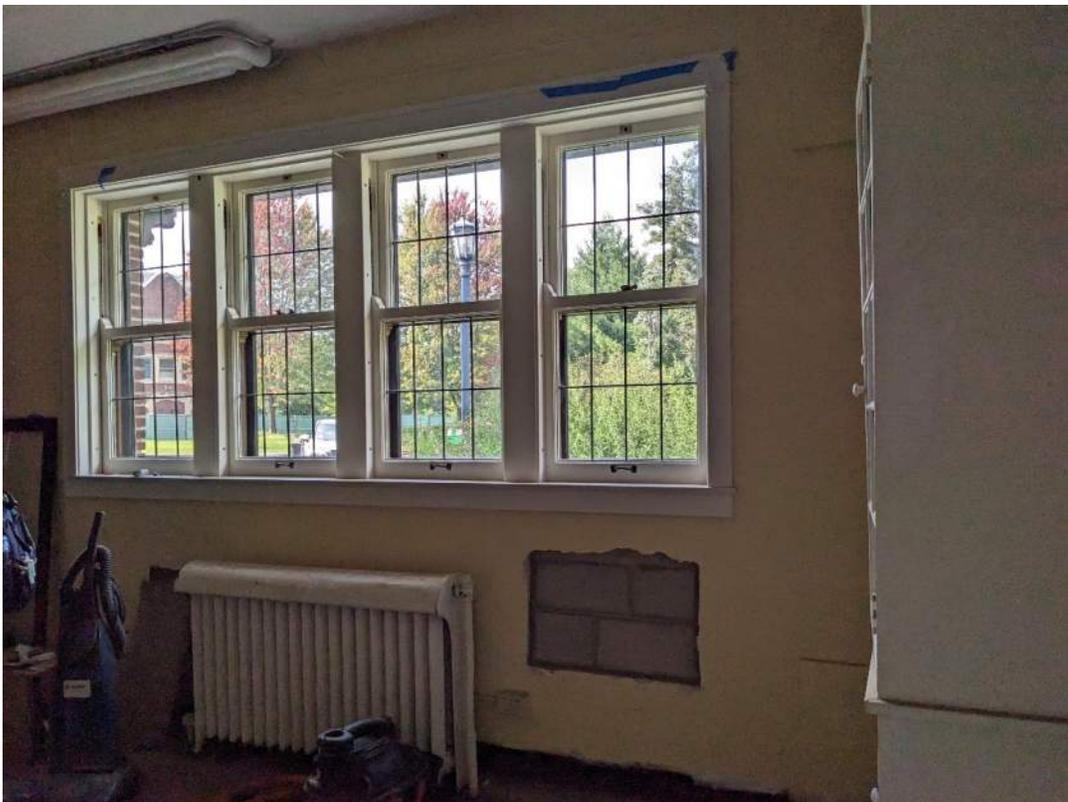
Figure 22 Mansion Service Wing. Plaster opening below window.

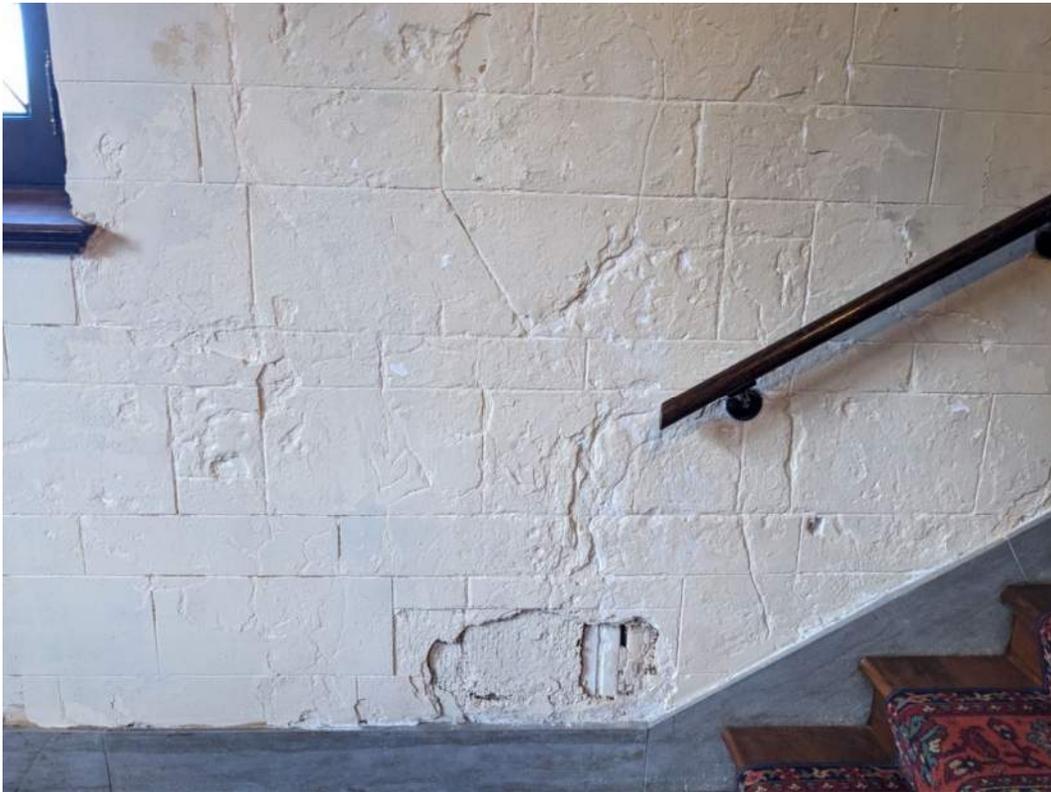
Figure 25 Mansion. Plaster damage at Entry Hall landing.

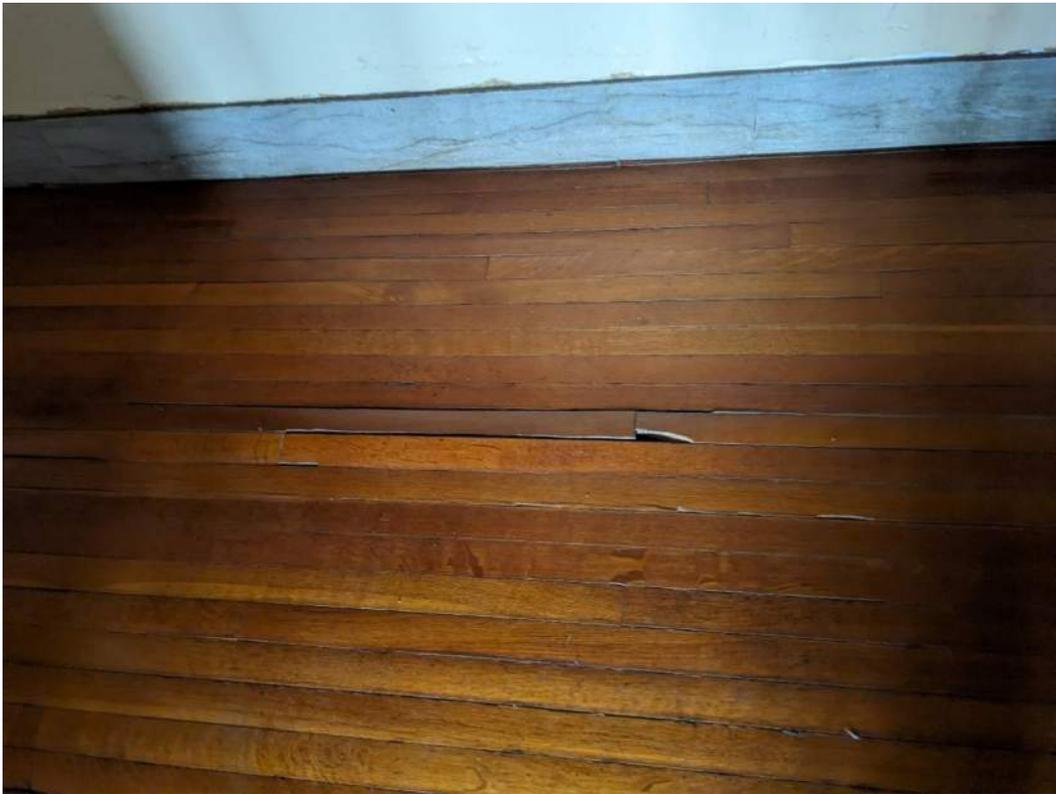
Figure 27 Mansion. Chipped and buckled wood in Hallway.

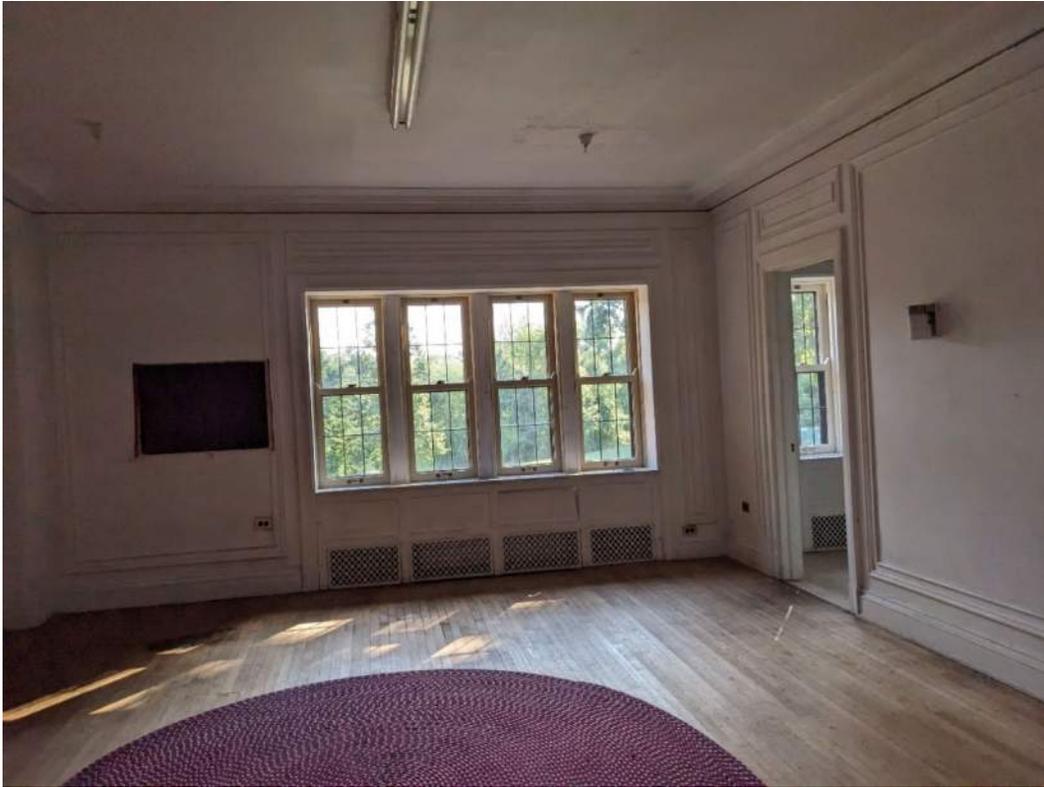
Figure 28 Mansion. Chamber 2. Damaged plaster on ceiling.

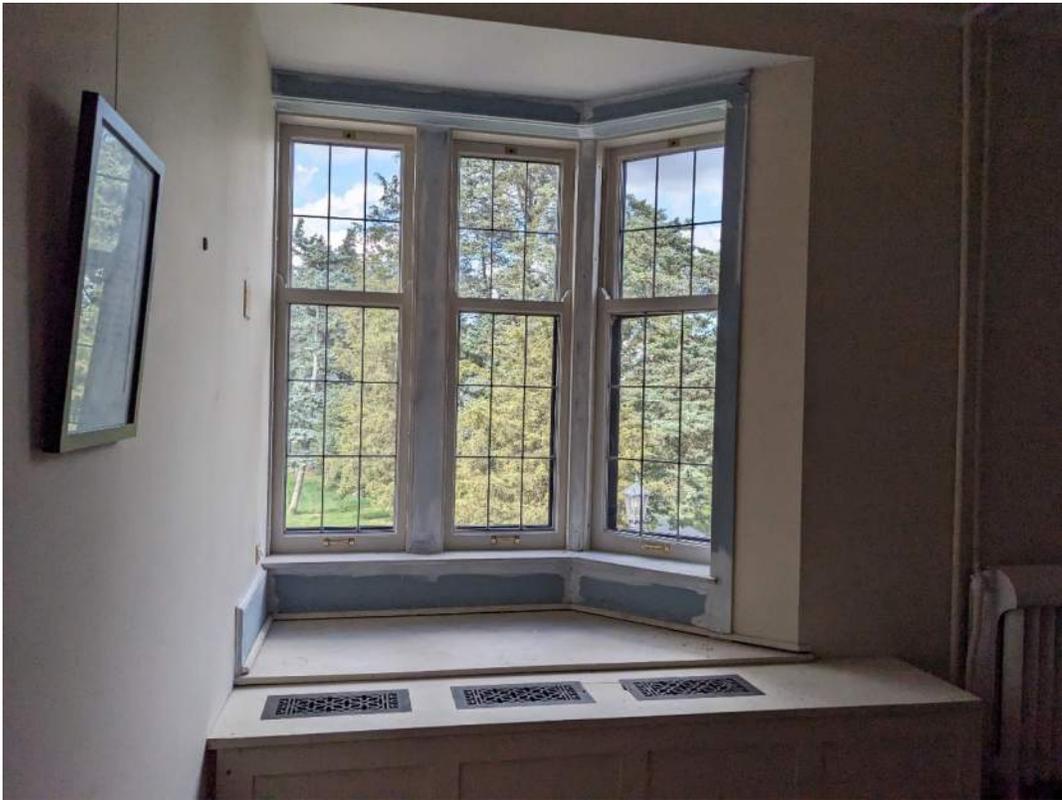
Figure 33 Mansion. Housekeeper 2 facing north.

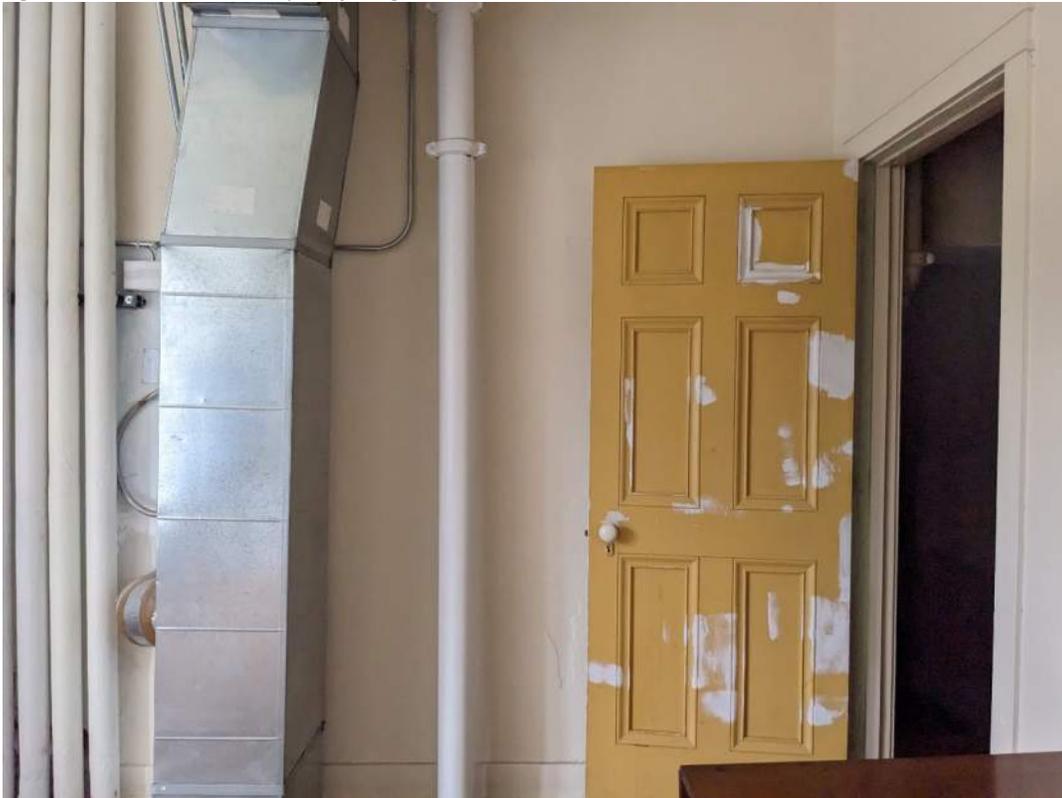
Figure 34 Mansion. Housekeeper 2. Mechanical equipment in room.

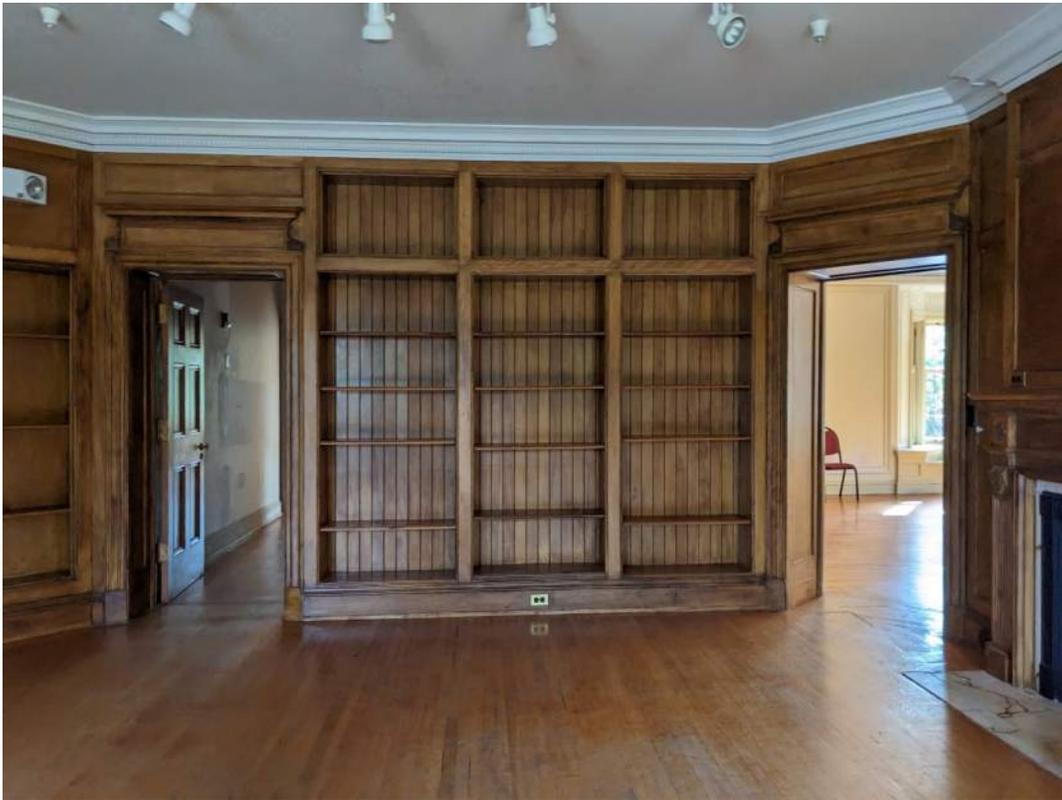
Figure 37 Mansion. Second floor Sitting Room, facing south.

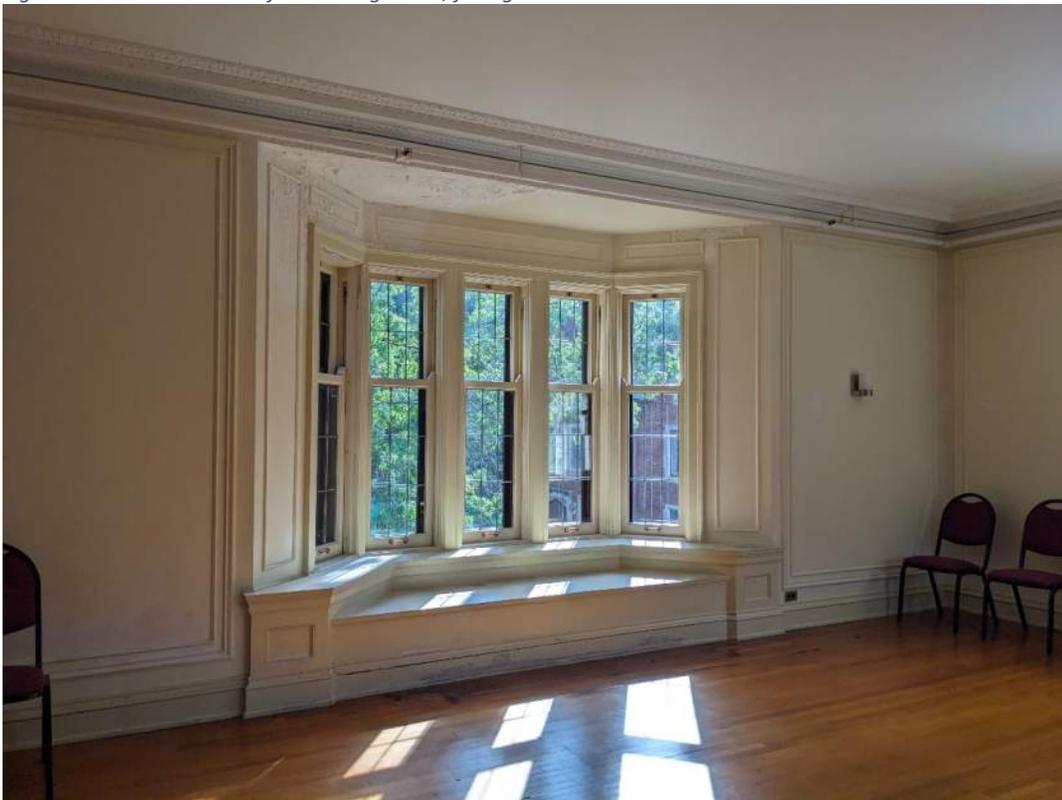
Figure 38 Mansion. Mr. Peabody's Chamber looking south.

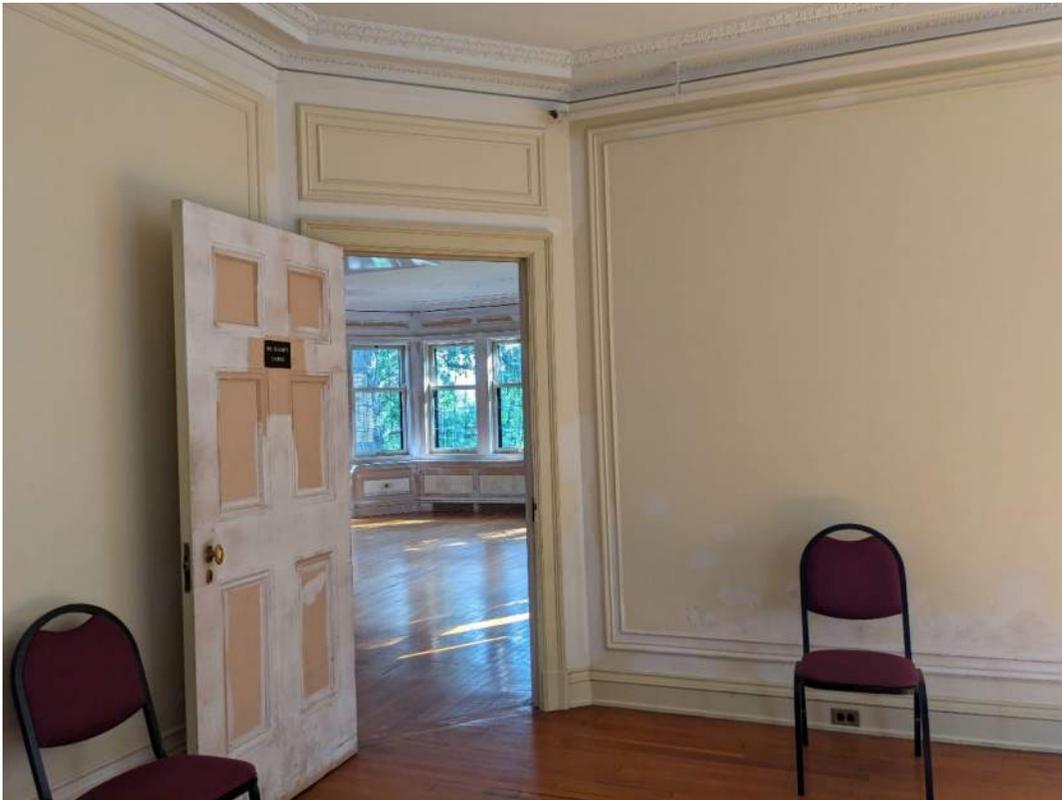
Figure 39 Mansion. Mr. Peabody's Chamber looking into Mrs. Peabody's Chamber.

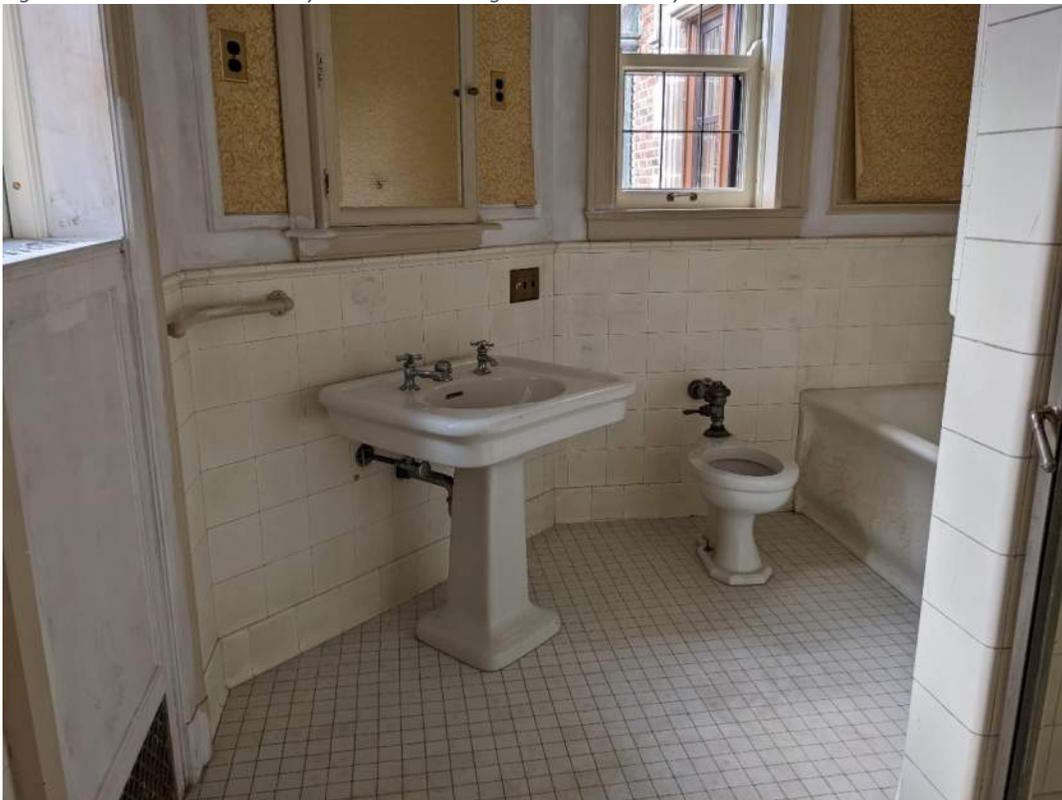
Figure 40 Mansion. Bath in Mr. Peabody's Chamber.

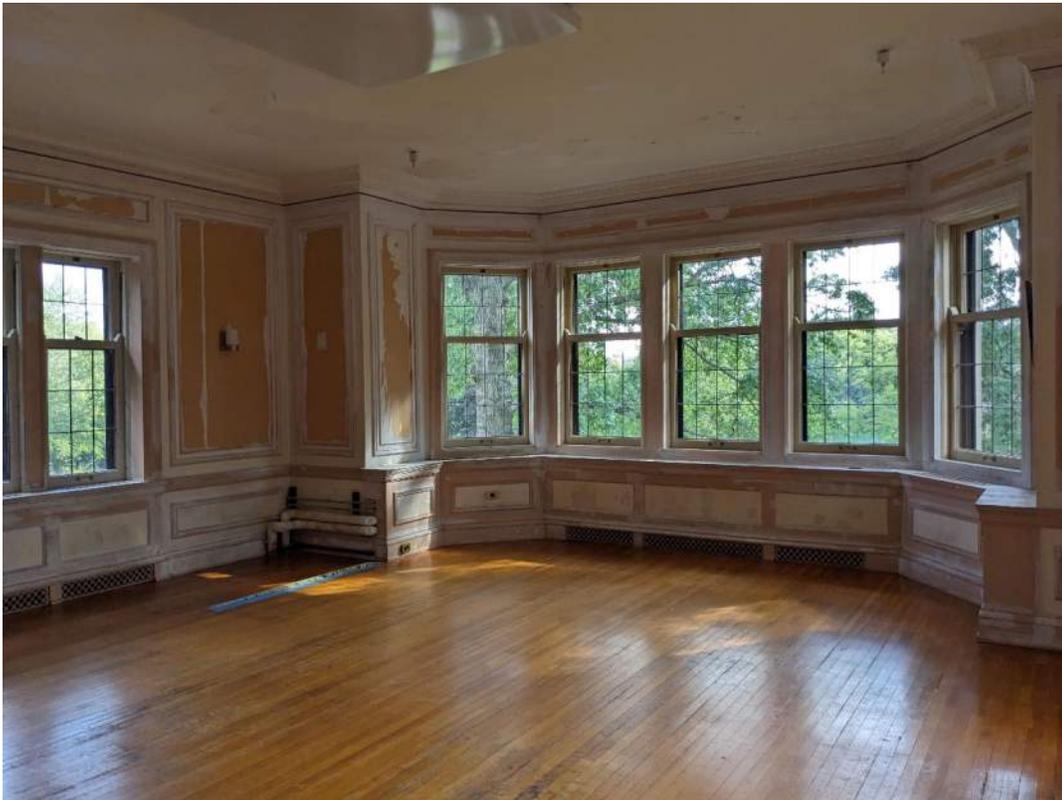
Figure 41 Mansion. Mrs. Peabody's Chamber looking south.

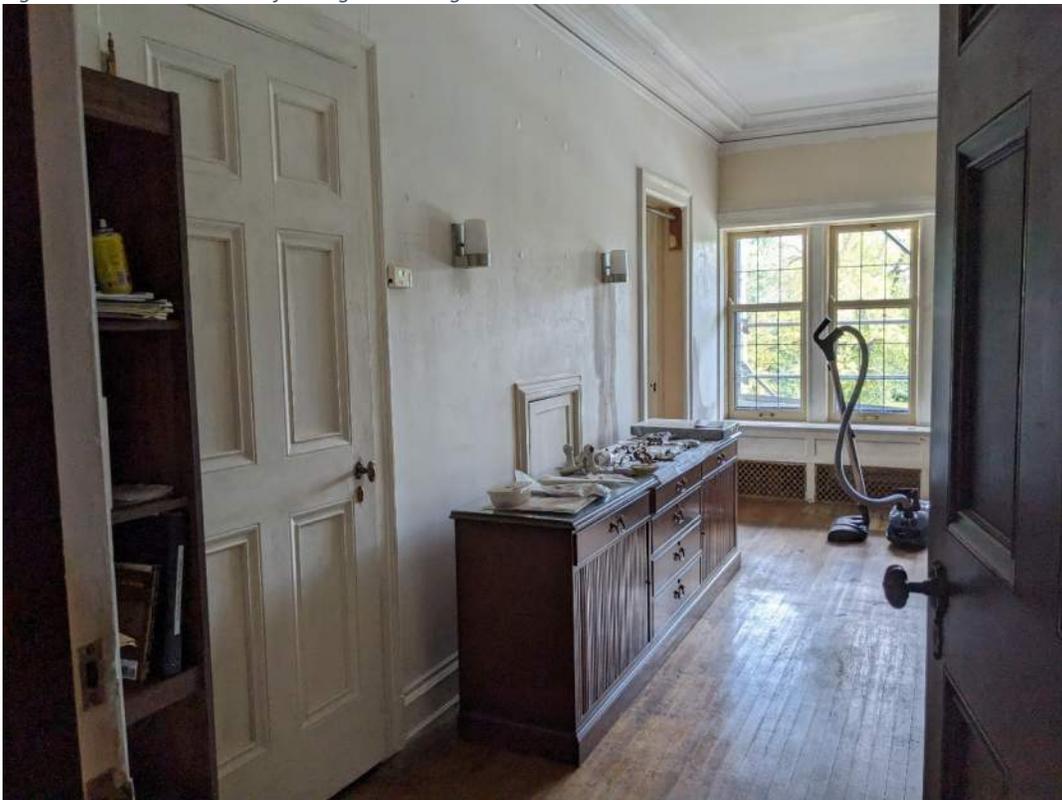
Figure 46 Mansion. Chamber 3 looking east.

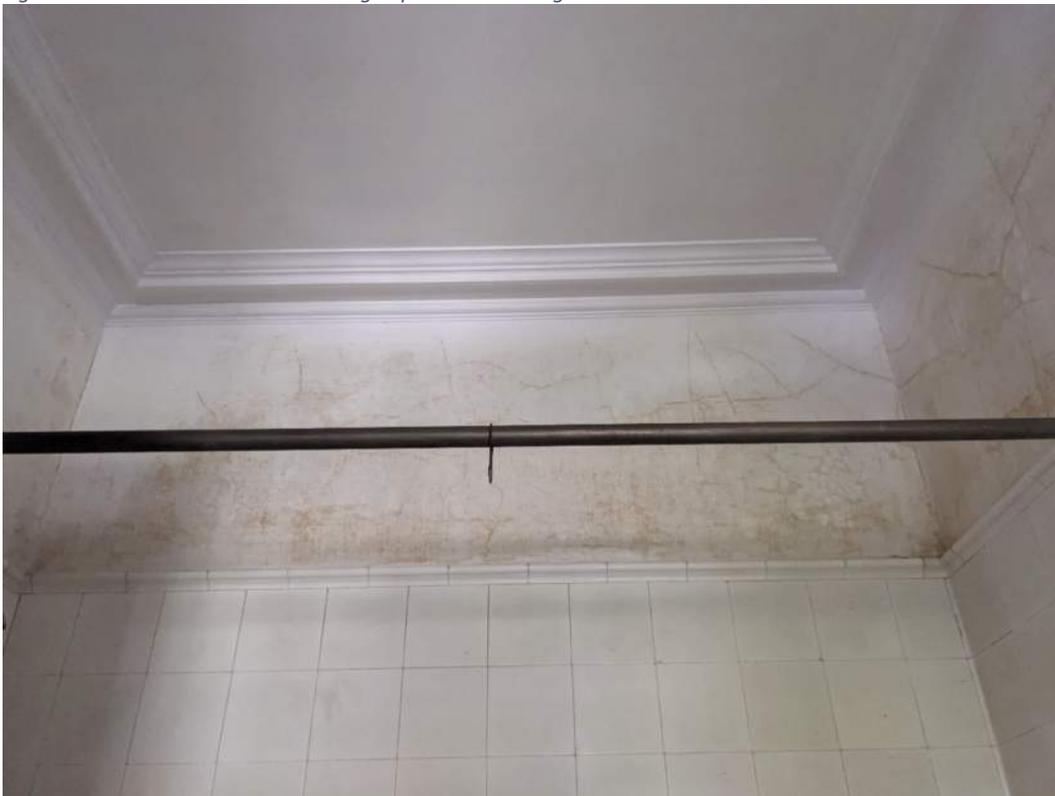
Figure 48 Mansion. Deteriorating Plaster in Chamber 3 Bath.

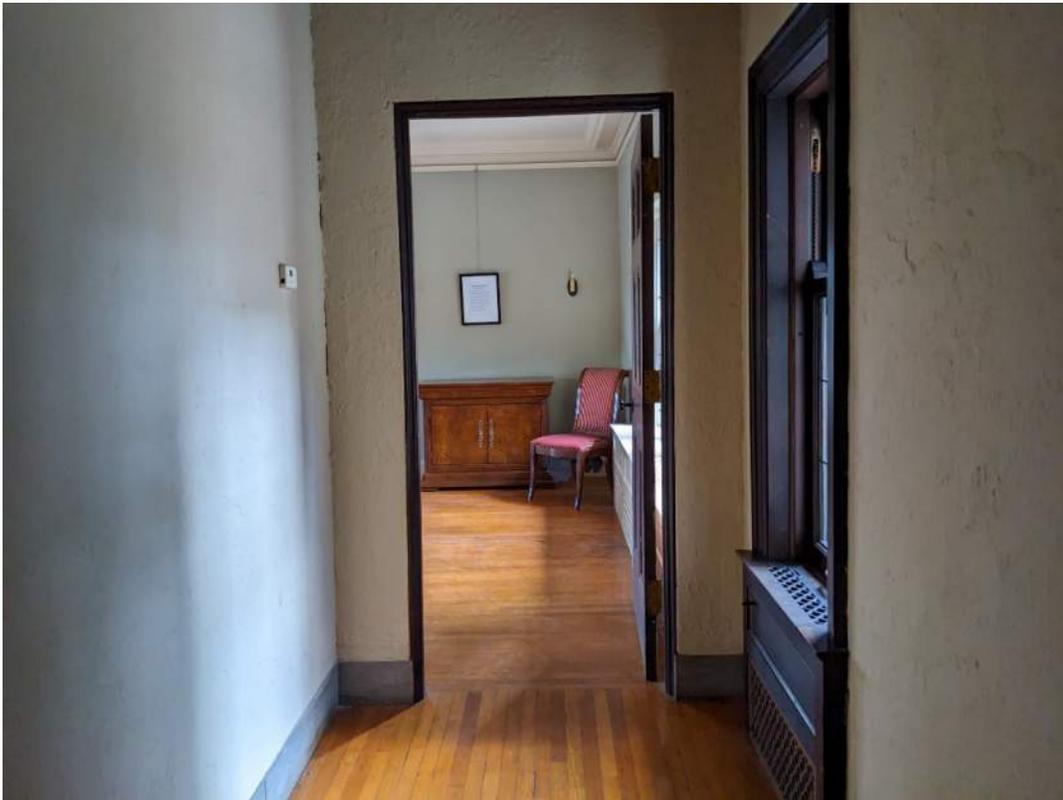
Figure 49 Mansion. Hall looking south into Chamber 4.

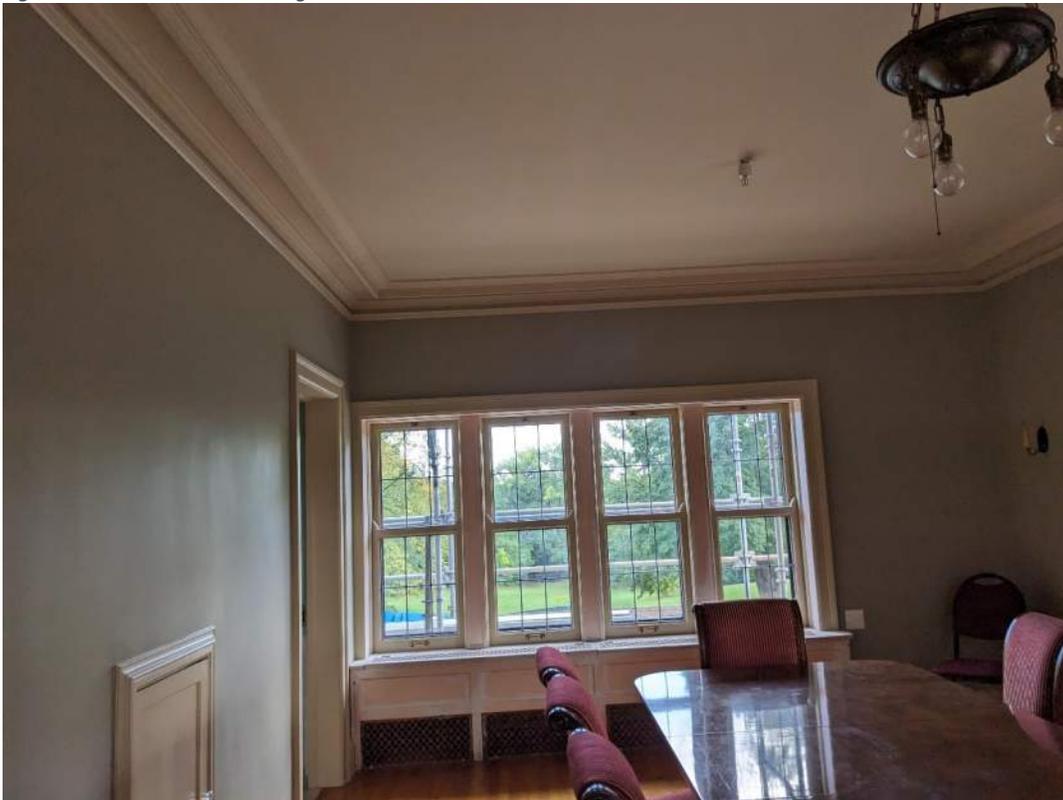
Figure 50 Mansion. Chamber 4 looking east.

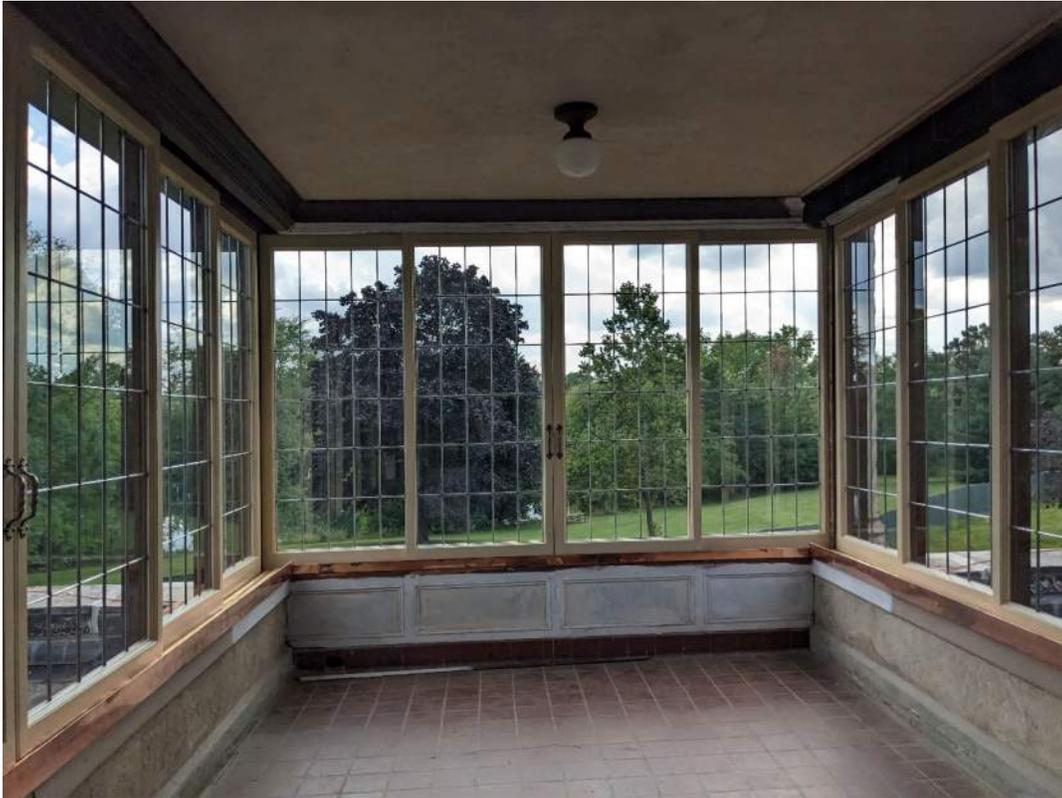
Figure 51 Mansion. Sleeping Porch looking south.

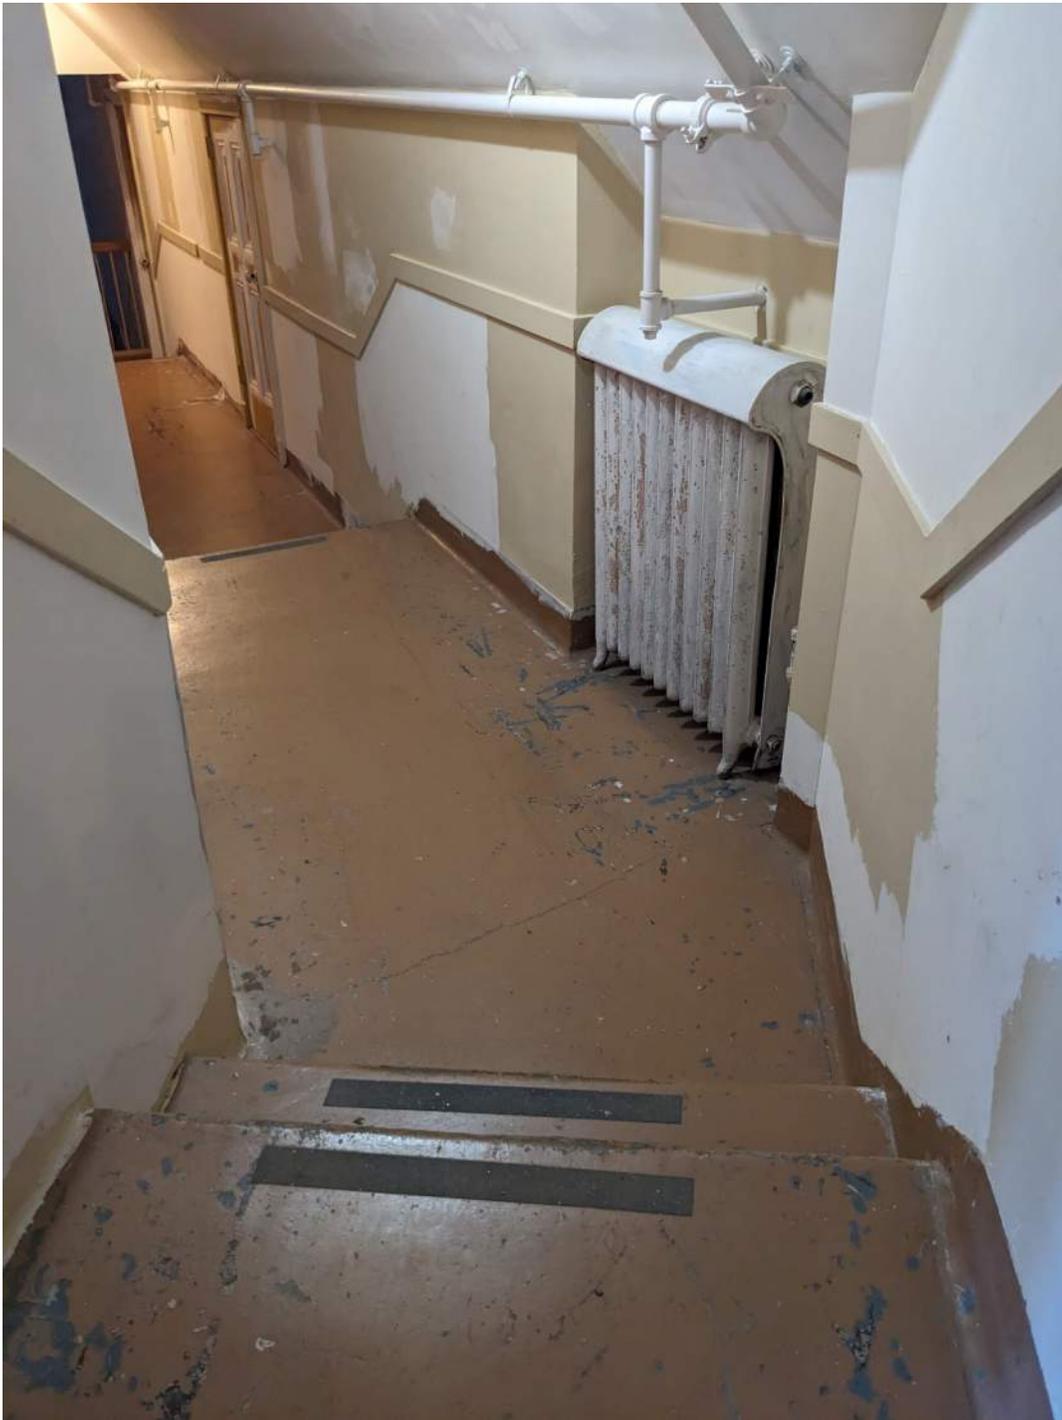
Figure 53 Mansion Service Wing. Corridor into Service Wing.

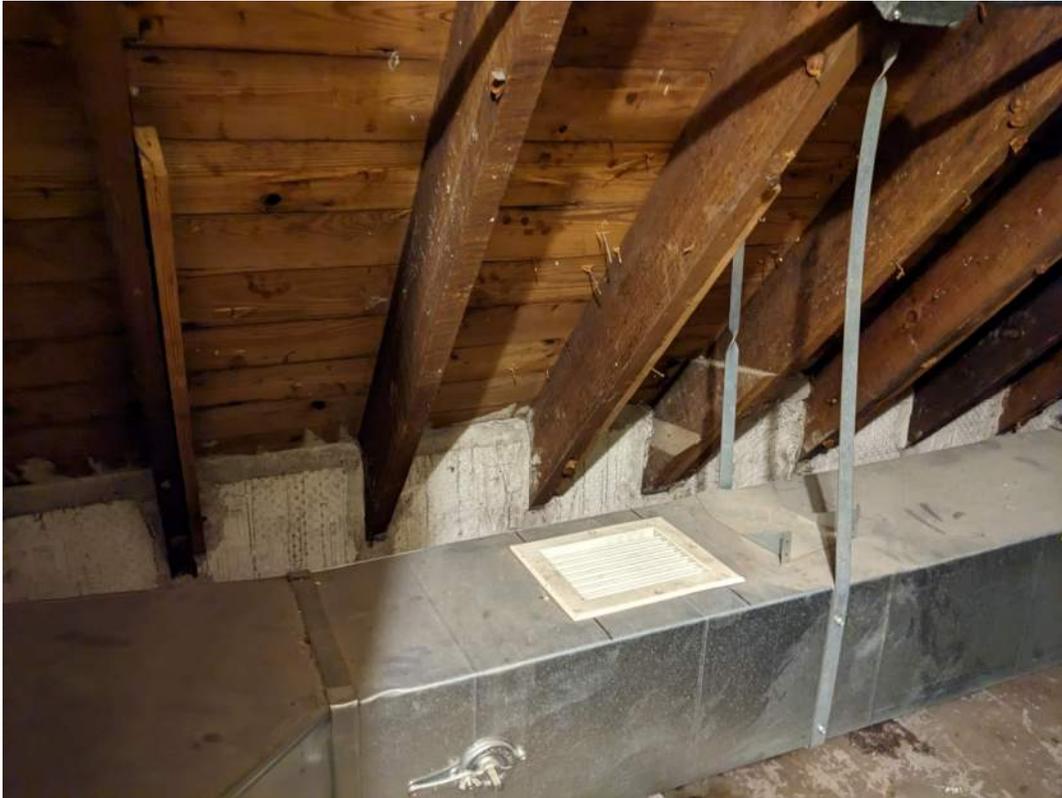
Figure 54 Mansion Service Wing. Attic closet. Roof joists meet exterior wall.

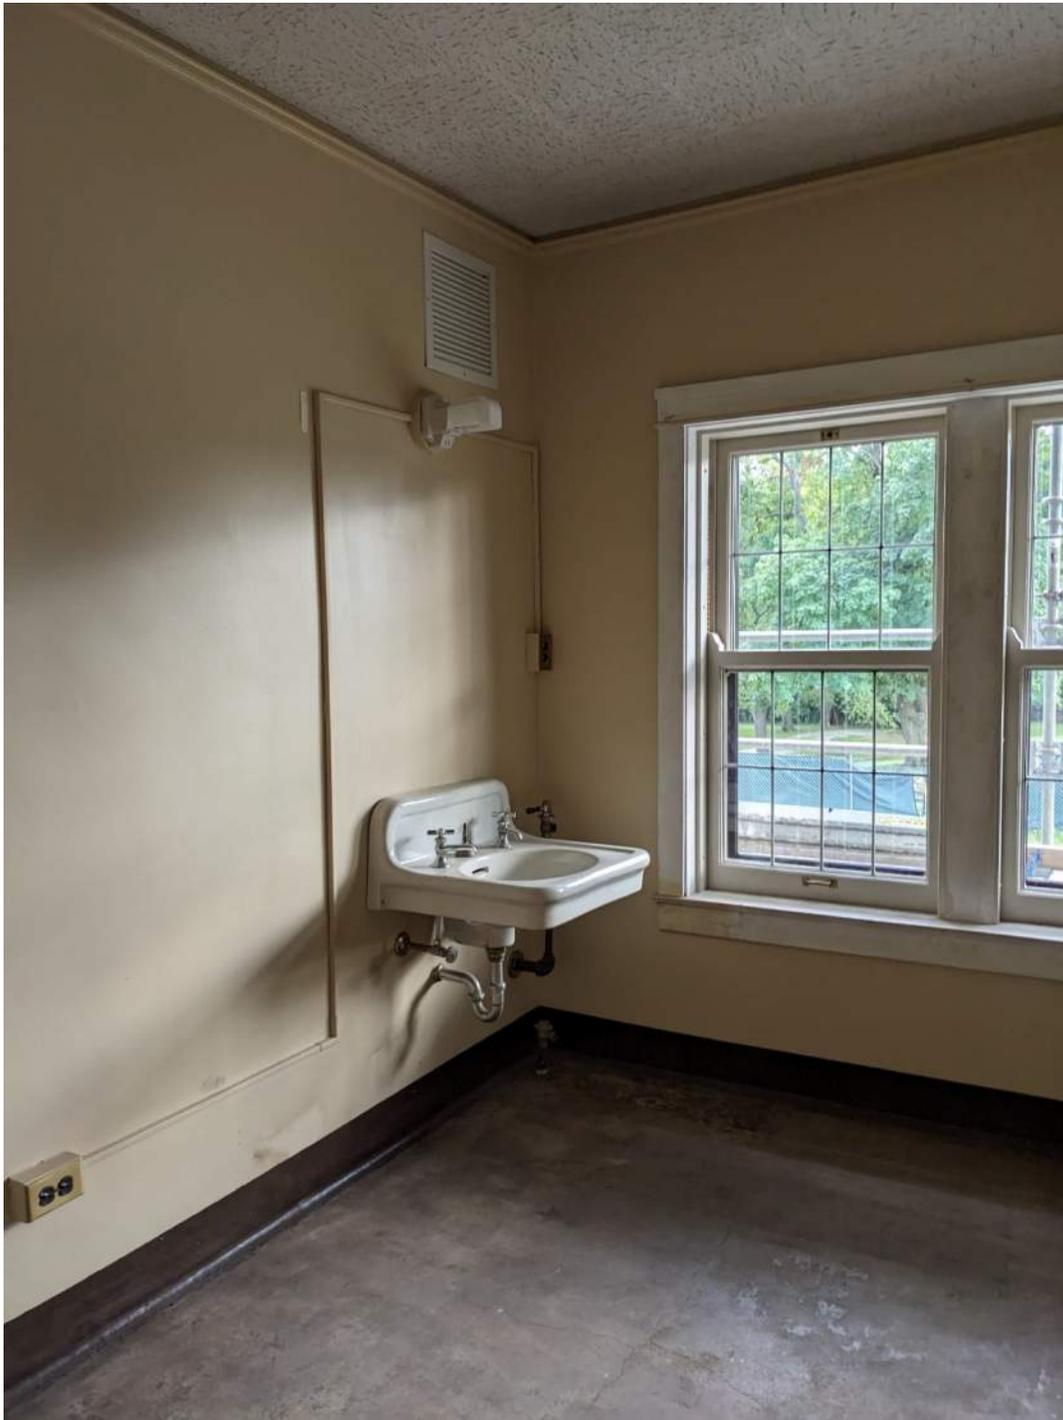
Figure 55 Mansion Service Wing. Servant's Chamber 1

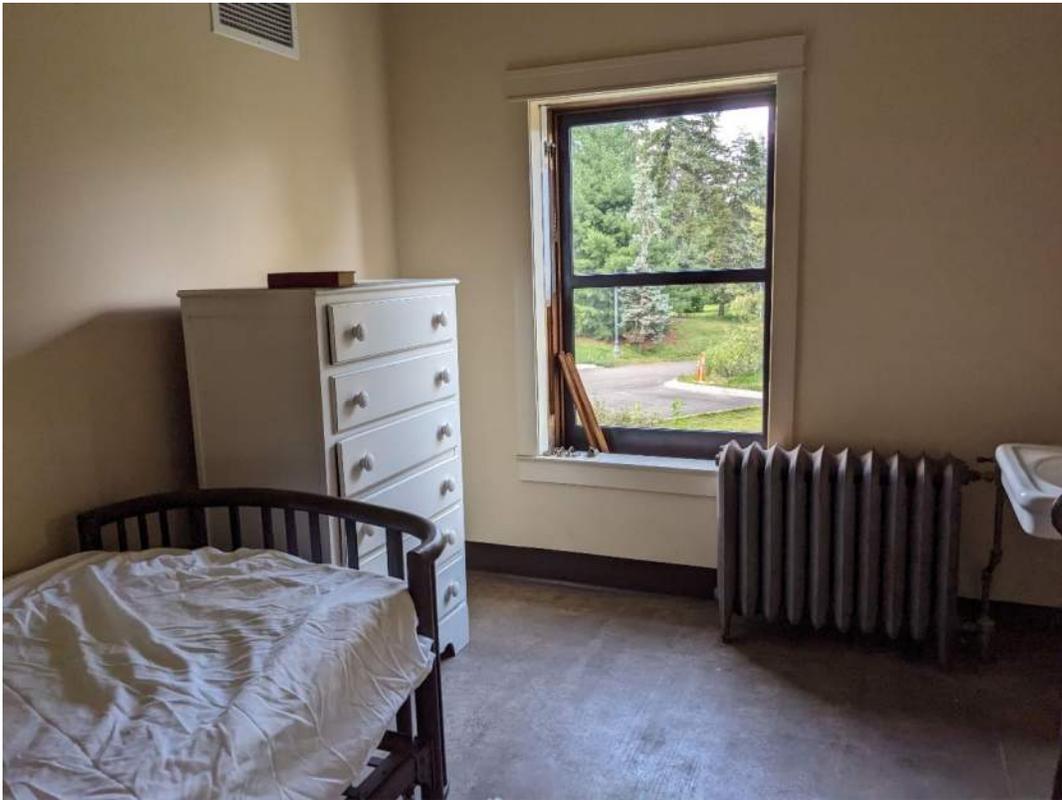
Figure 56 Mansion Service Wing. Servant's Chamber 5.

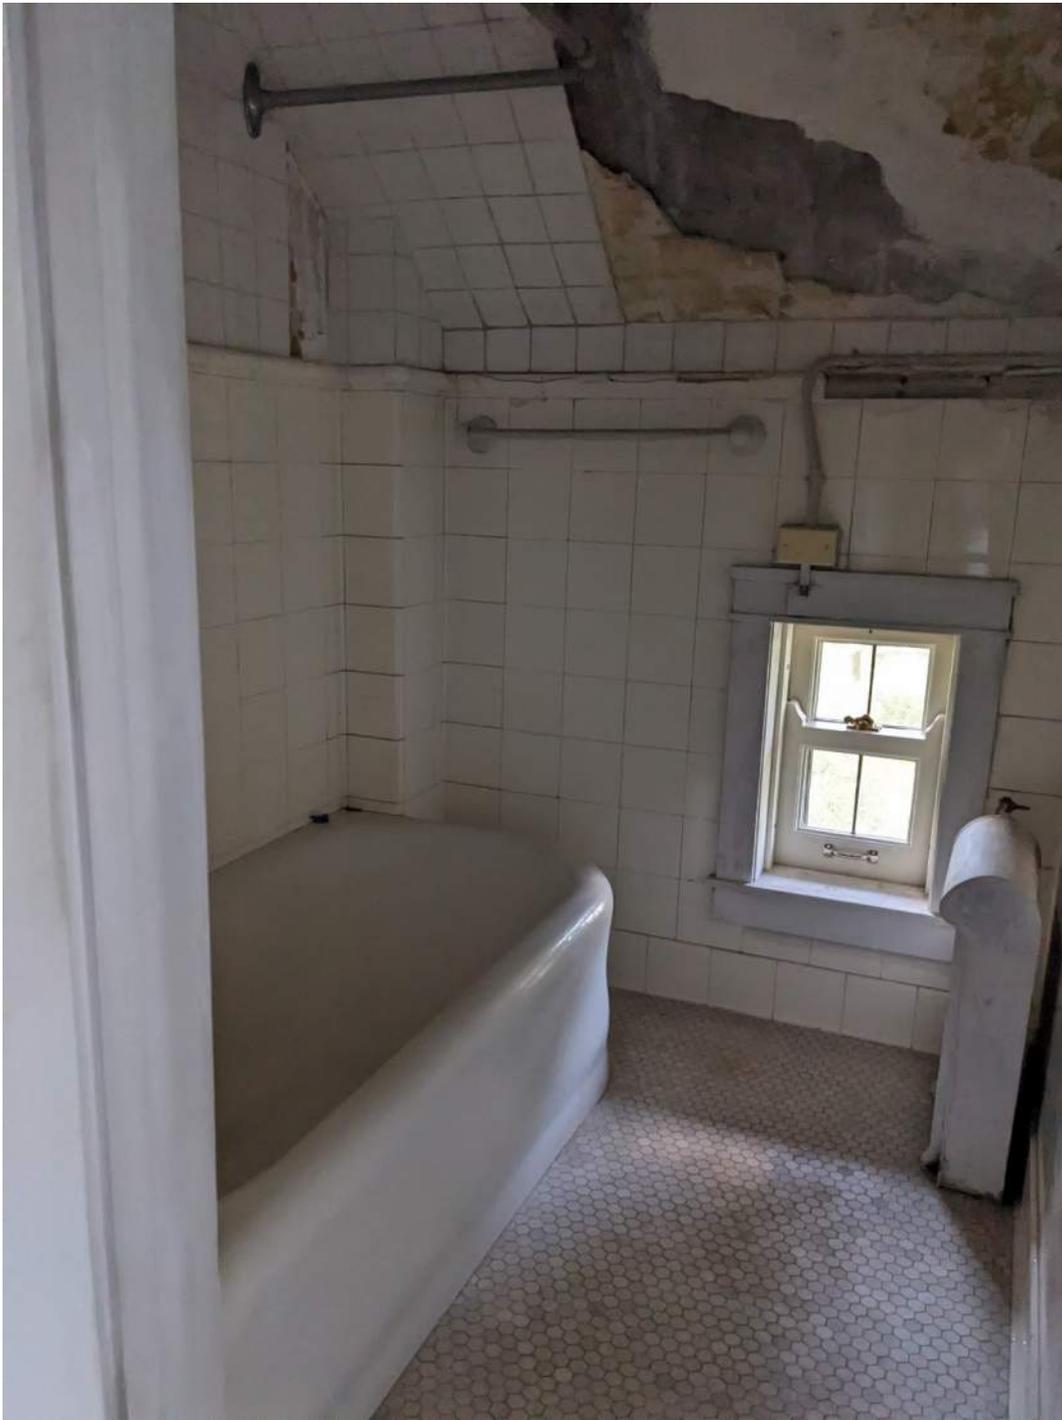
Figure 57 Mansion Service Wing. Tub.

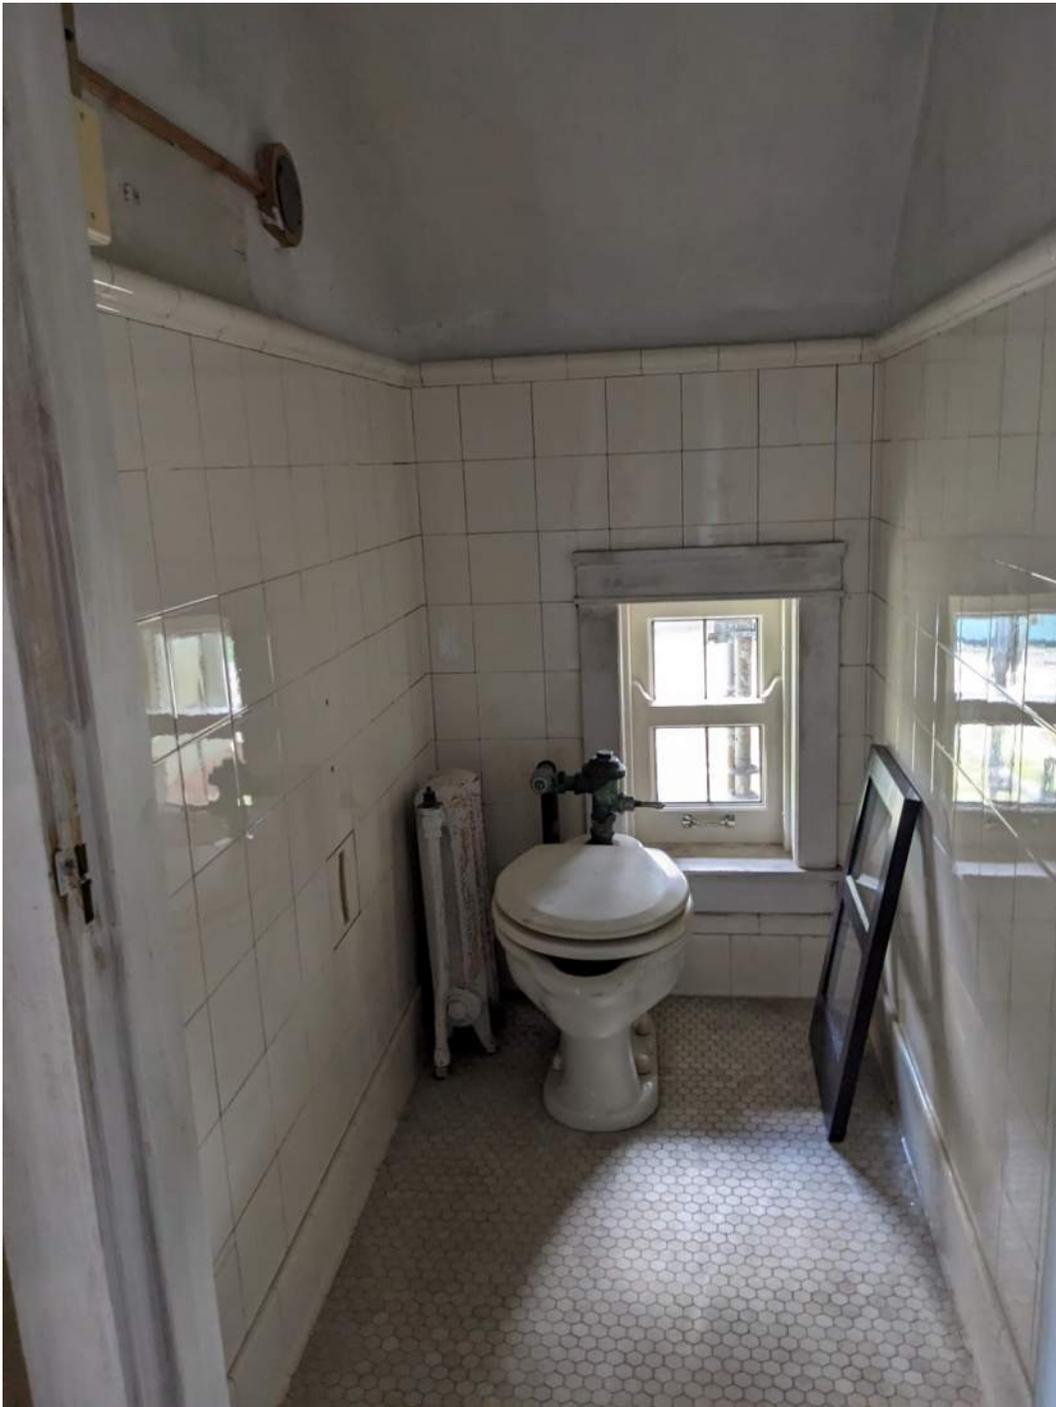
Figure 59 Mansion Service Wing. Toilet.

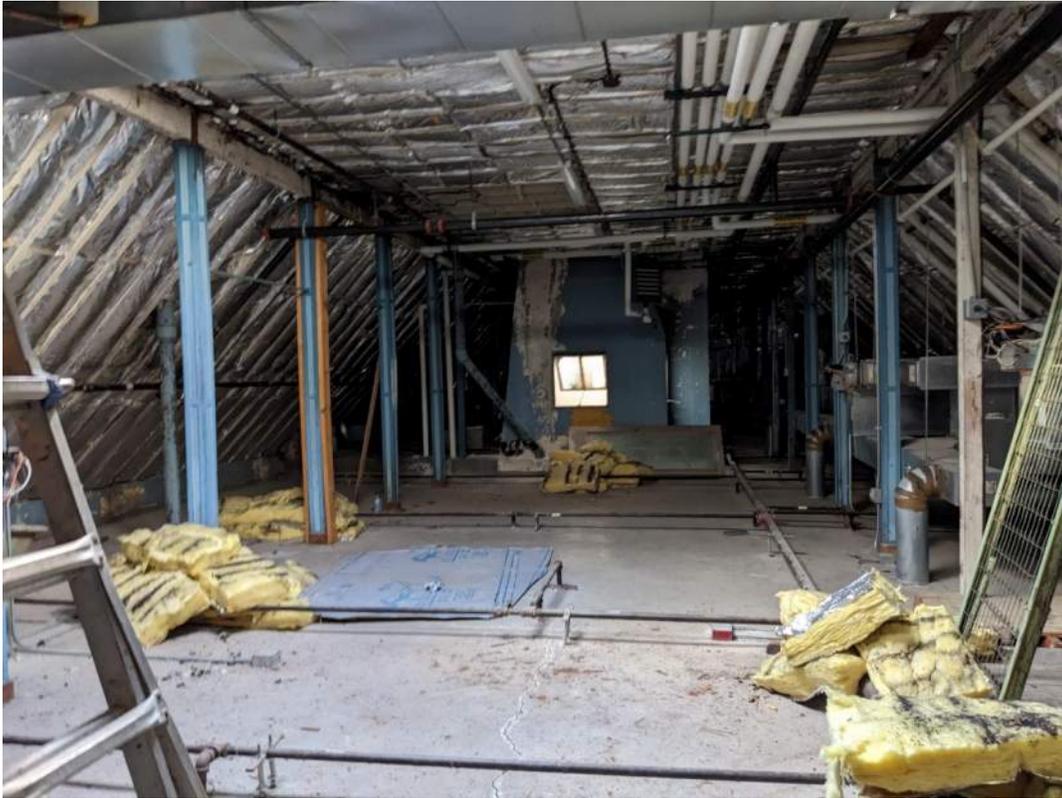
Figure 60 Mansion. Attic space looking west.

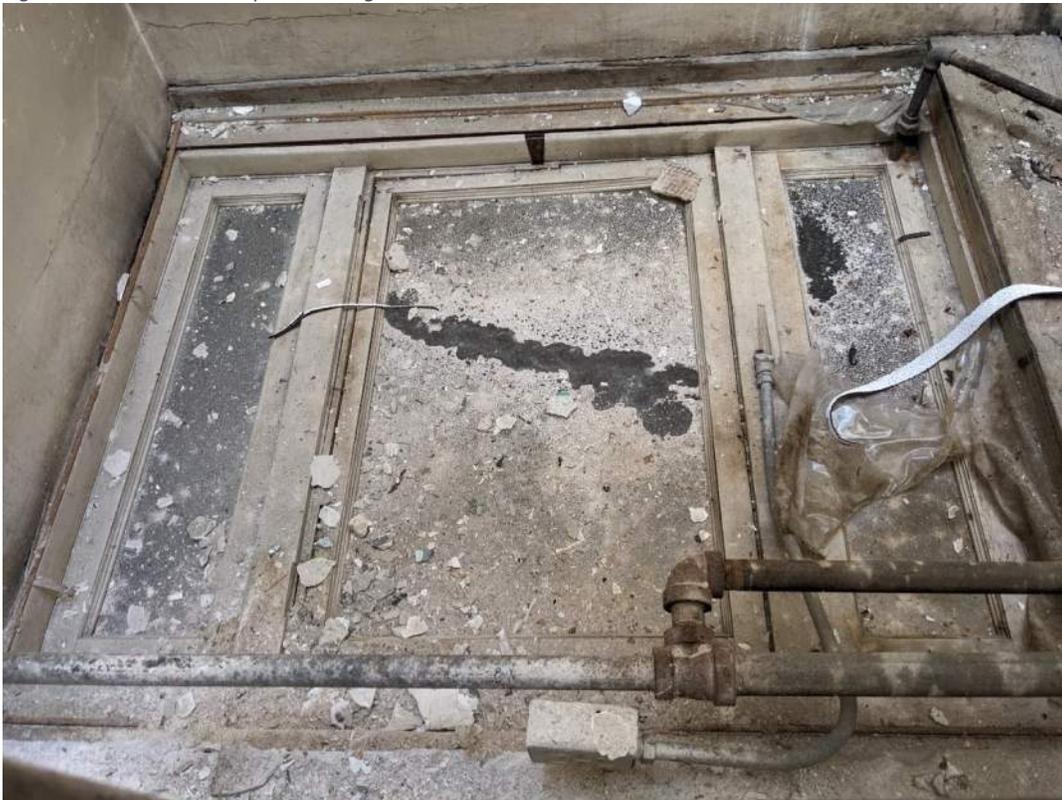
Figure 61 Mansion. Attic space, view into lightwell.
