Mayslake Peabody Estate
Forest Preserve District of DuPage County

Master Plan Report

November 1, 2024

Facility Condition Assessment Report

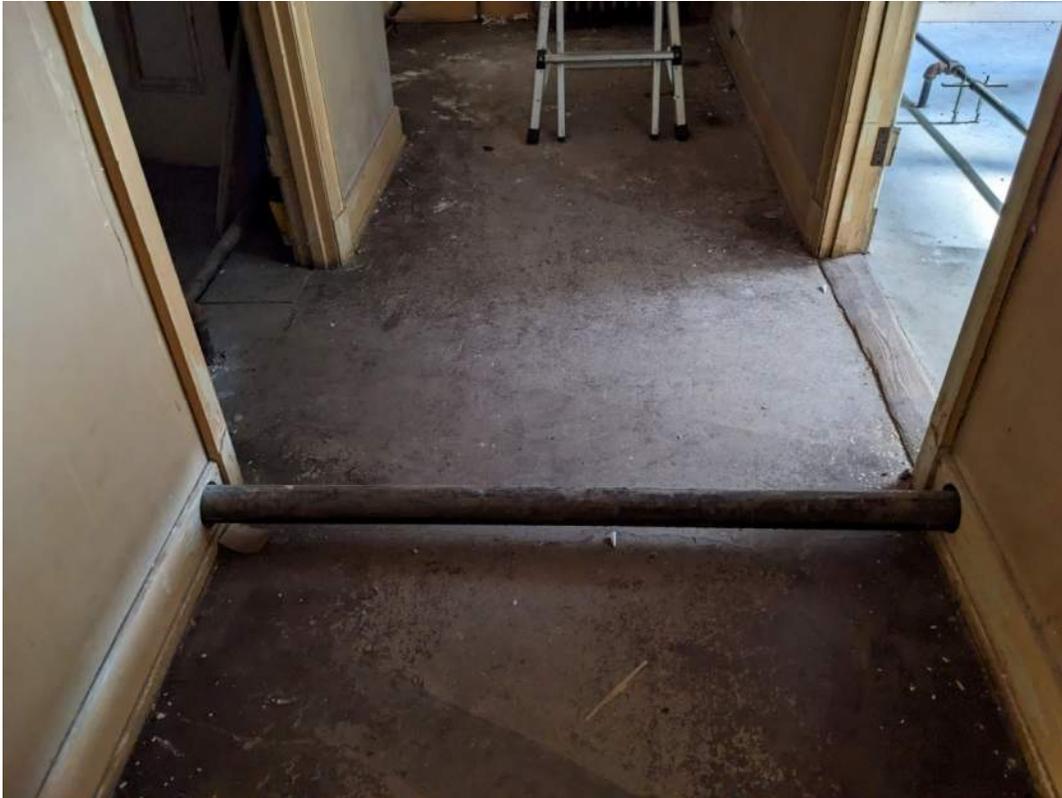
Figure 63 Mansion. Fire sprinkler piping in Attic.

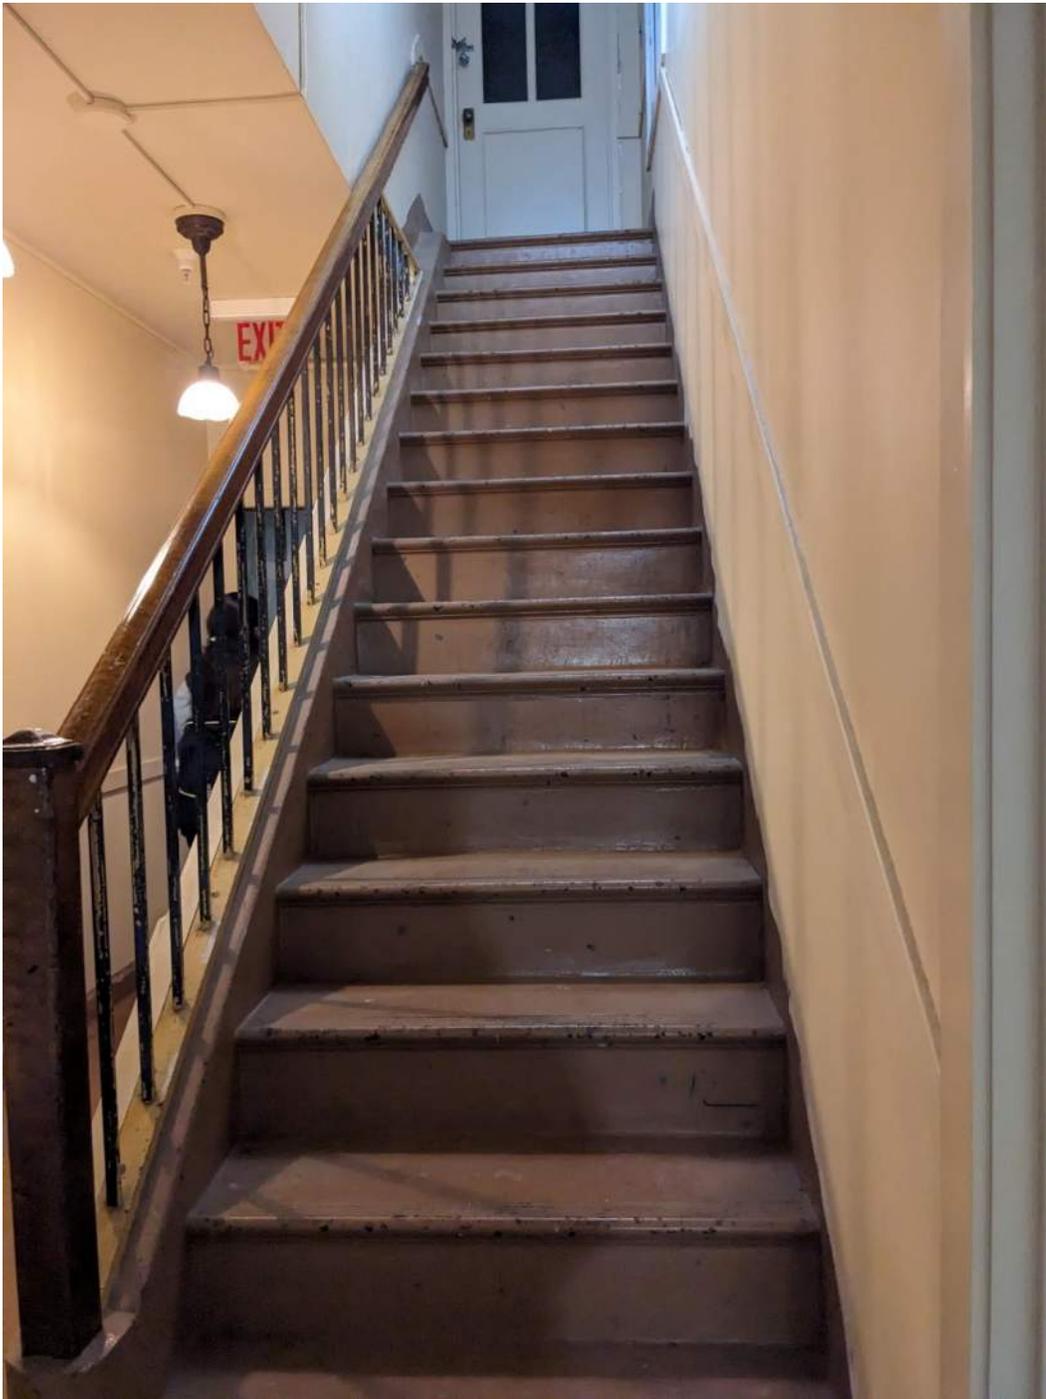
Figure 64 Mansion. Staircase to attic.

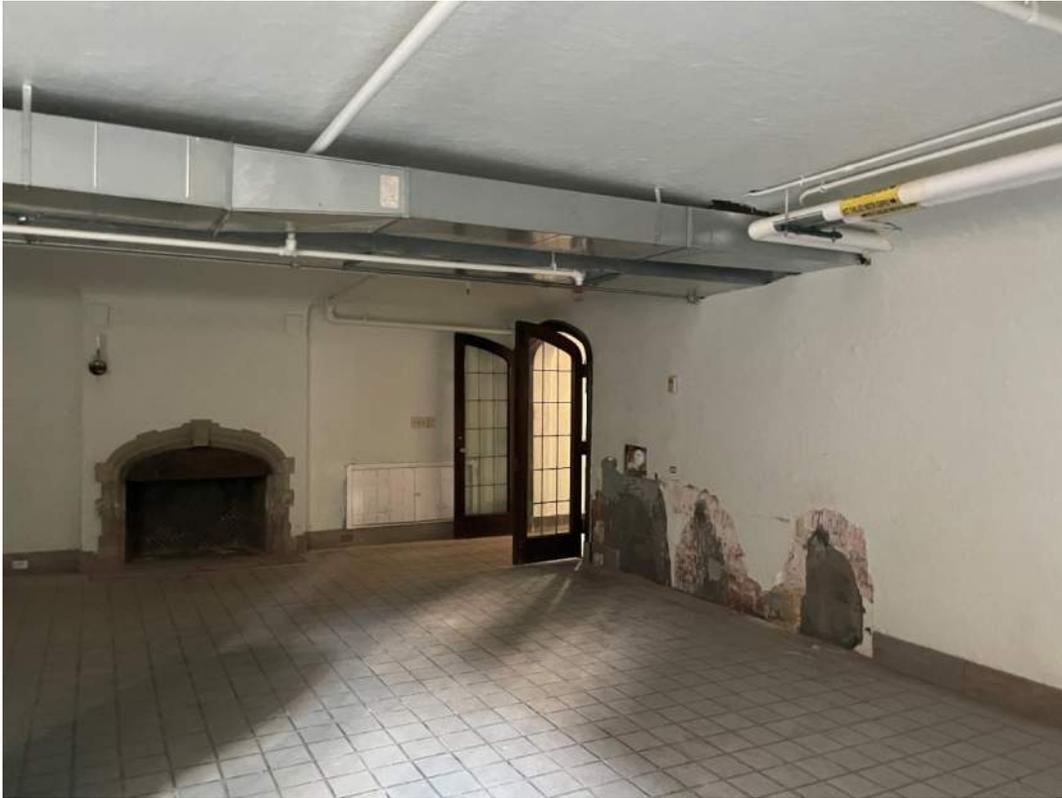
Figure 65 Mansion. Billiards Room in basement. Plaster damage.

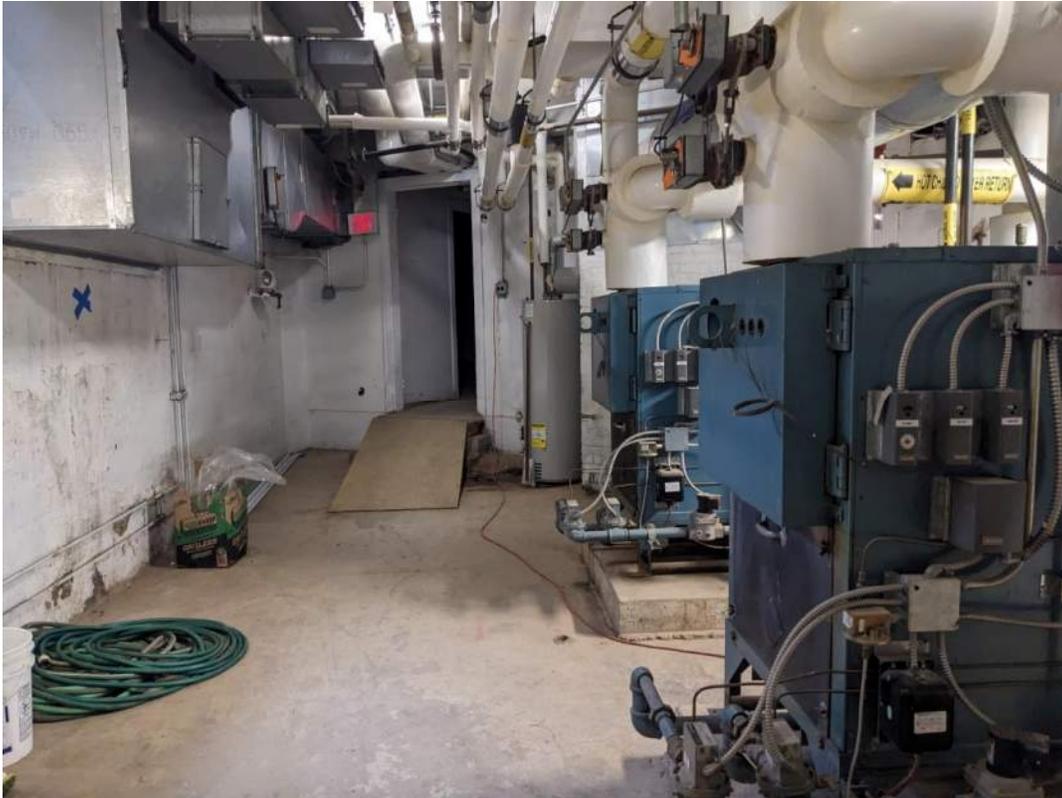
Figure 66 Mansion. Mechanical Equipment in Basement.

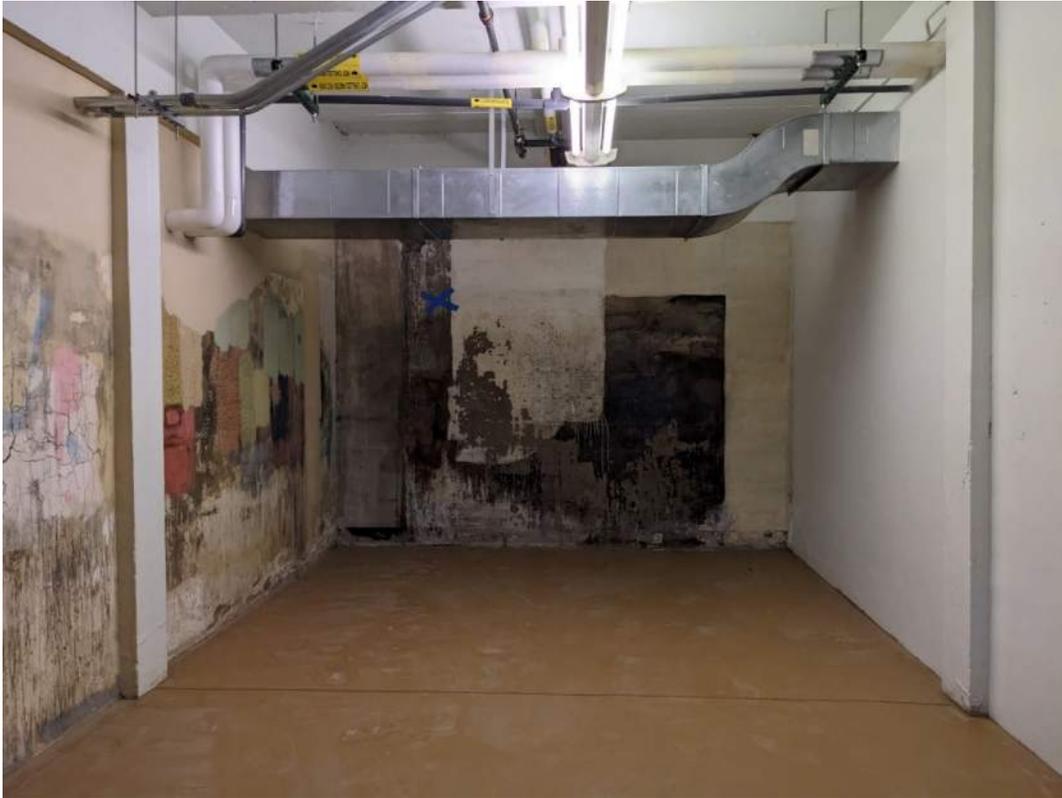
Figure 67 Mansion. Basement room, not currently utilized.

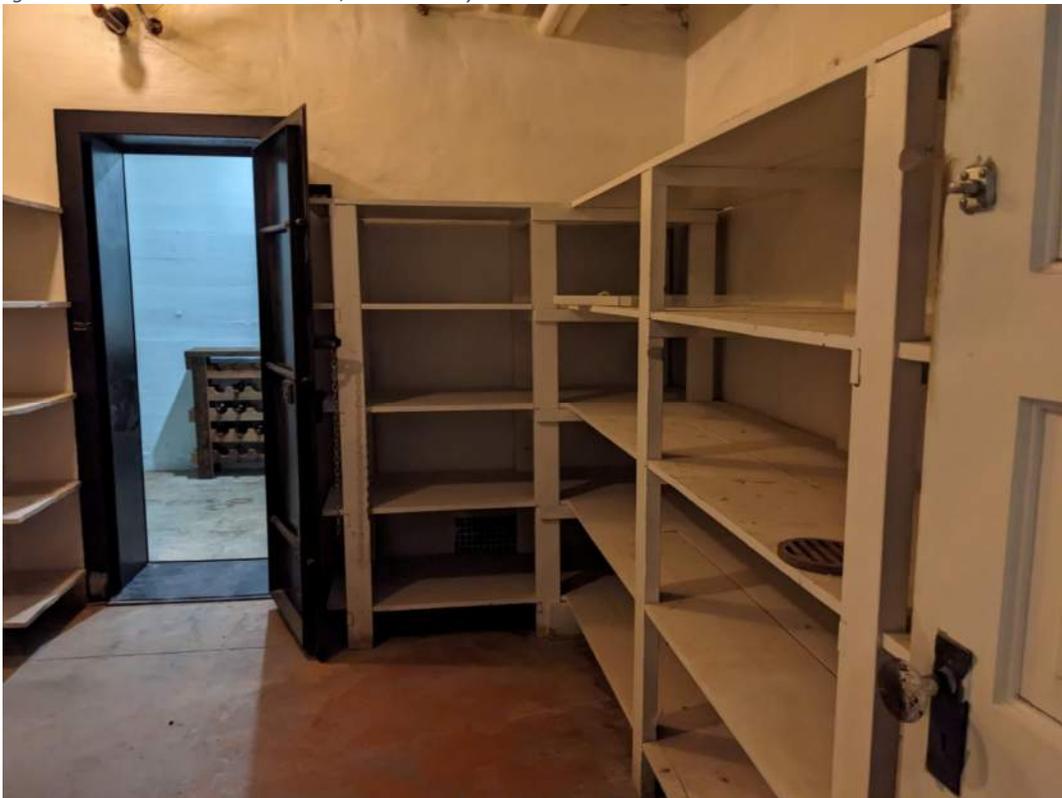
Figure 68 Mansion. Basement Room. Utilized for tours, view into wine cellar.

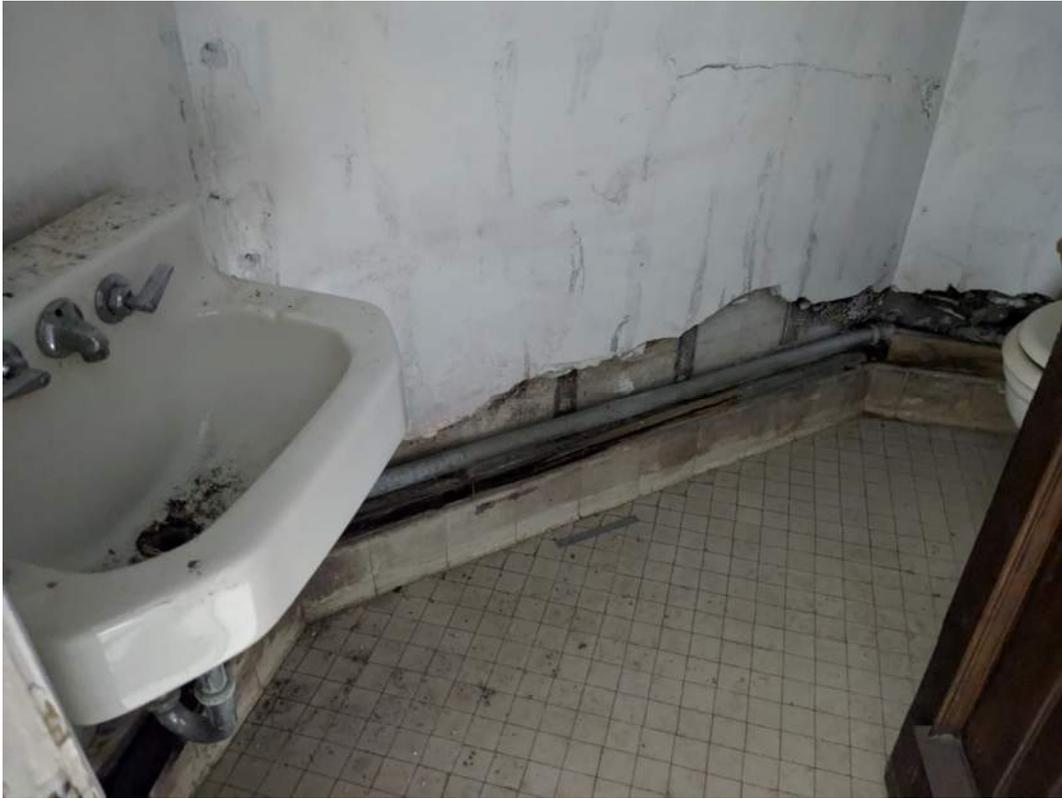
Figure 71 Mansion. Basement Toilet. Plaster damage.

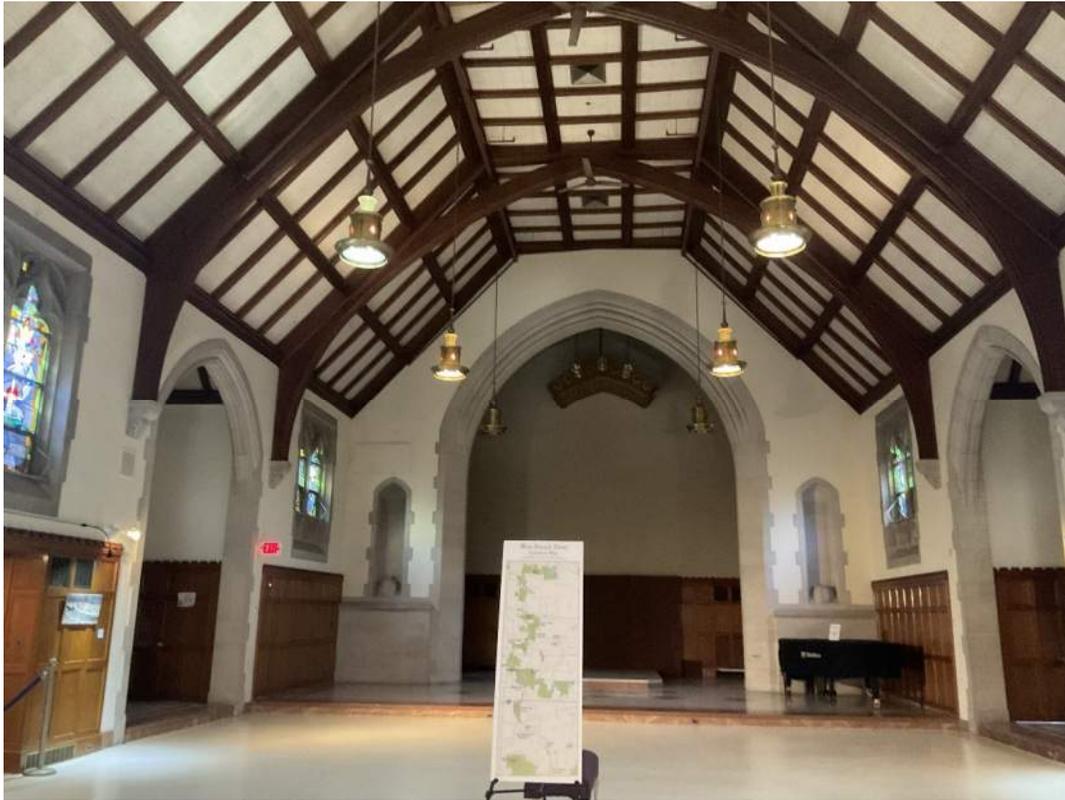
Figure 72 Retreat Building. Event Space looking west.

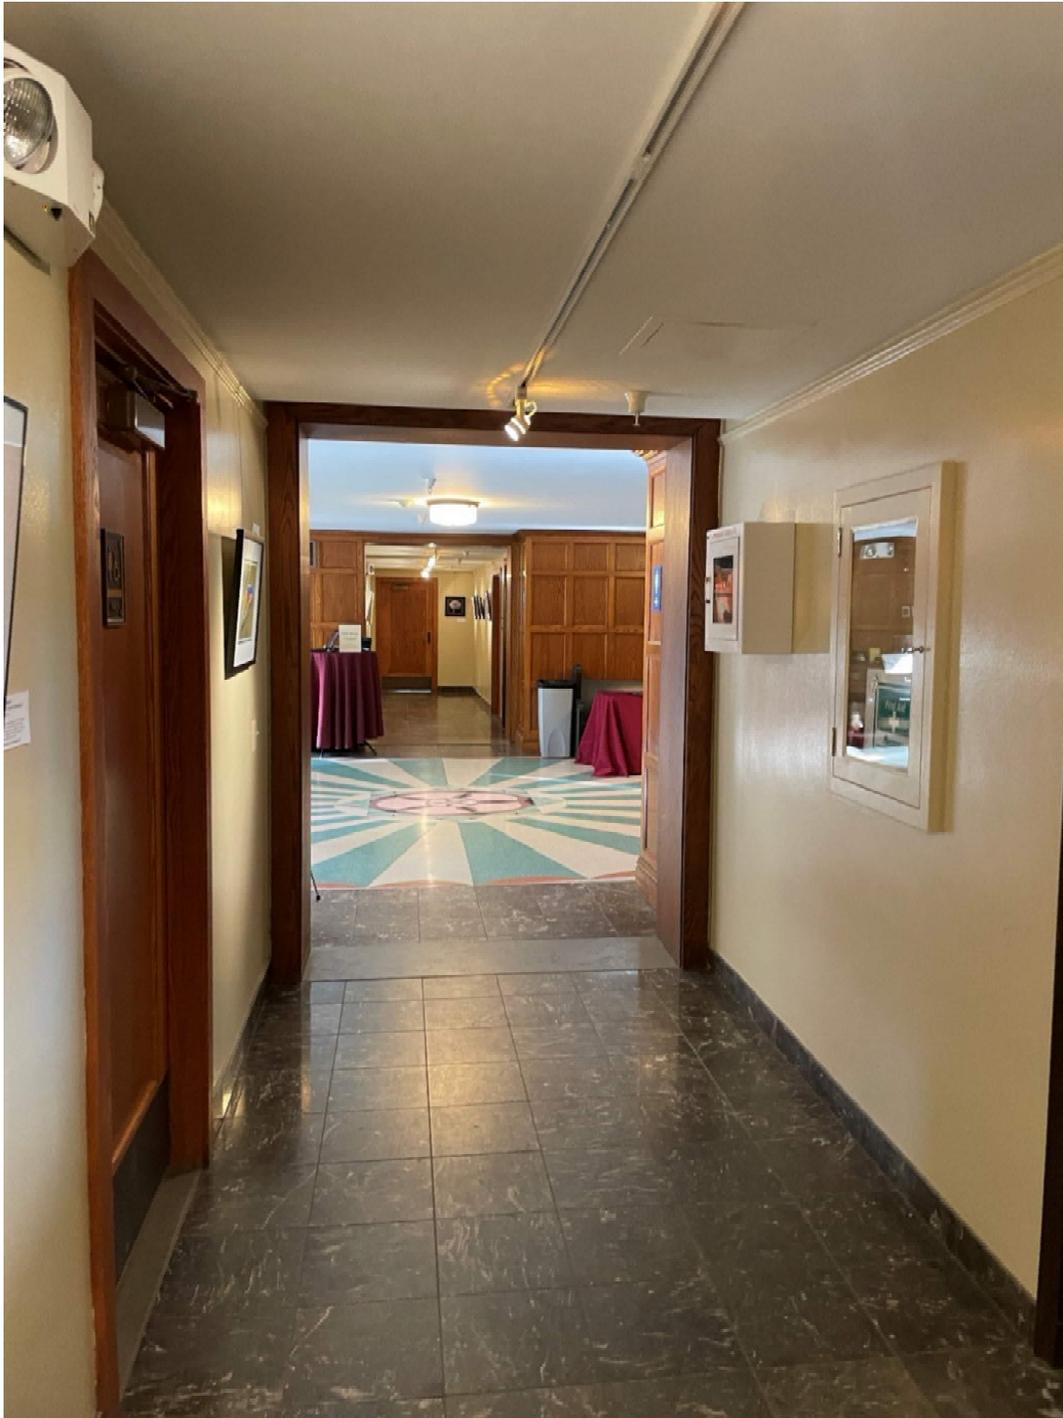
Figure 73 Retreat Building. First floor corridor looking south.

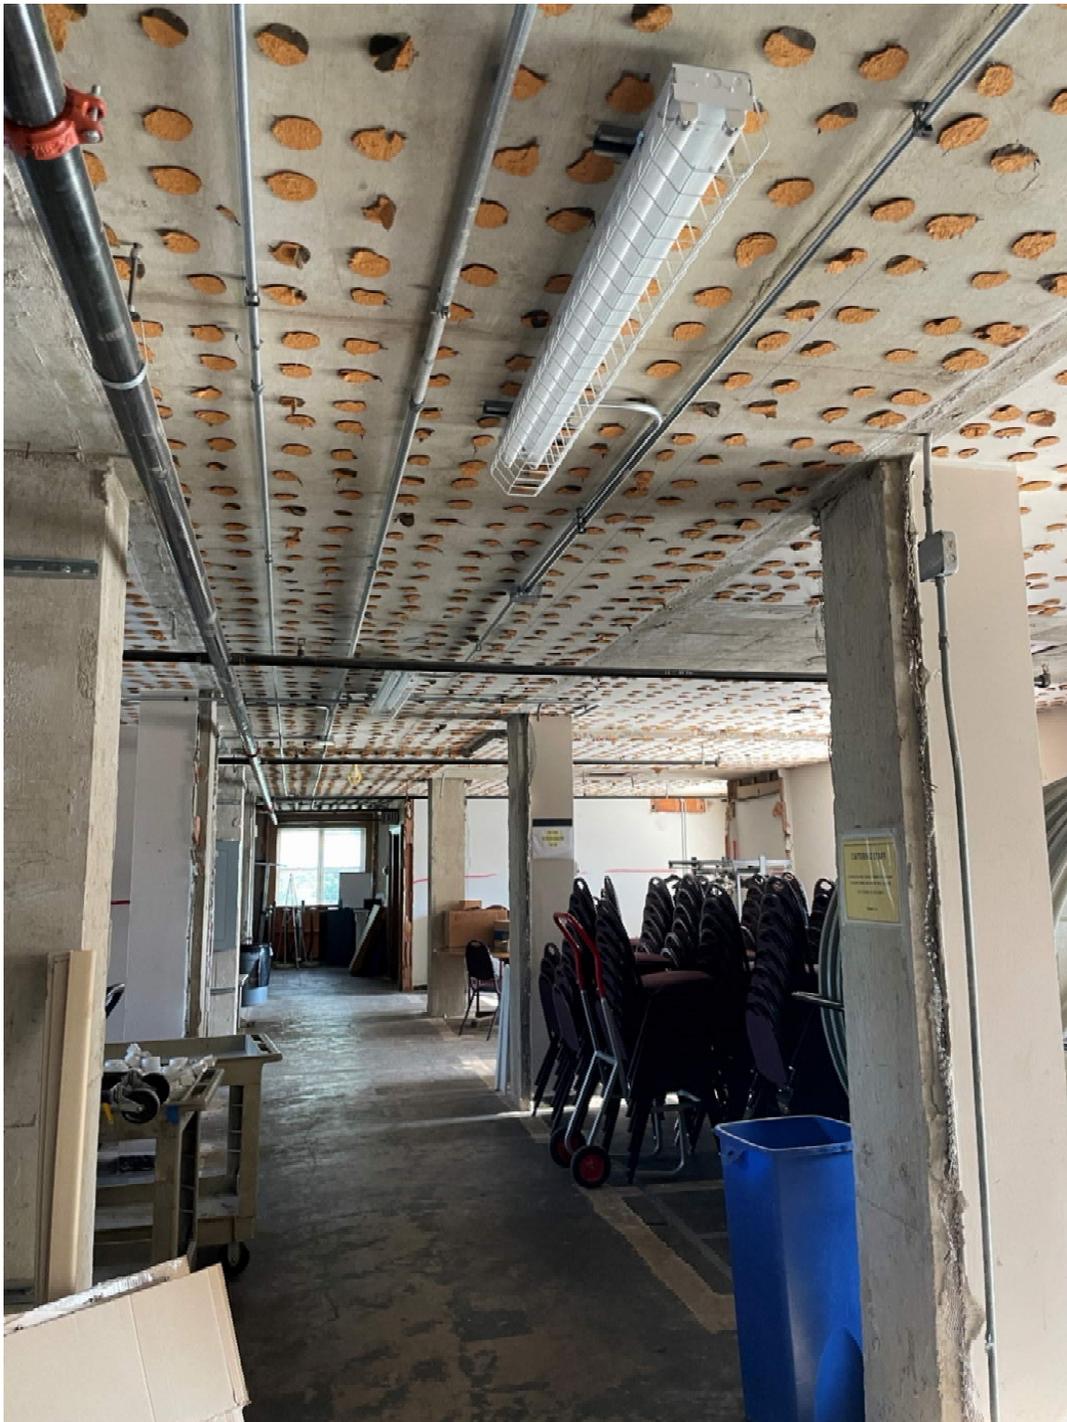
Figure 74 Retreat Building. First floor north wing.

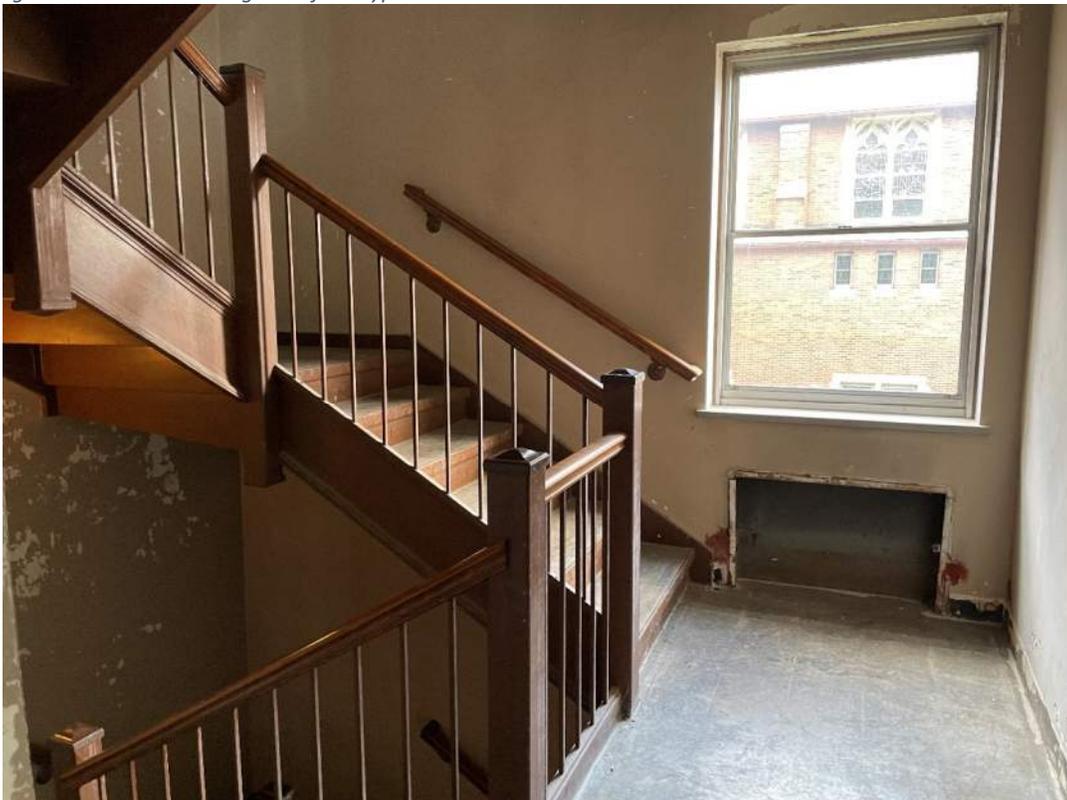
Figure 76 Retreat Building stairwell.

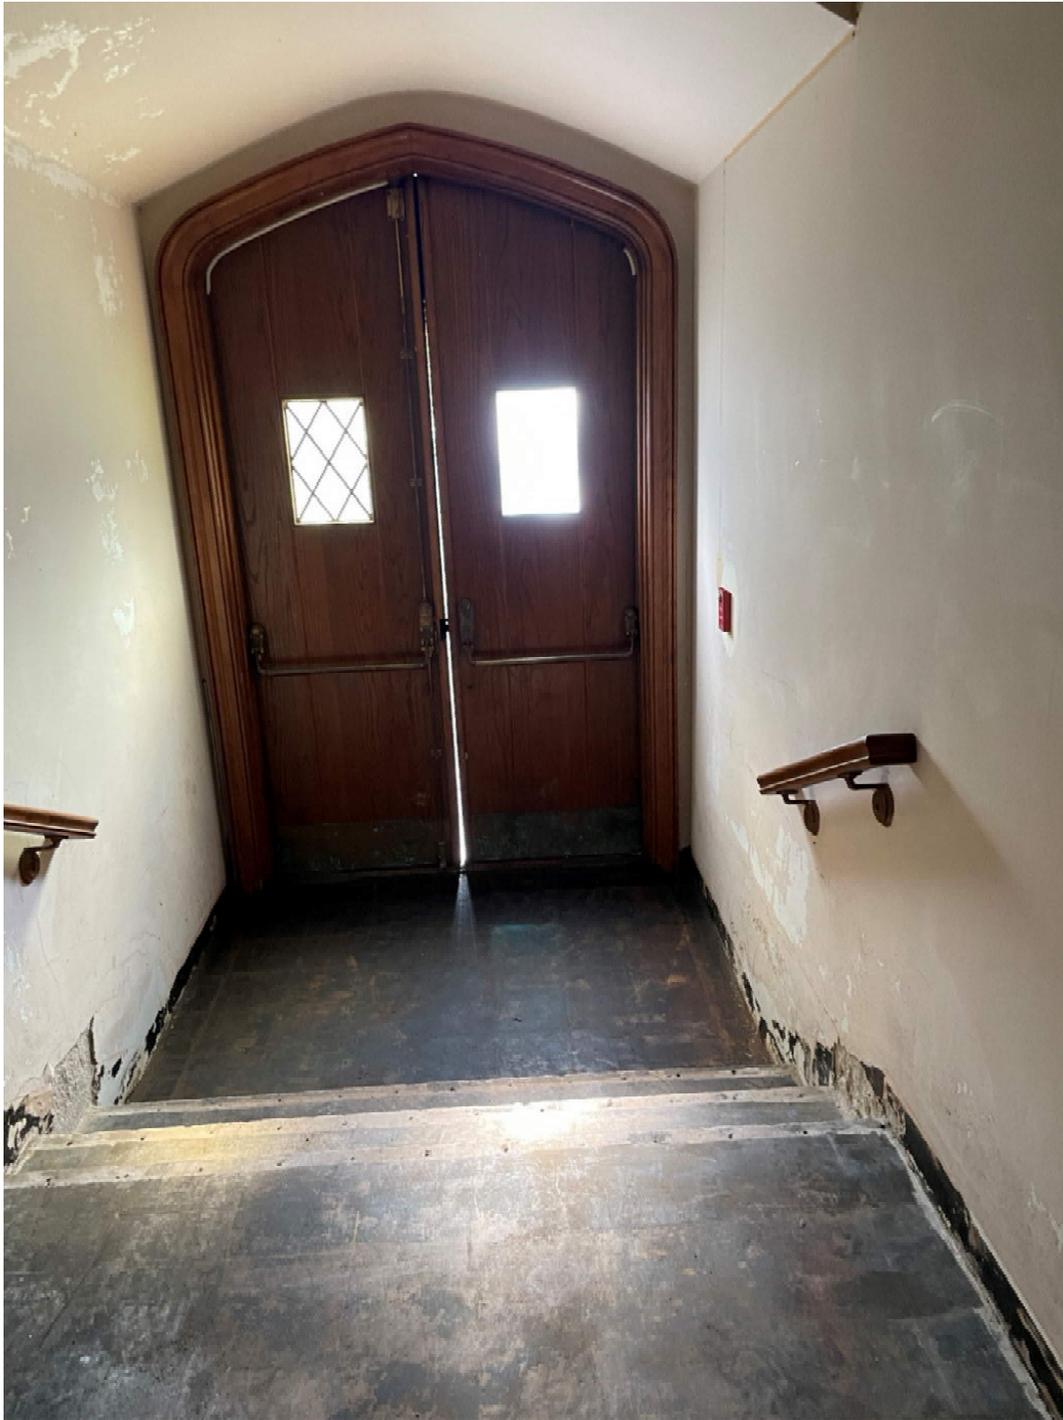
Figure 77 Retreat Building. First floor vestibule, not utilized in daily operations.

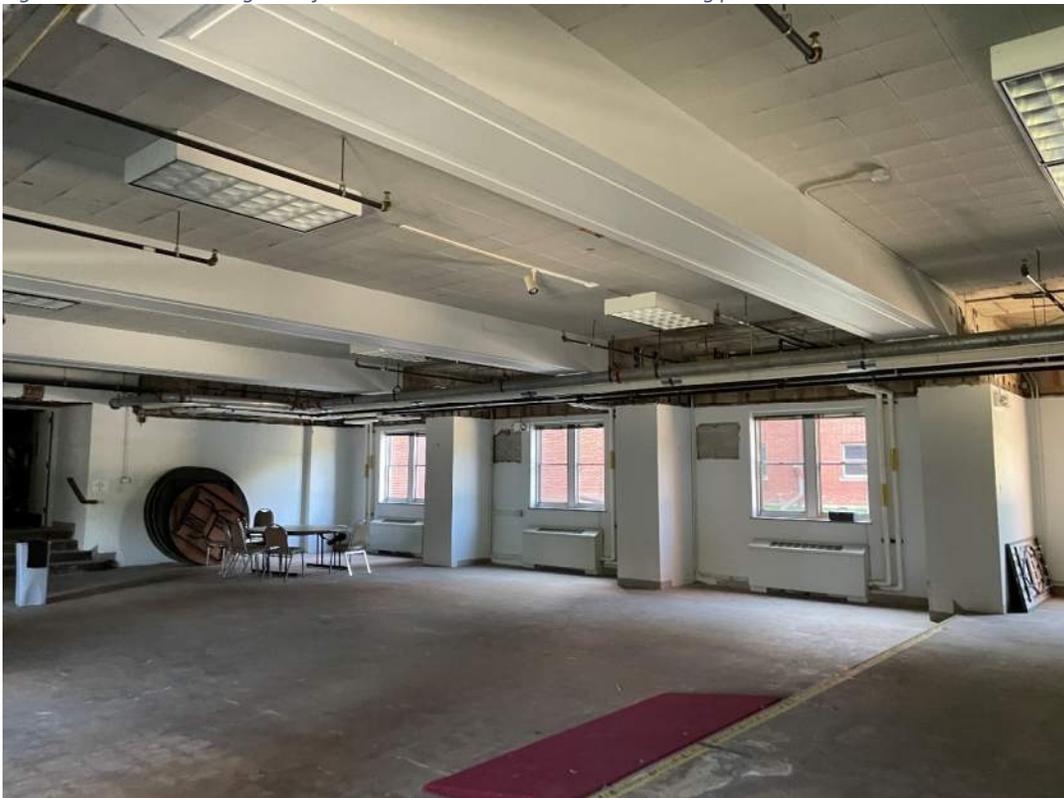
Figure 79 Retreat Building. First floor gathering hall underneath Event Space.

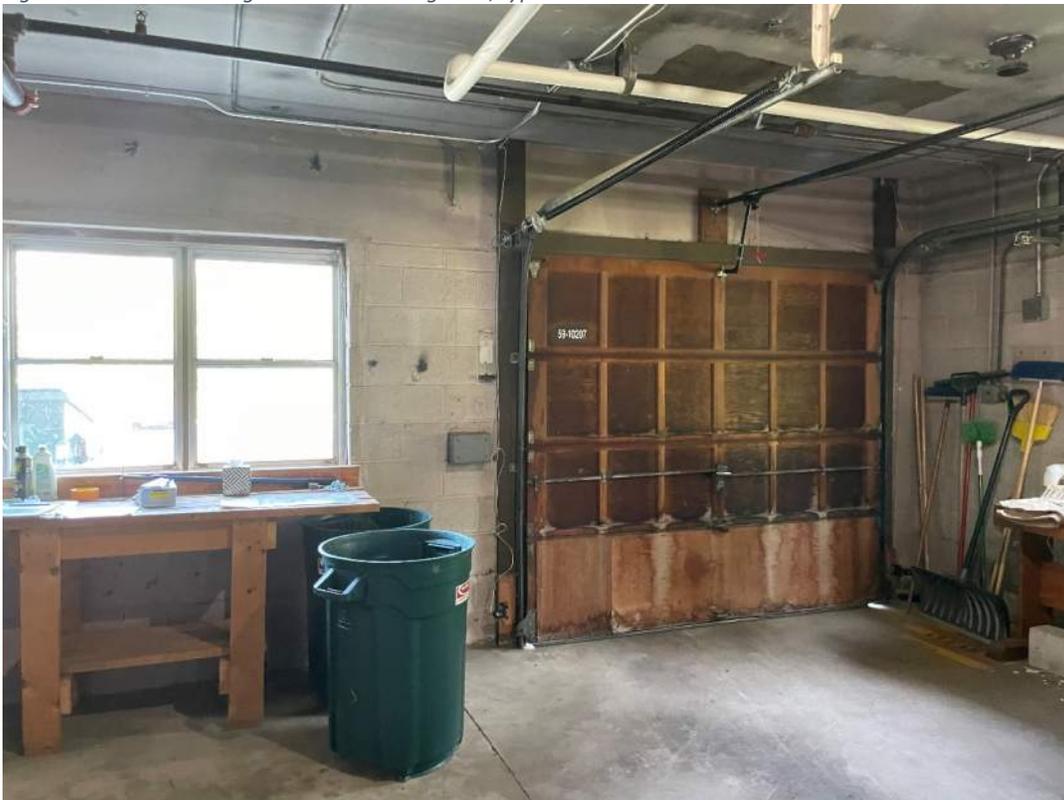
Figure 81 Retreat Building. Basement garage door which exits to grade.

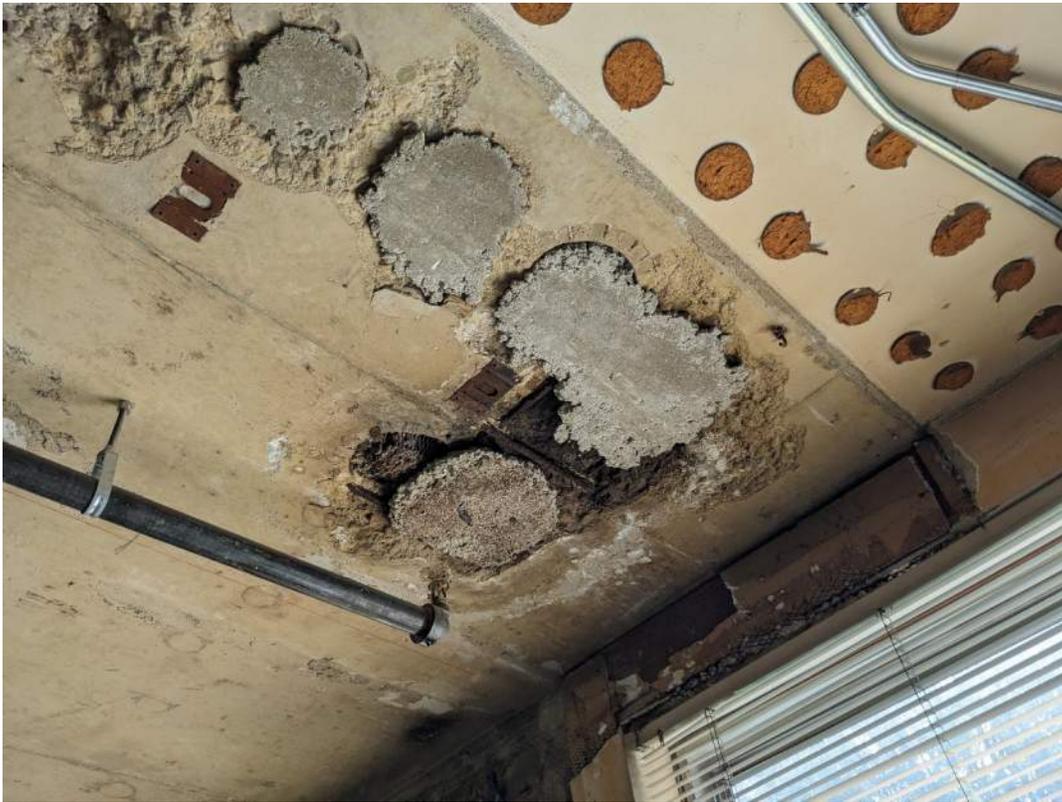
Figure 82 Retreat Building. Exposed rebar in ceiling.

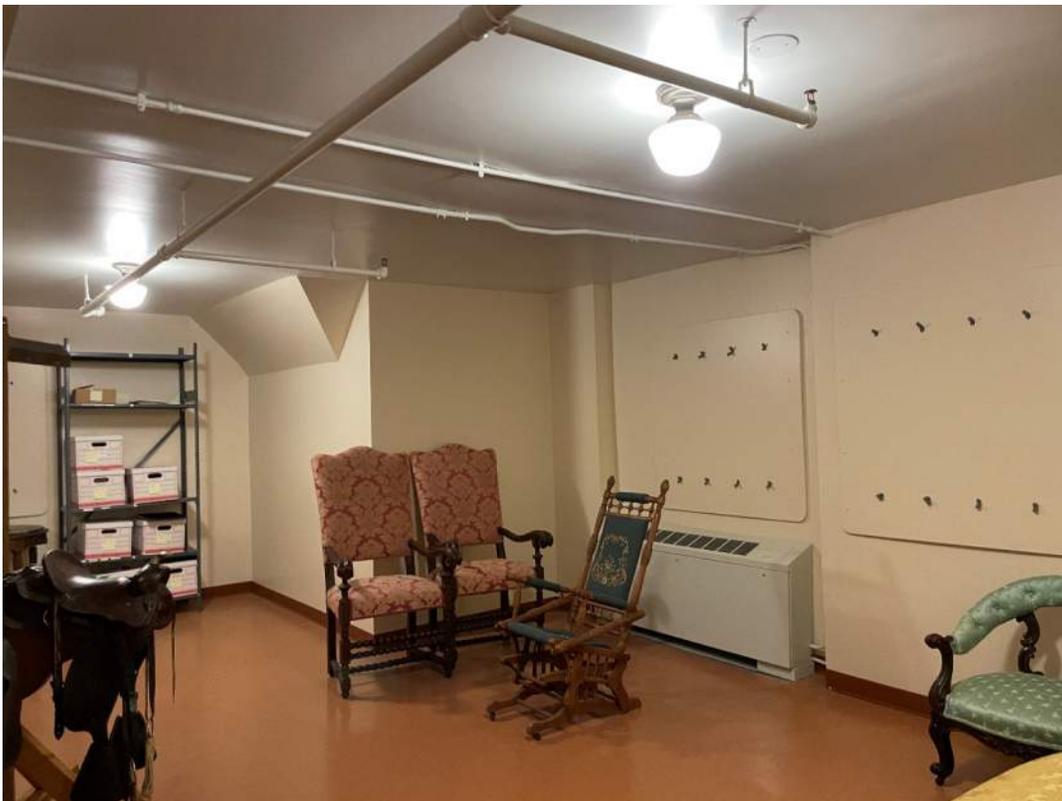
Figure 83 Retreat Building. Third floor Archive space. Note panels covering windows.

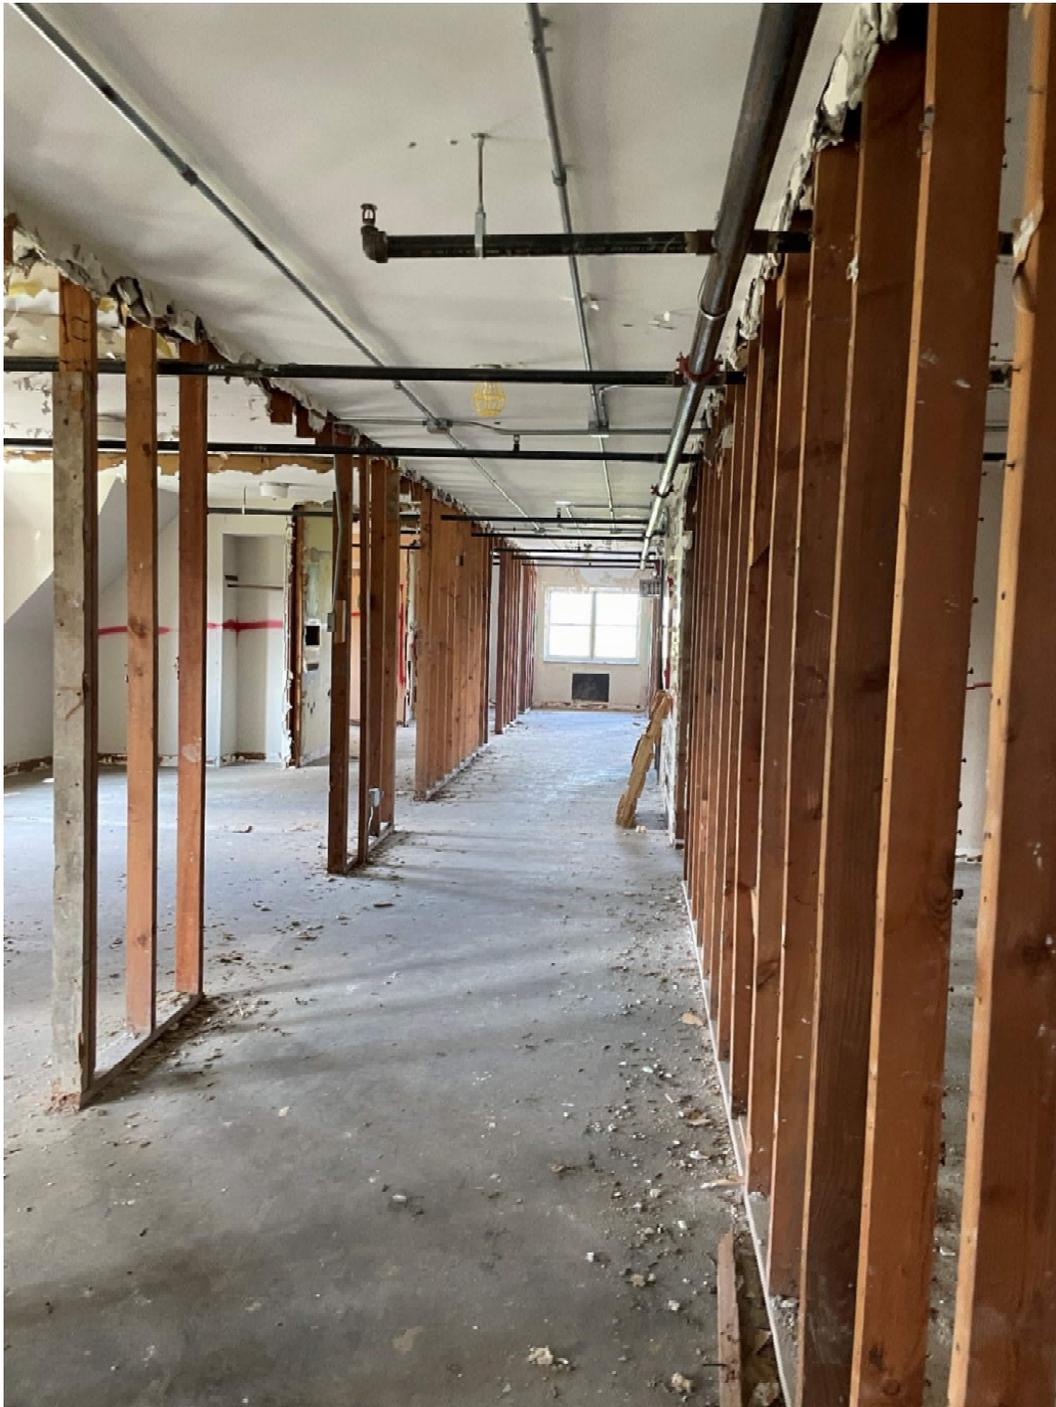
Figure 84 Retreat Building. Third floor unfinished space.

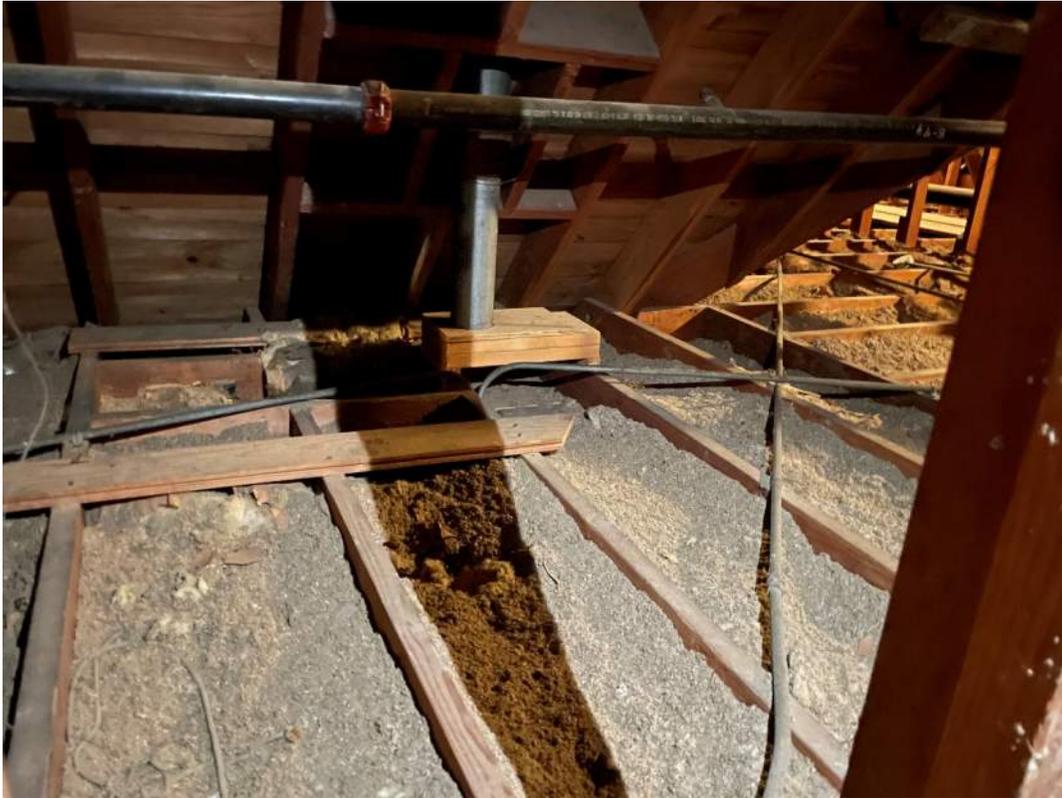
Figure 85 Retreat Building. Attic. Note plumbing vent is abandoned.

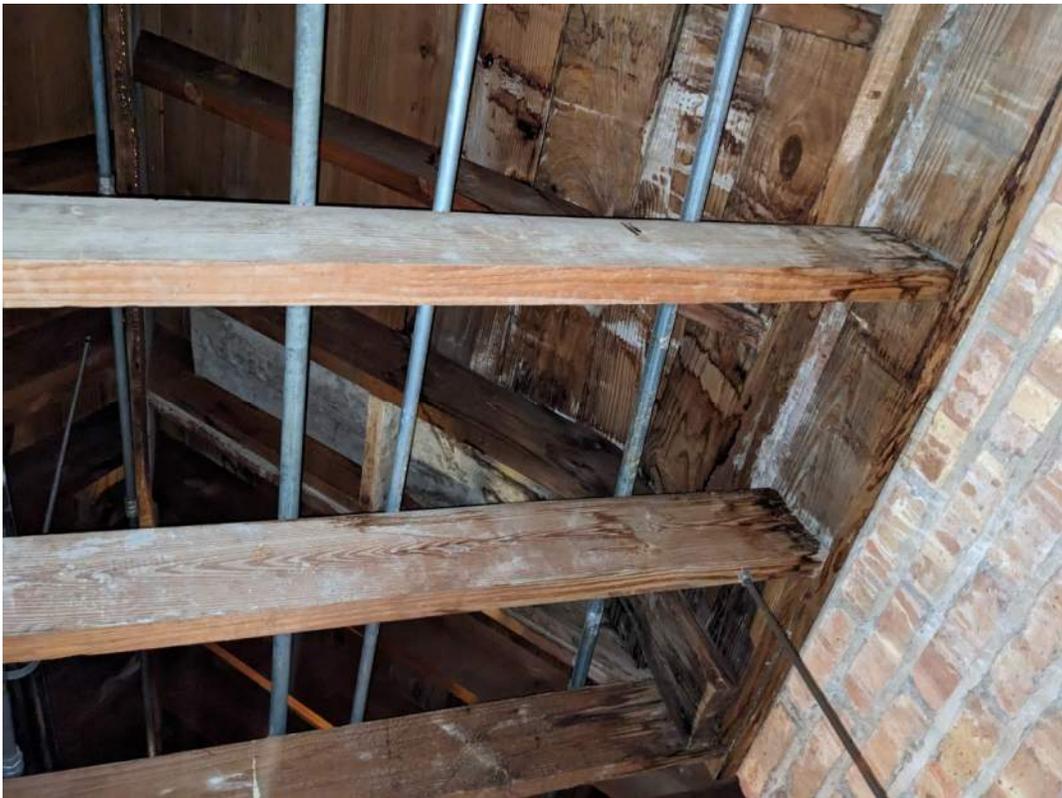
Figure 86 Retreat Building. Attic, stains from past water damage.

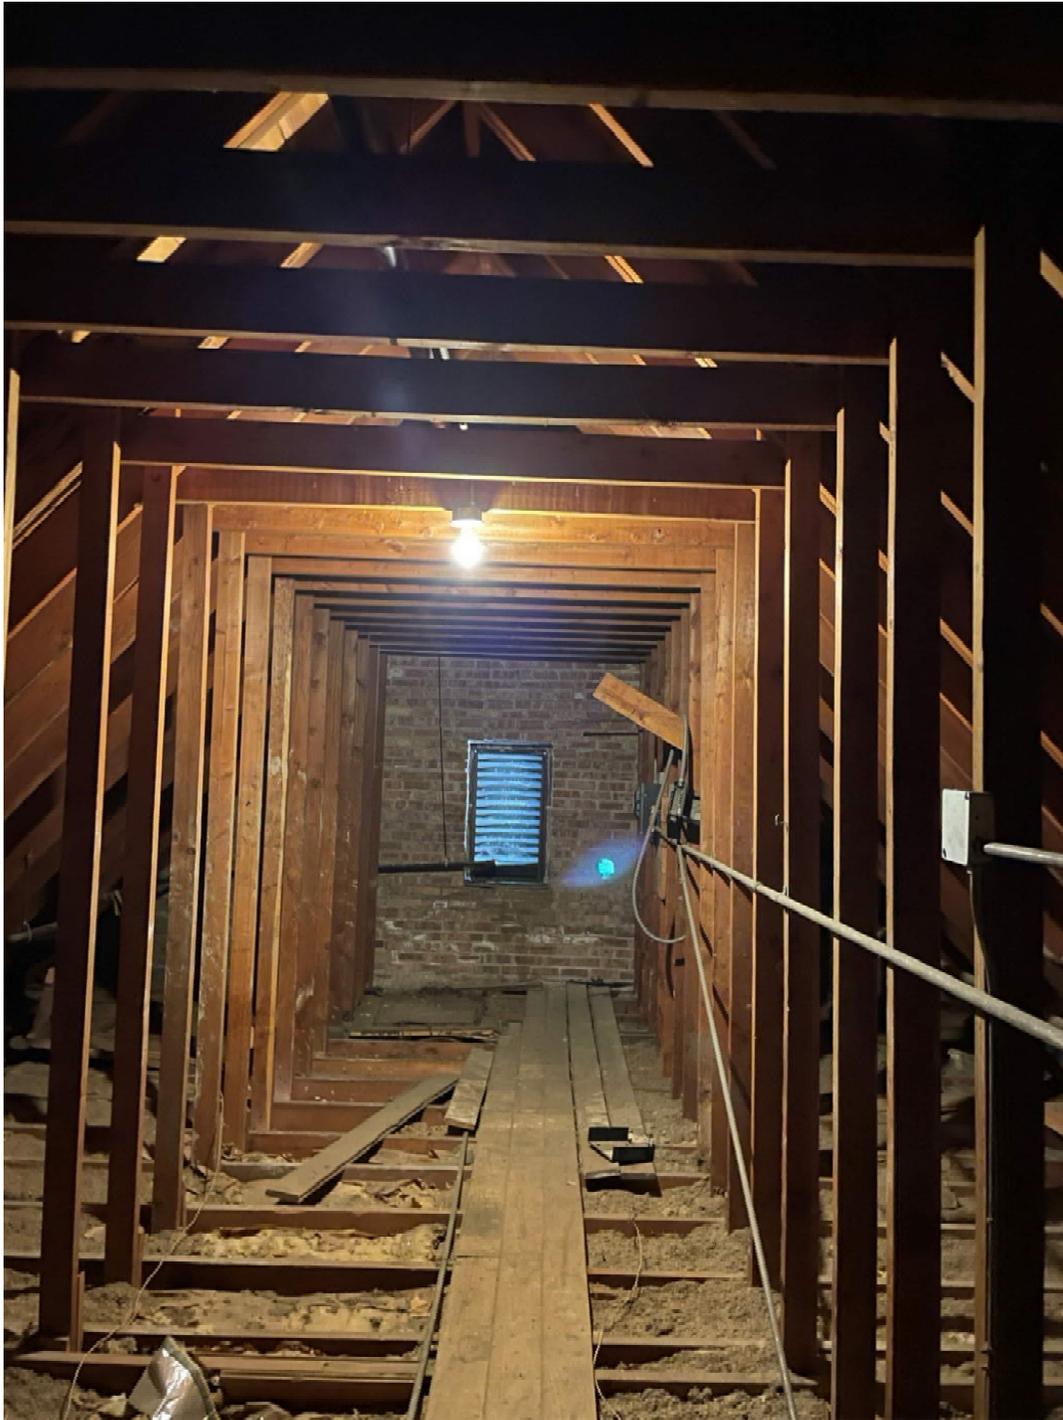
Figure 87 Retreat Building. Attic, looking towards louver.

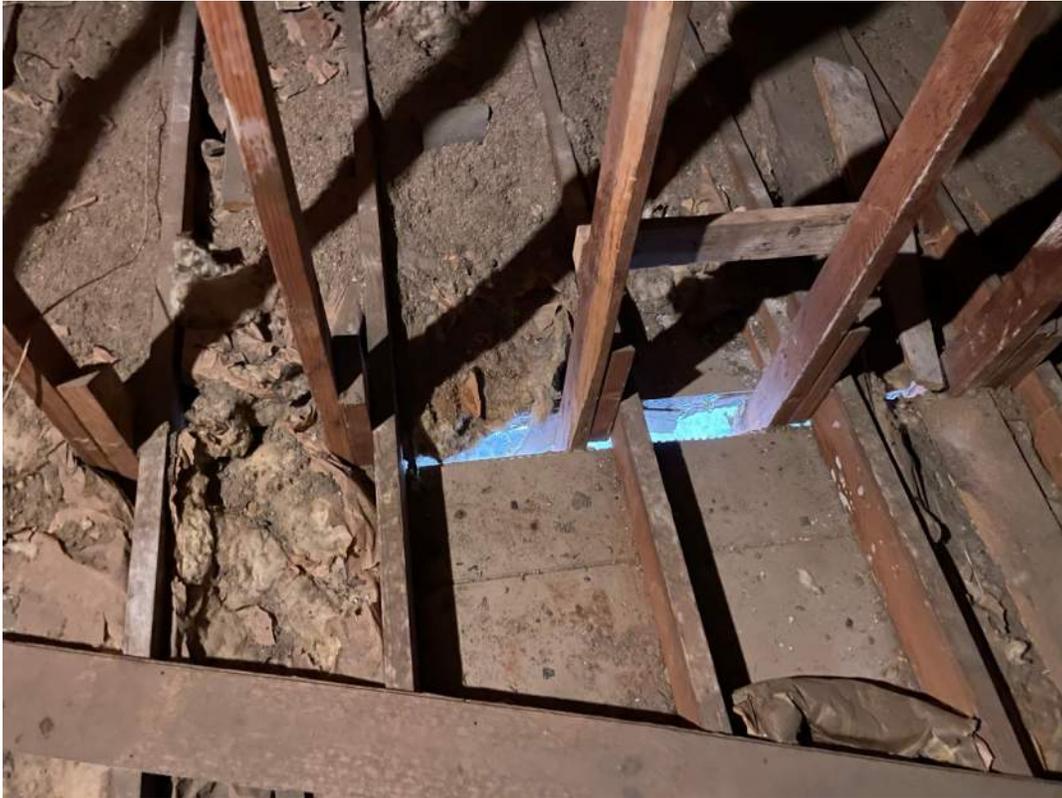
Figure 88 Retreat Building. Gap in floor/ceiling where studs from third floor connect to attic studs.
