Mayslake Peabody Estate
Forest Preserve District of DuPage County

Master Plan Report

November 1, 2024

Facility Condition Assessment Report

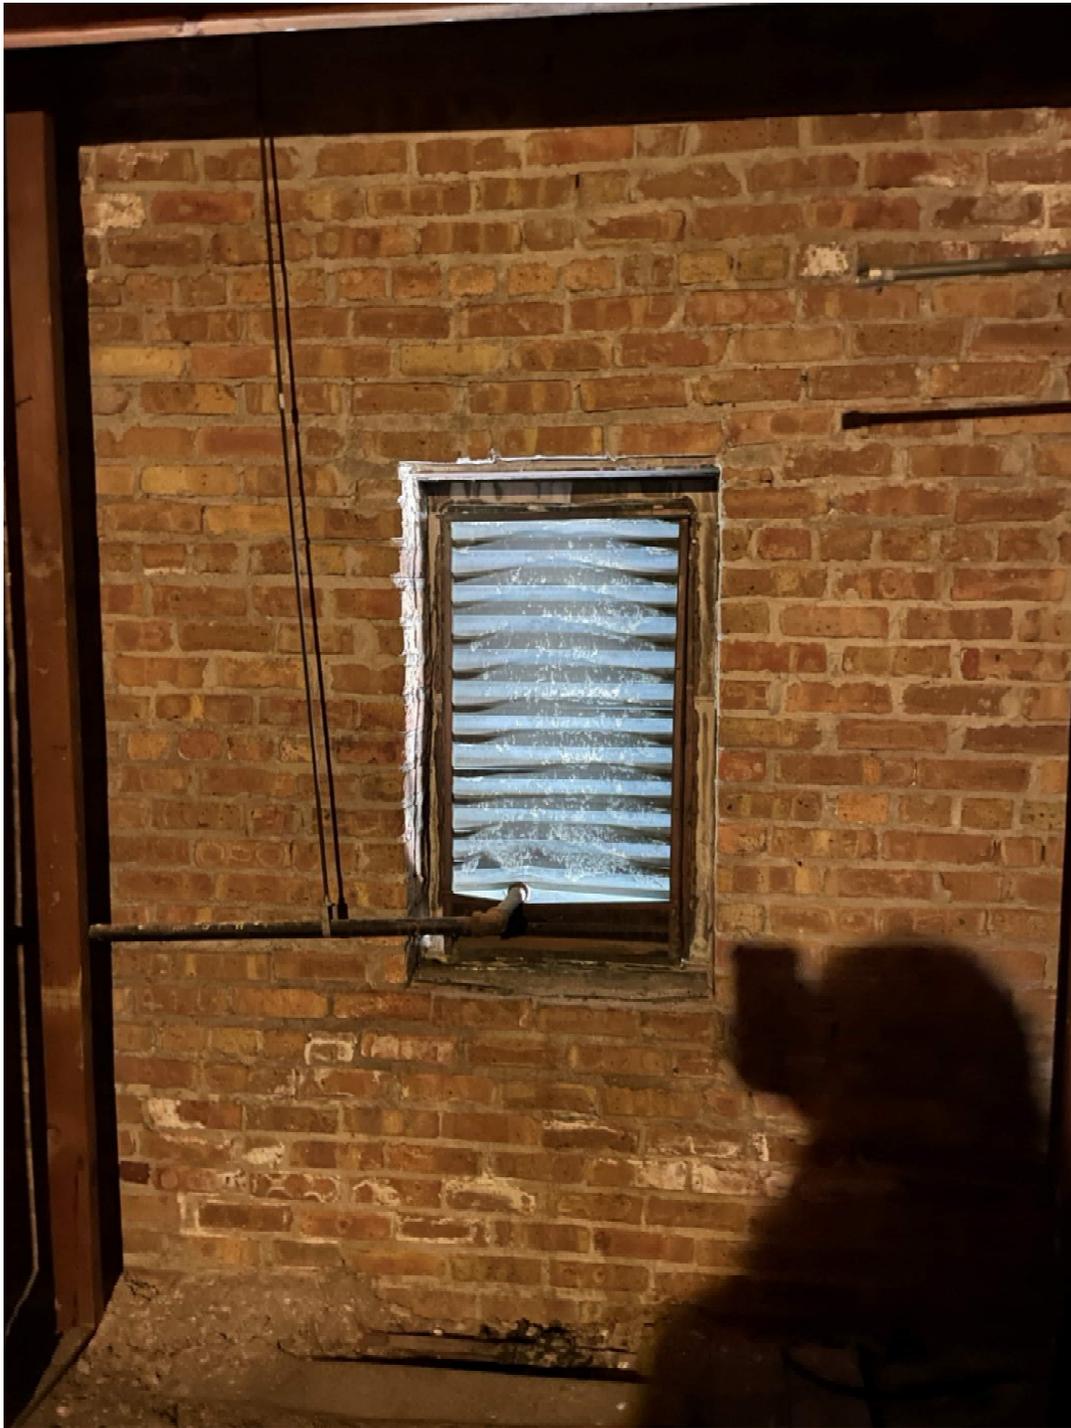
Figure 89 Retreat Building. Attic louver, typical.

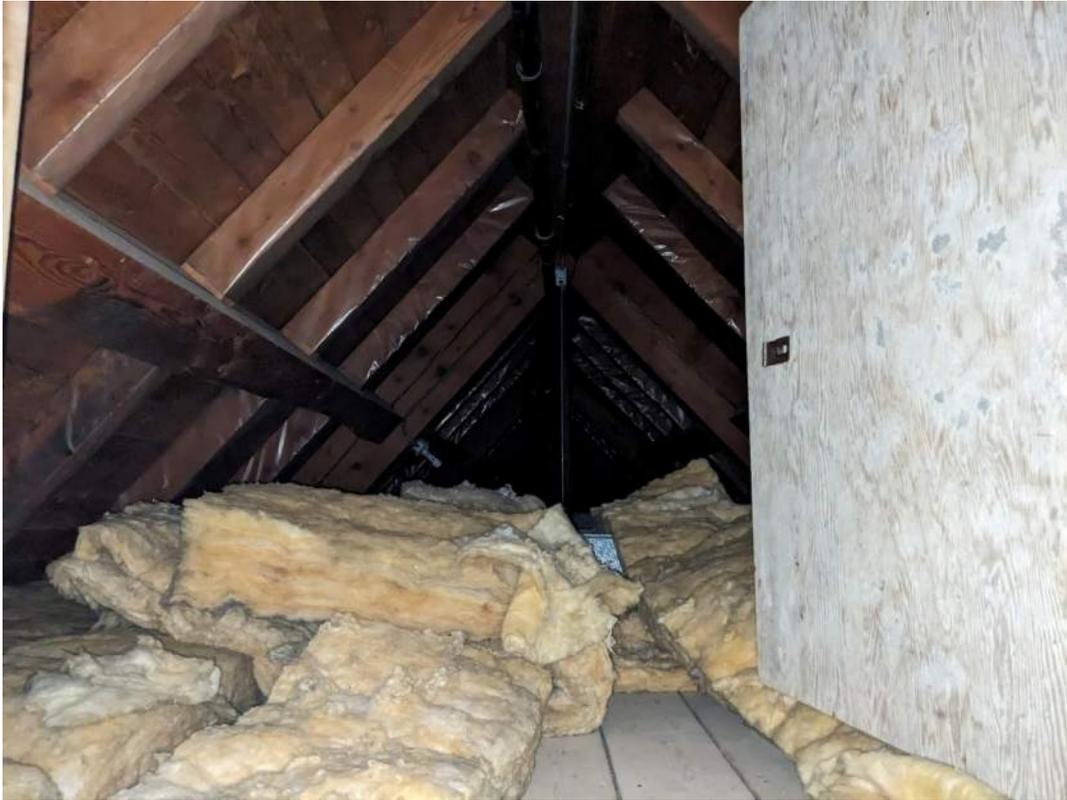
Figure 90 Retreat Building. View into attic of Event Space.

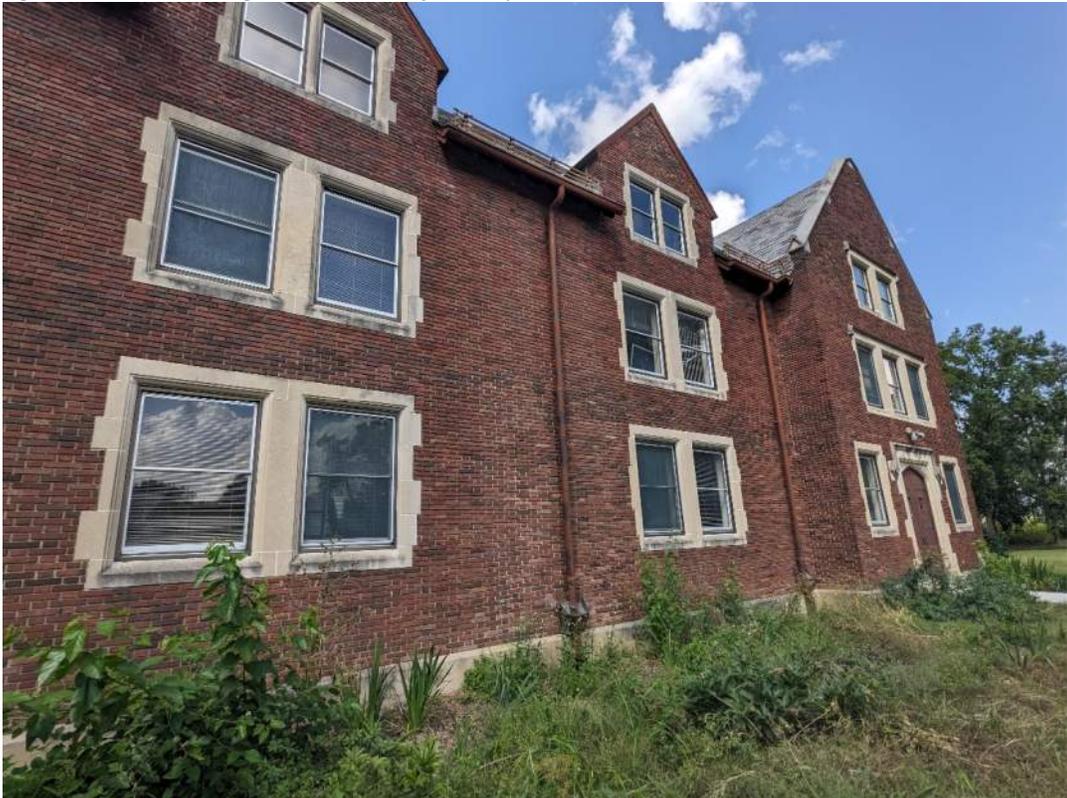
Figure 91 Retreat Building. North end of east facade.

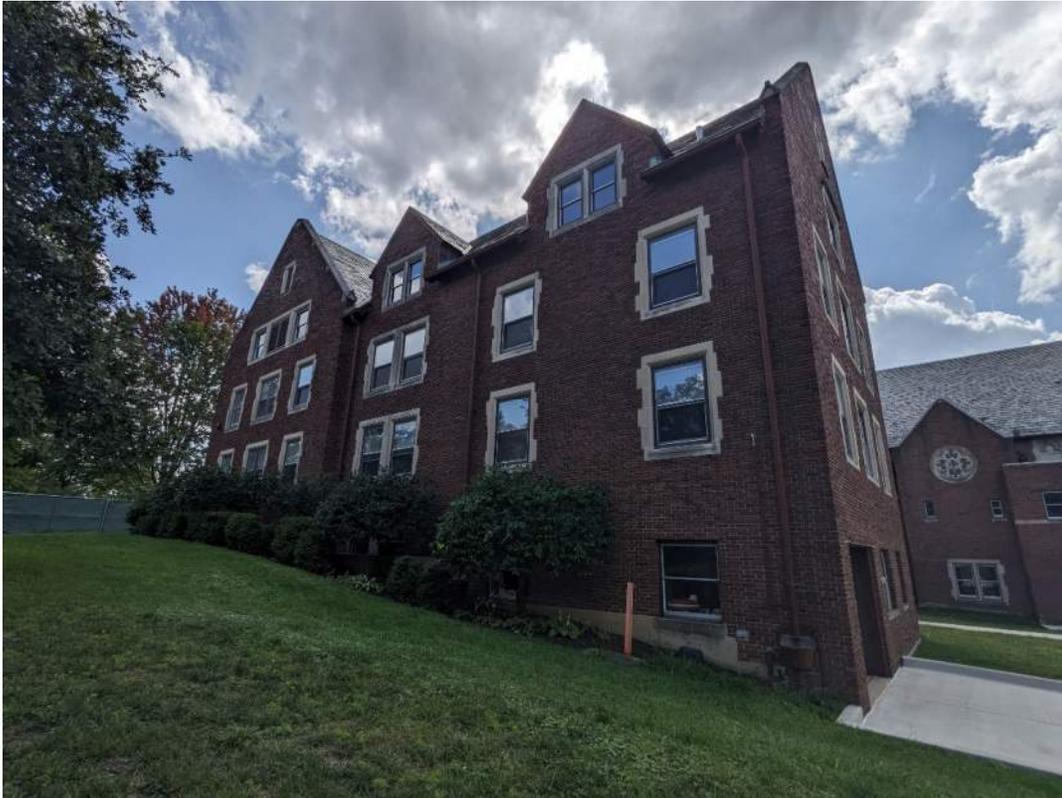
Figure 94 Retreat Building. North facade.

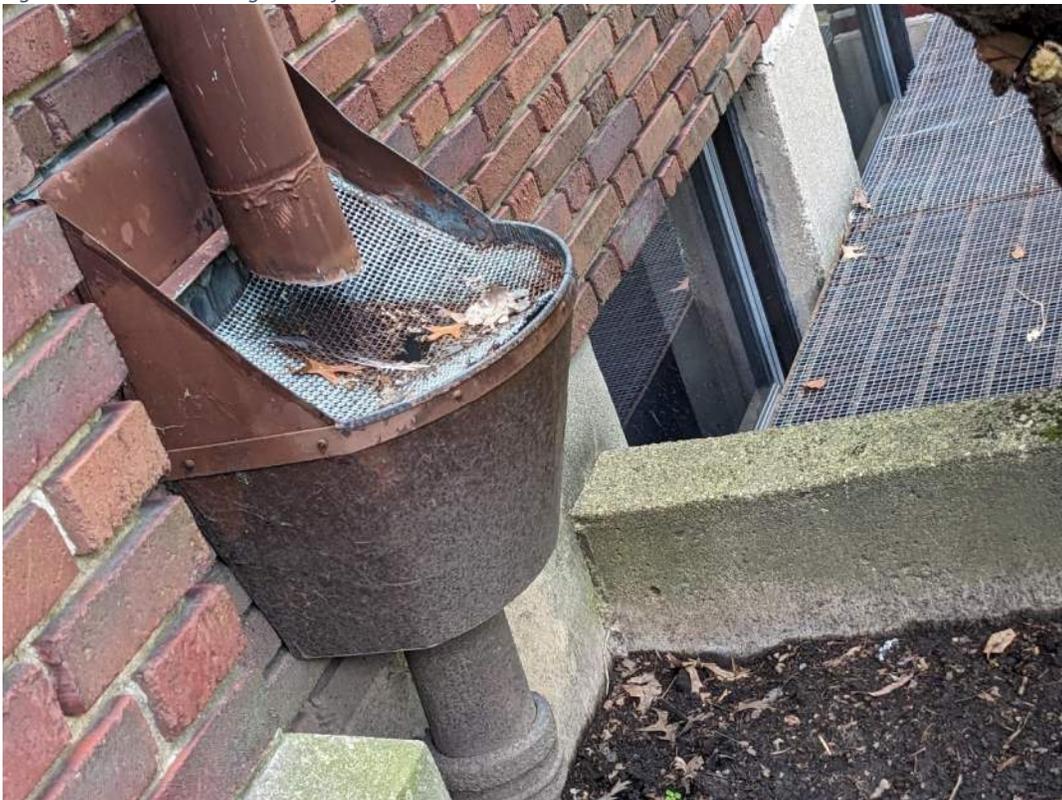
Figure 95 Retreat Building. North facade. Example of conductor box and strainer.

Façade	A6	A	Patch spalled limestone in window surrounds. Color and profile to match existing.	11	SF	\$175.00	\$1,925	
Façade	A7	A	Grind and repoint areas of deteriorated brick. Mortar color and joint style to match existing.	155	SF	\$25.00	\$3,875	
Façade	A8	A	Replace spalled brick. Brick color, mortar color, and mortar joint style to match existing	60	EA	\$185.00	\$11,100	
Façade	A9	A	Grind and repoint limestone head joints in door surround	5	LF	\$30.00	\$150	
Façade	A10	A	Repoint joint in limestone base	2	LF	\$30.00	\$60	
Façade	A11	A	Rout and seal concrete foundation crack	2	LF	\$135.00	\$270	
Façade	A12	A	Patch spall in concrete foundation wall	2	SF	\$250.00	\$500	
Façade	A13	B	Patch and repair concrete on exterior of light wells	5	SF	\$250.00	\$1,250	
Gutters & Downspouts	A14	A	Resolder open joints in copper gutters at corners	4	LF	\$100.00	\$400	
Gutters & Downspouts	A15	A	Remove and replace broken strainers on conductor boxes. Approx 16"x16"	10	EA	\$850.00	\$8,500

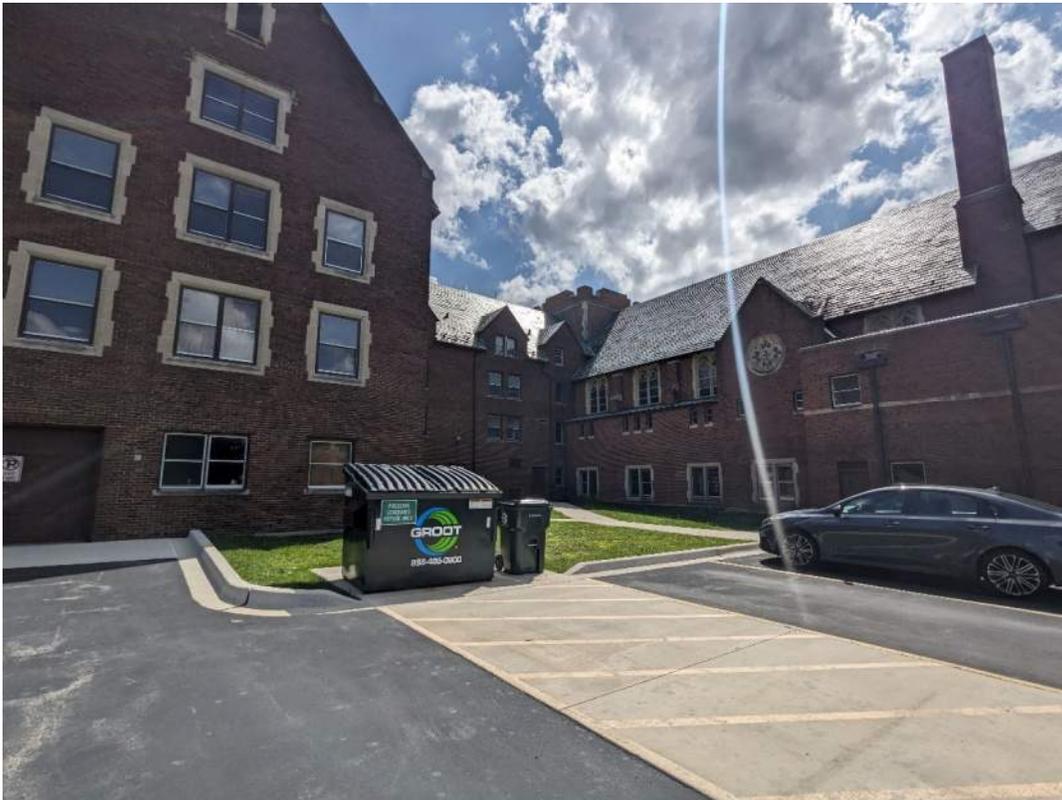
Figure 98 Retreat Building. West facade, north courtyard looking south.

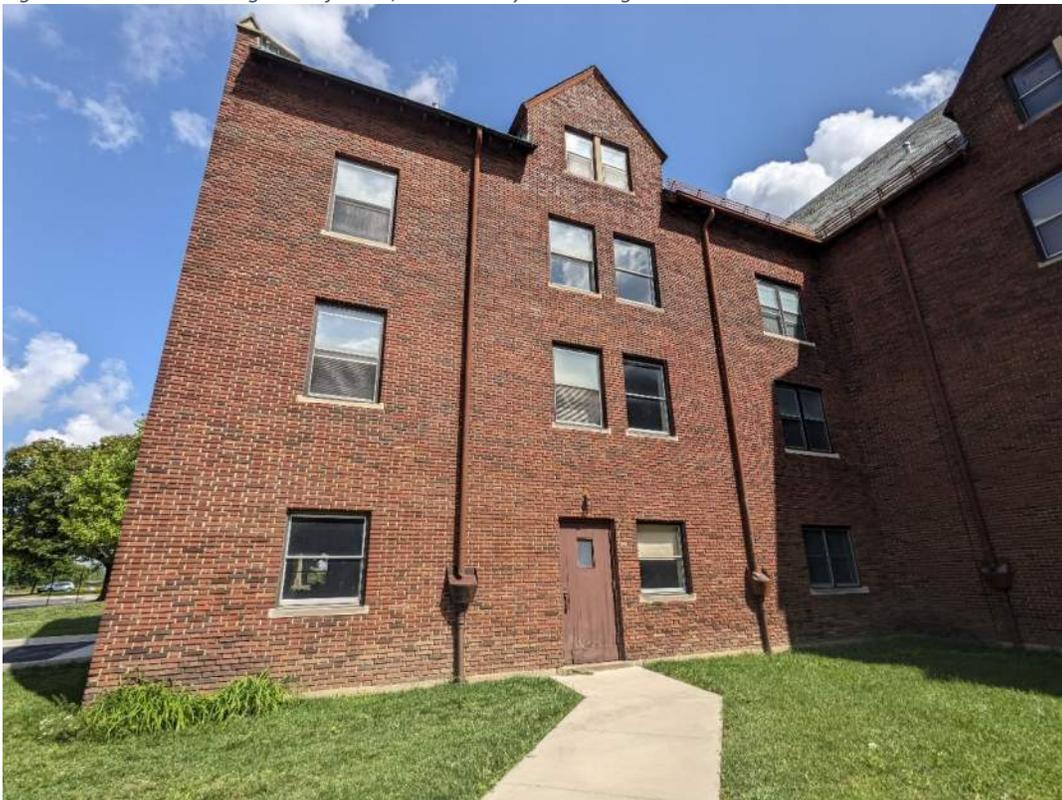
Figure 99 Retreat Building. West facade, north courtyard looking north.

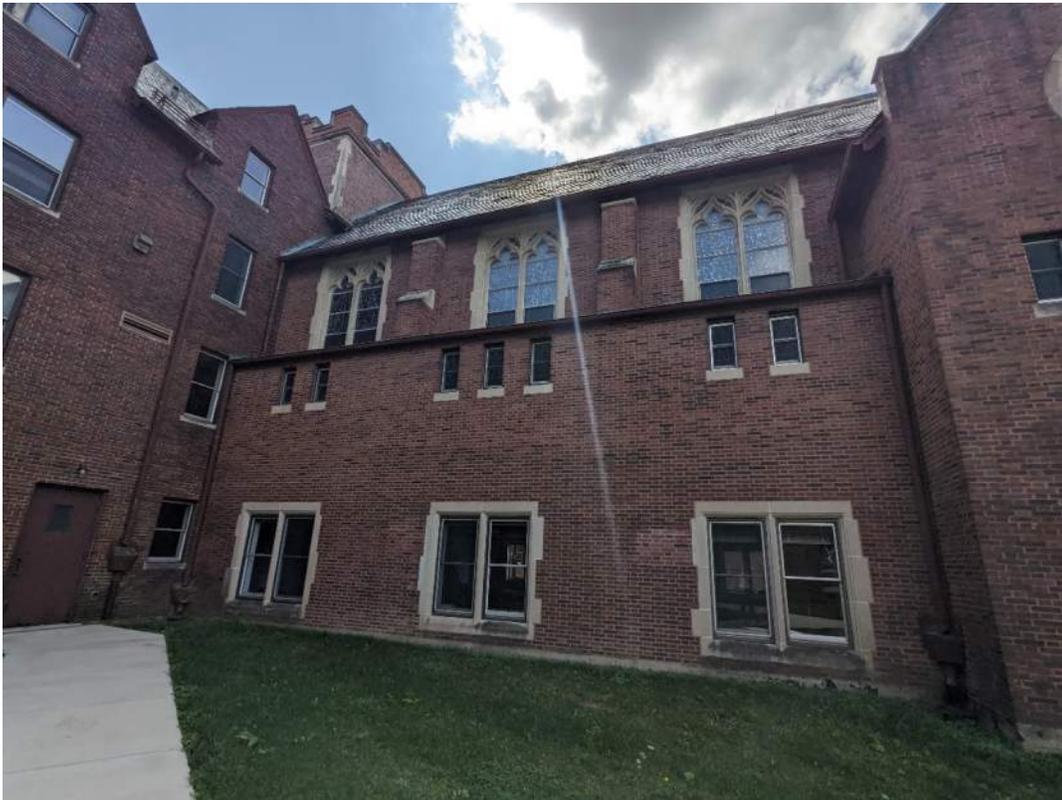
Figure 100 Retreat Building. North courtyard of west facade, looking towards north facade of Event Space.

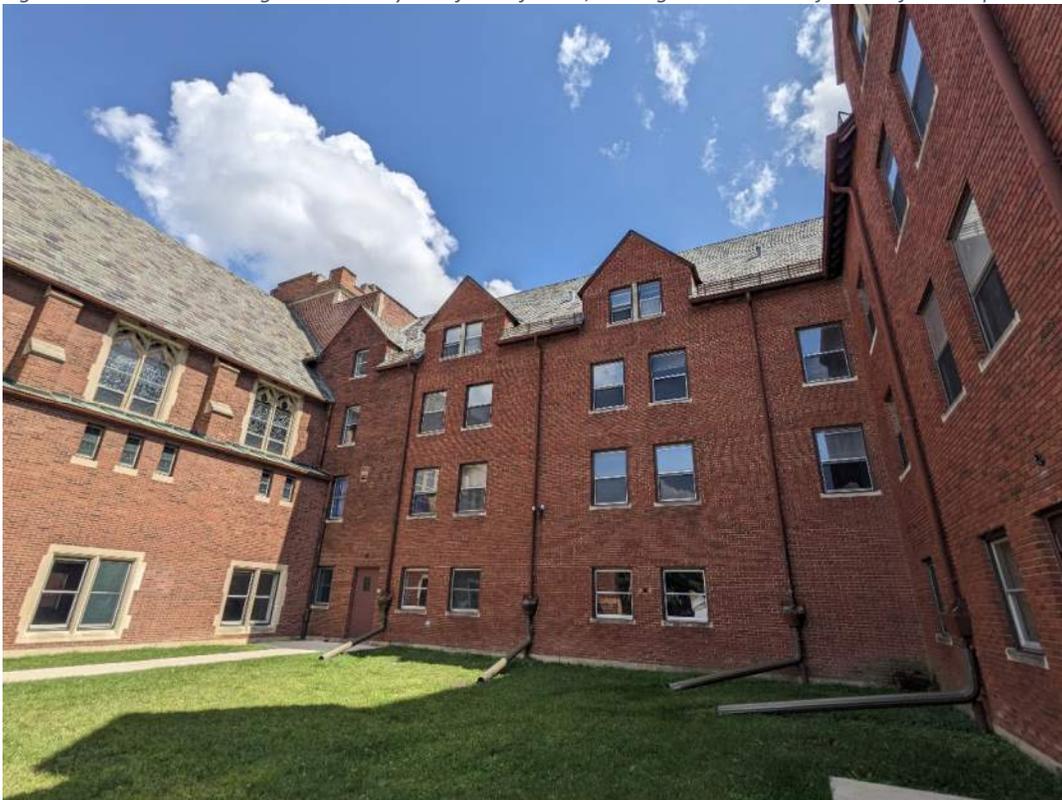
Figure 101 Retreat Building. South courtyard of west facade, looking northeast. Note downspout extensions.

Gutters & Downspouts	A16	A	Clear debris from intact strainers in conductor boxes	25	EA	\$150.00	\$3,750	
Gutters & Downspouts	A17	A	Clean debris from gutters and downspouts	800	LF	\$5.00	\$4,000	
Gutters & Downspouts	A18	A	Provide splash blocks at gutters that extend into lawn	5	EA	\$125.00	\$625	
Roof	A19	A	Remove and replace existing copper roof flashing. Approx 8" high with copper counter flashing and sealant. Remove and replace adjacent slate tiles for proper installation.	500	LF	\$150.00	\$75,000	
Roof	A20	A	Seal around abandoned plumbing roof vent stacks. Approx 4" diameter	10	EA	\$115.00	\$1,150	
Roof	A21	A	Grind, repaint, and seal head joints at limestone gables and limestone parapet	350	LF	\$30.00	\$10,500	
Roof	A22	B	Remove broken tiles and replace with reclaimed slate tiles with hall hooks	20	EA	\$120.00	\$2,400	
Roof	A23	A	Paint exposed wood eaves, approx. 1 foot overhang.	250	LF	\$20.00	\$5,000

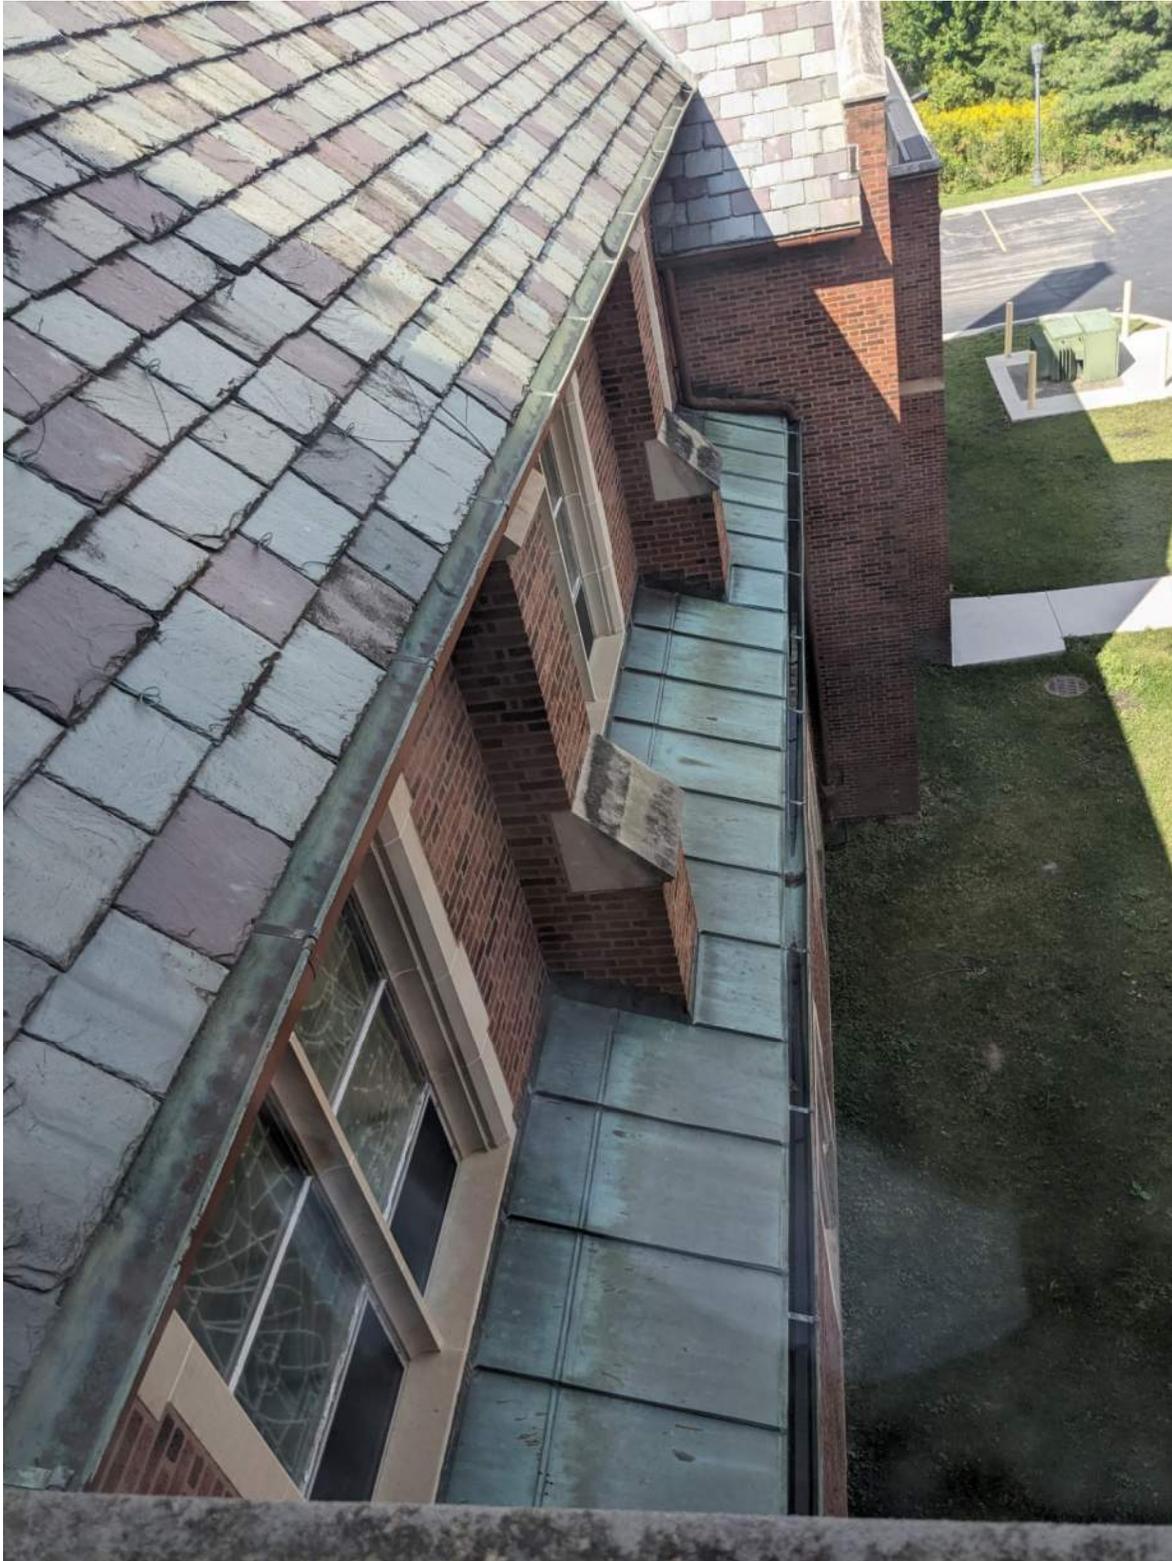
Figure 102 Retreat Building. Roof of north facade of Event Space taken from above. Note snow guards on slate roof and copper roof below.

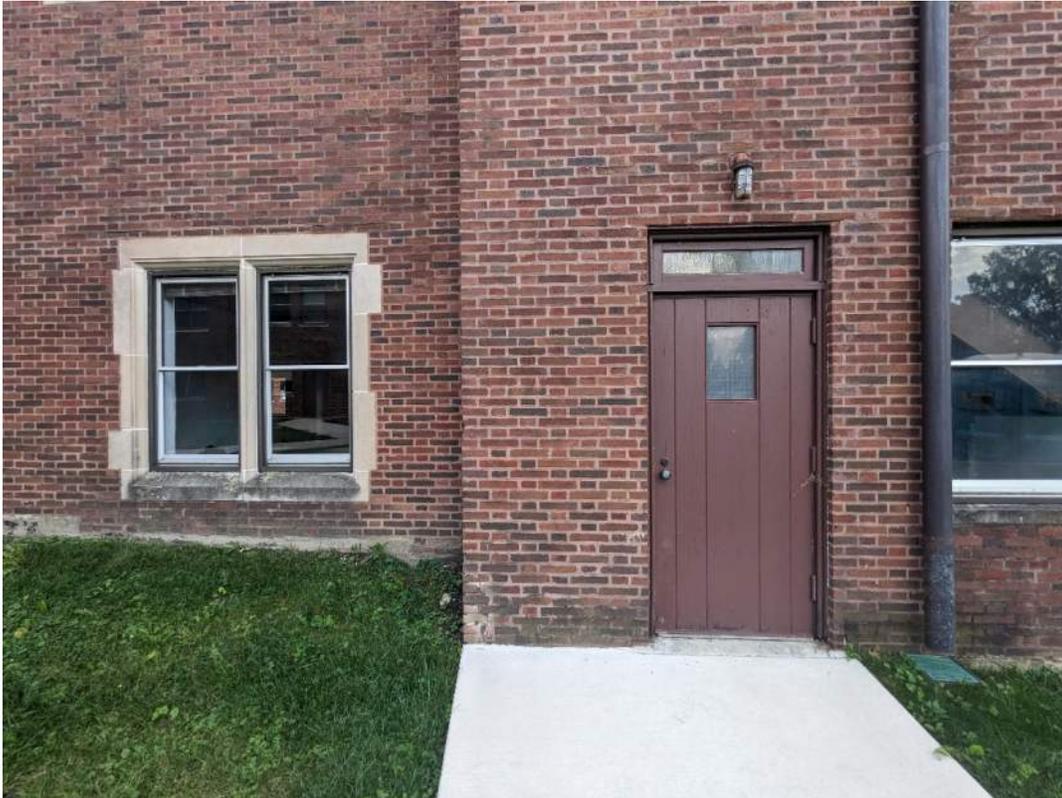
Figure 105 Retreat Building. West facade, staining on limestone sills and lower brick courses.

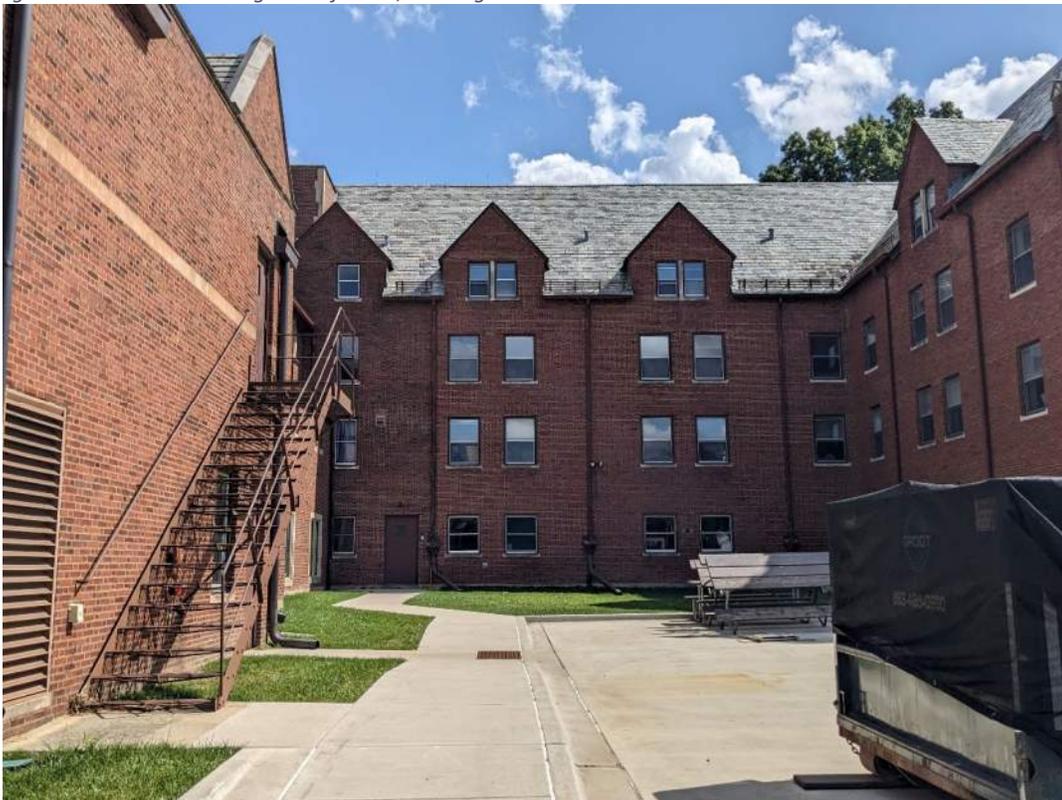
Figure 106 Retreat Building. West facade south courtyard.

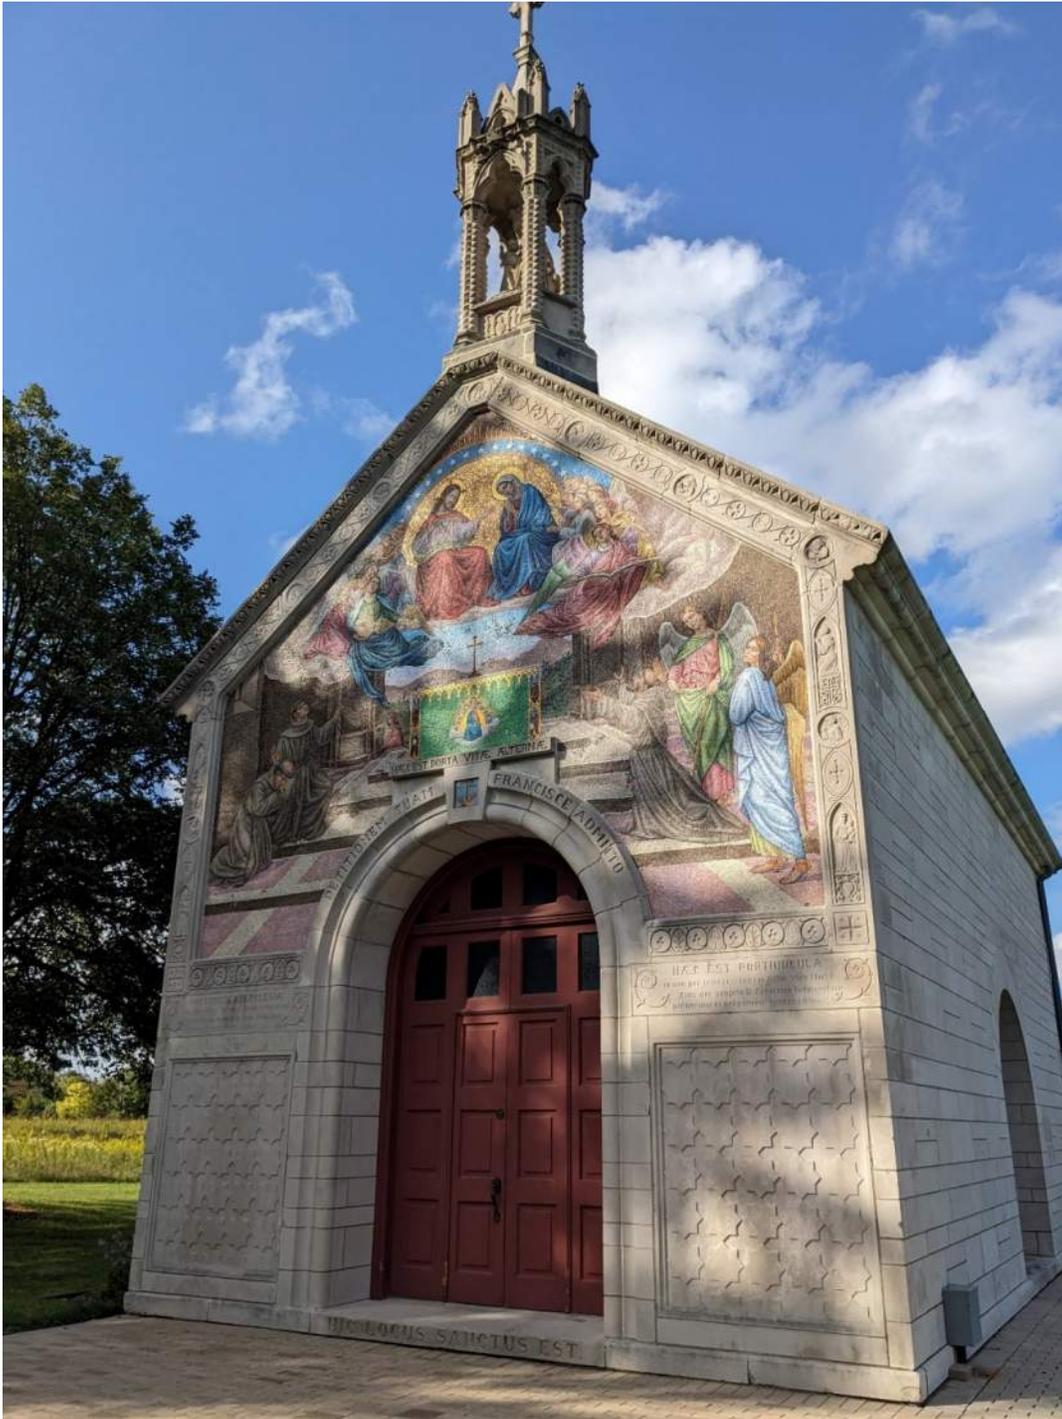
Figure 112 Chapel. Front facade.

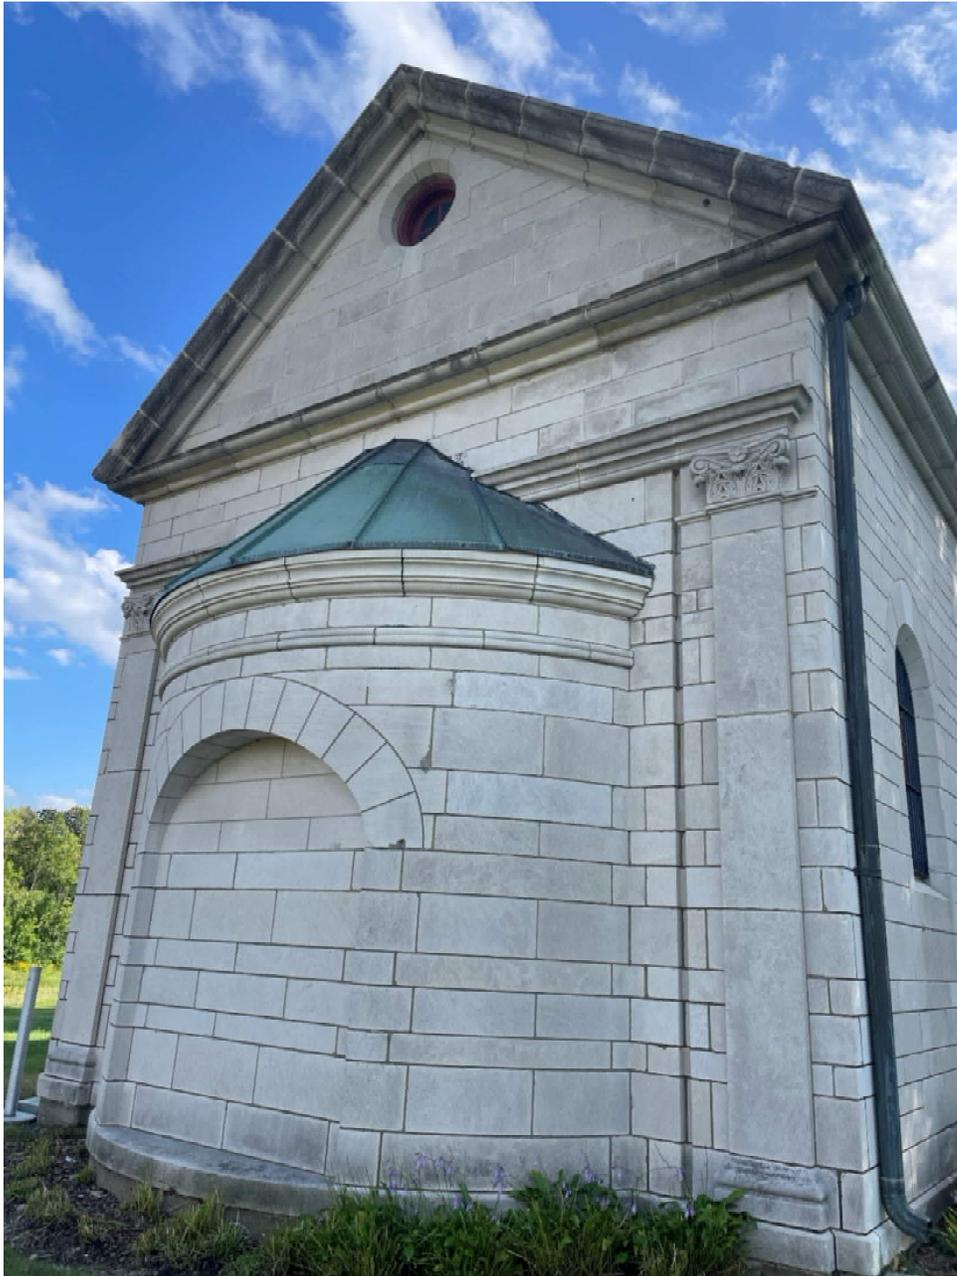
Figure 113 Chapel. Rear facade.

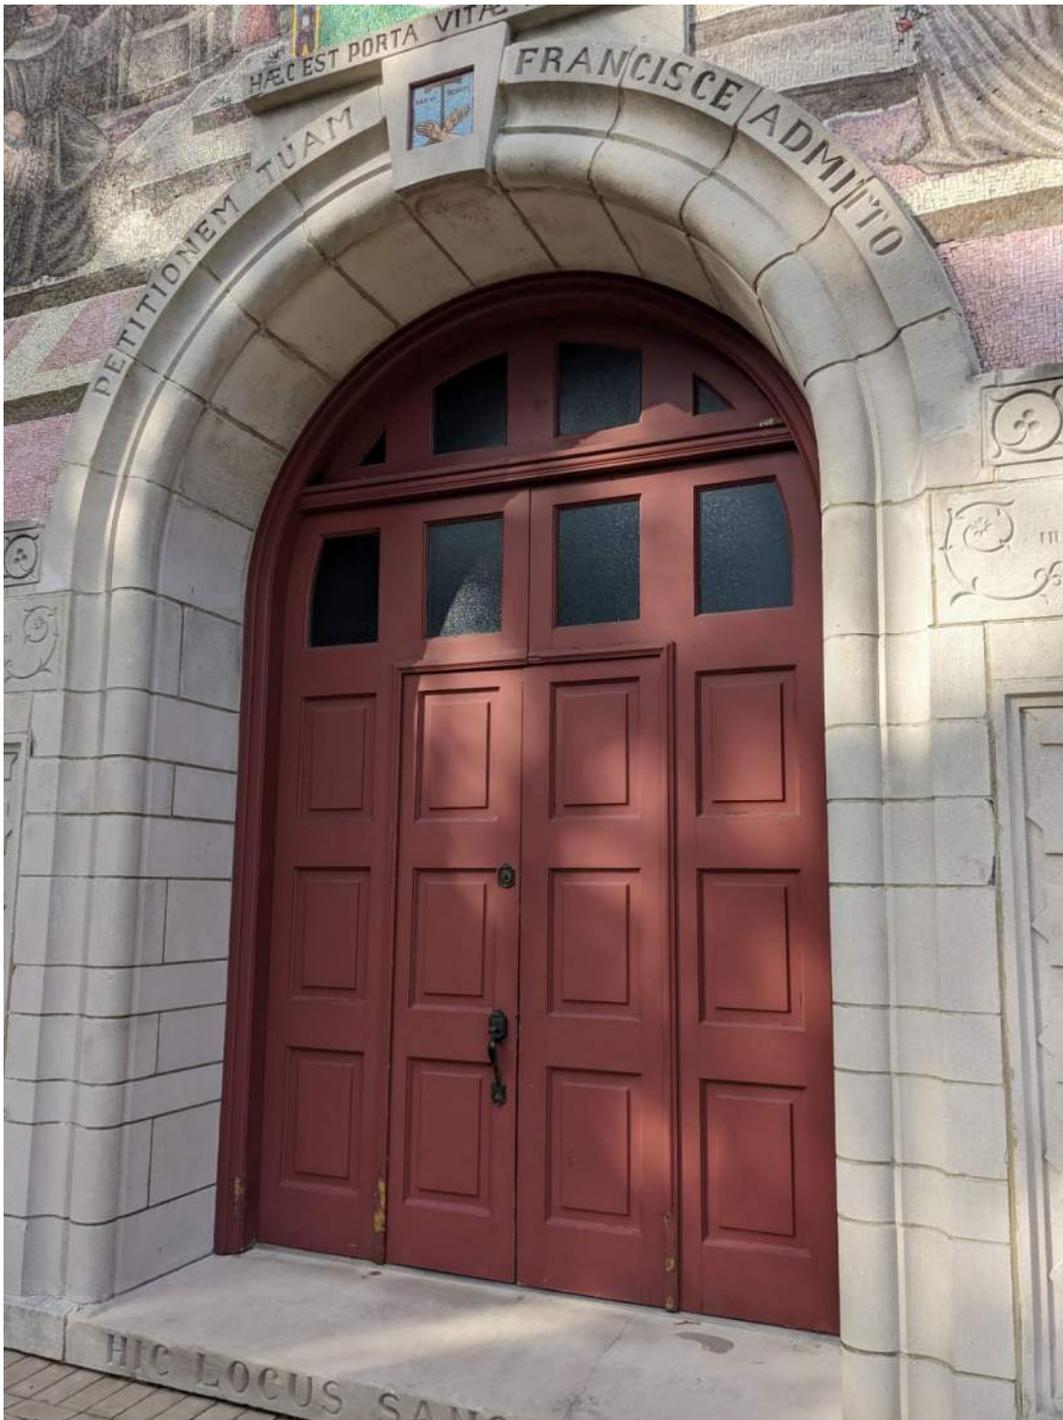
Figure 115 Chapel. Front facade wood entry door.

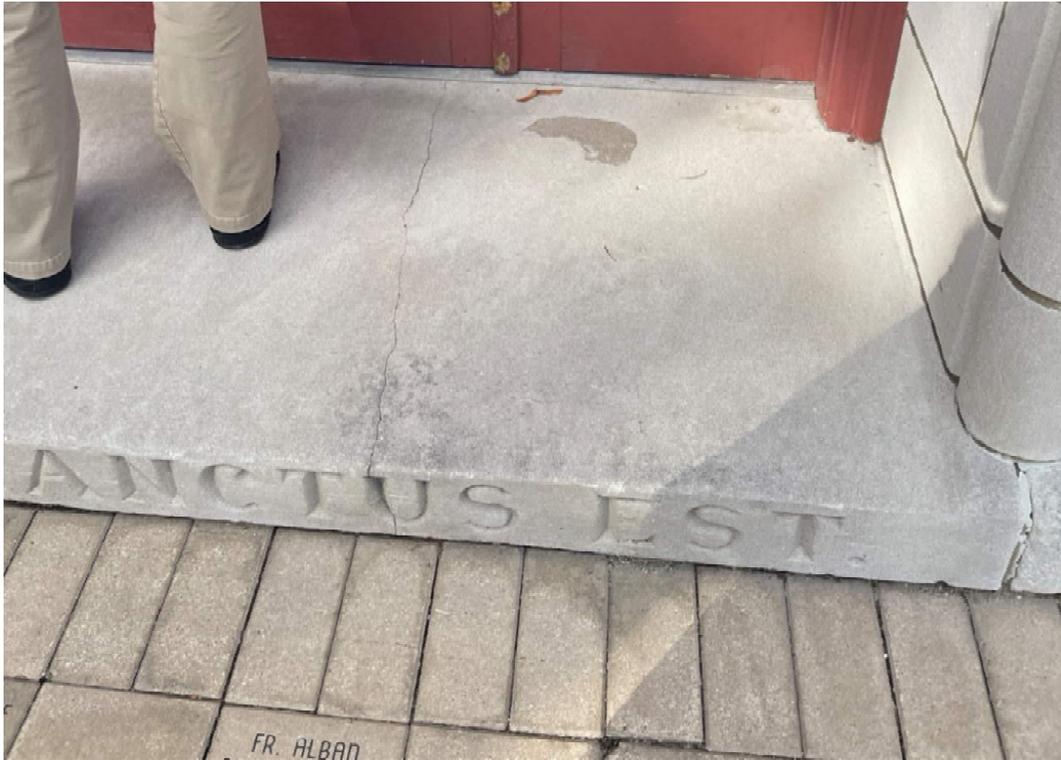
Figure 116 Chapel. Crack in front step.

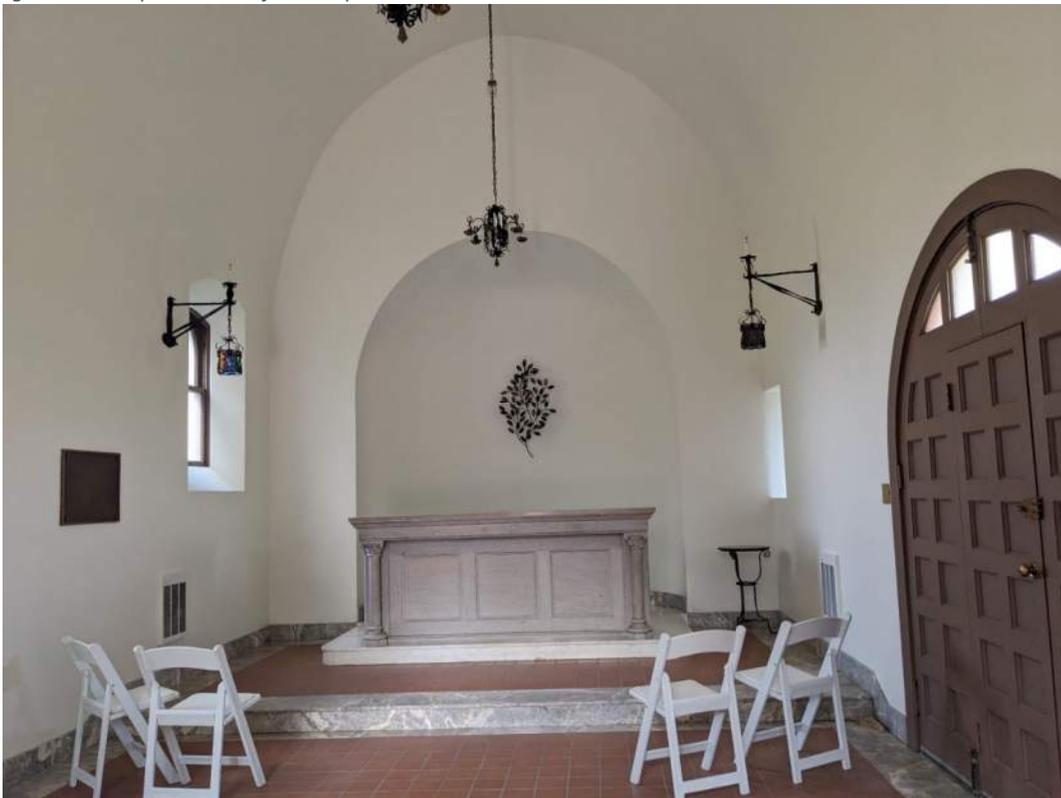
Figure 117 Chapel. Interior looking north.

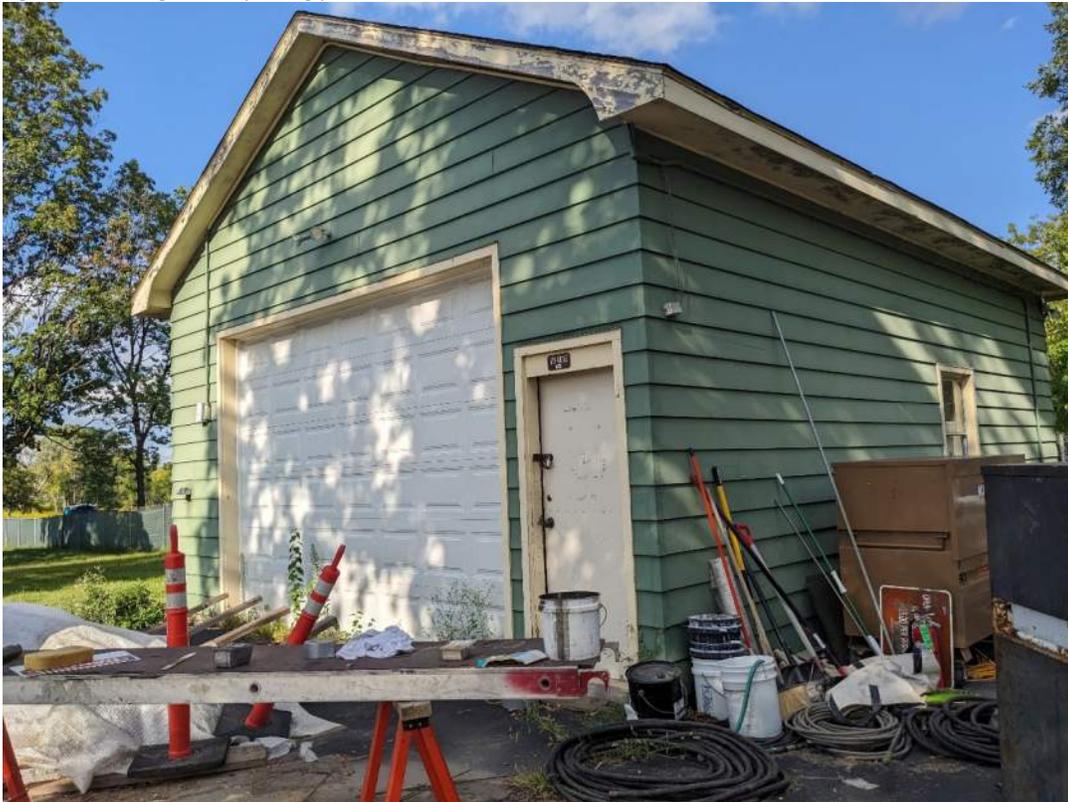
Figure 119 Garage.

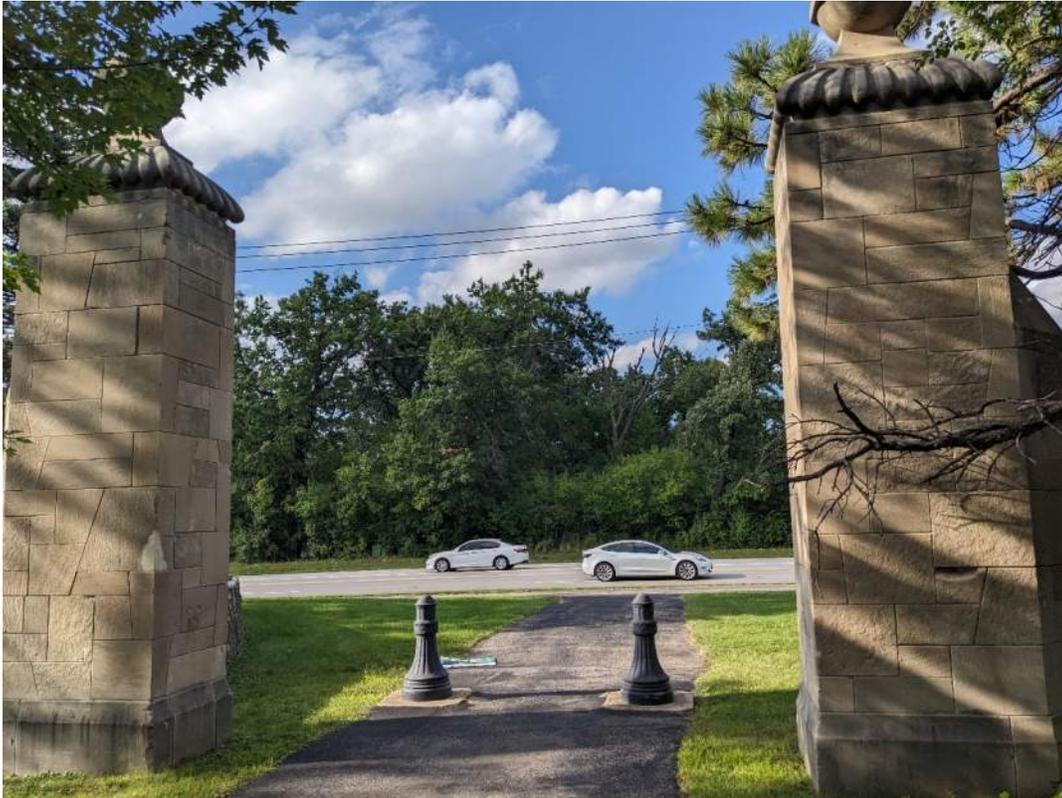
Figure 120 Gate. East and west piers, looking north.

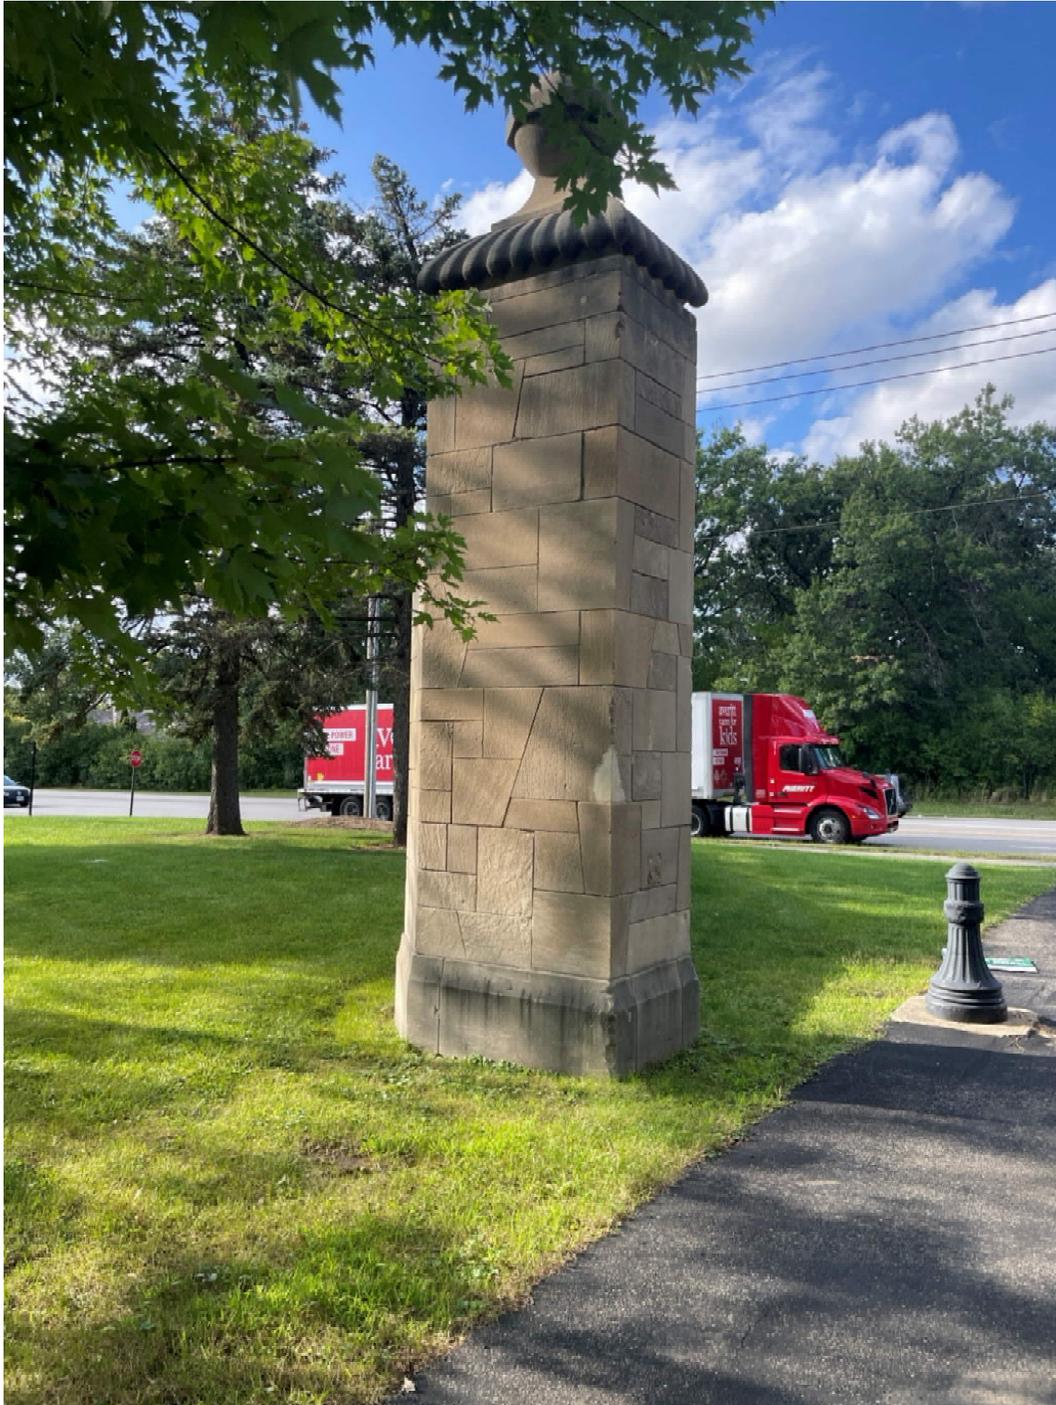
Figure 122 Gate. West pier.
