Mayslake Peabody Estate
Forest Preserve District of DuPage County

Master Plan Report

November 1, 2024

Facility Condition Assessment Report

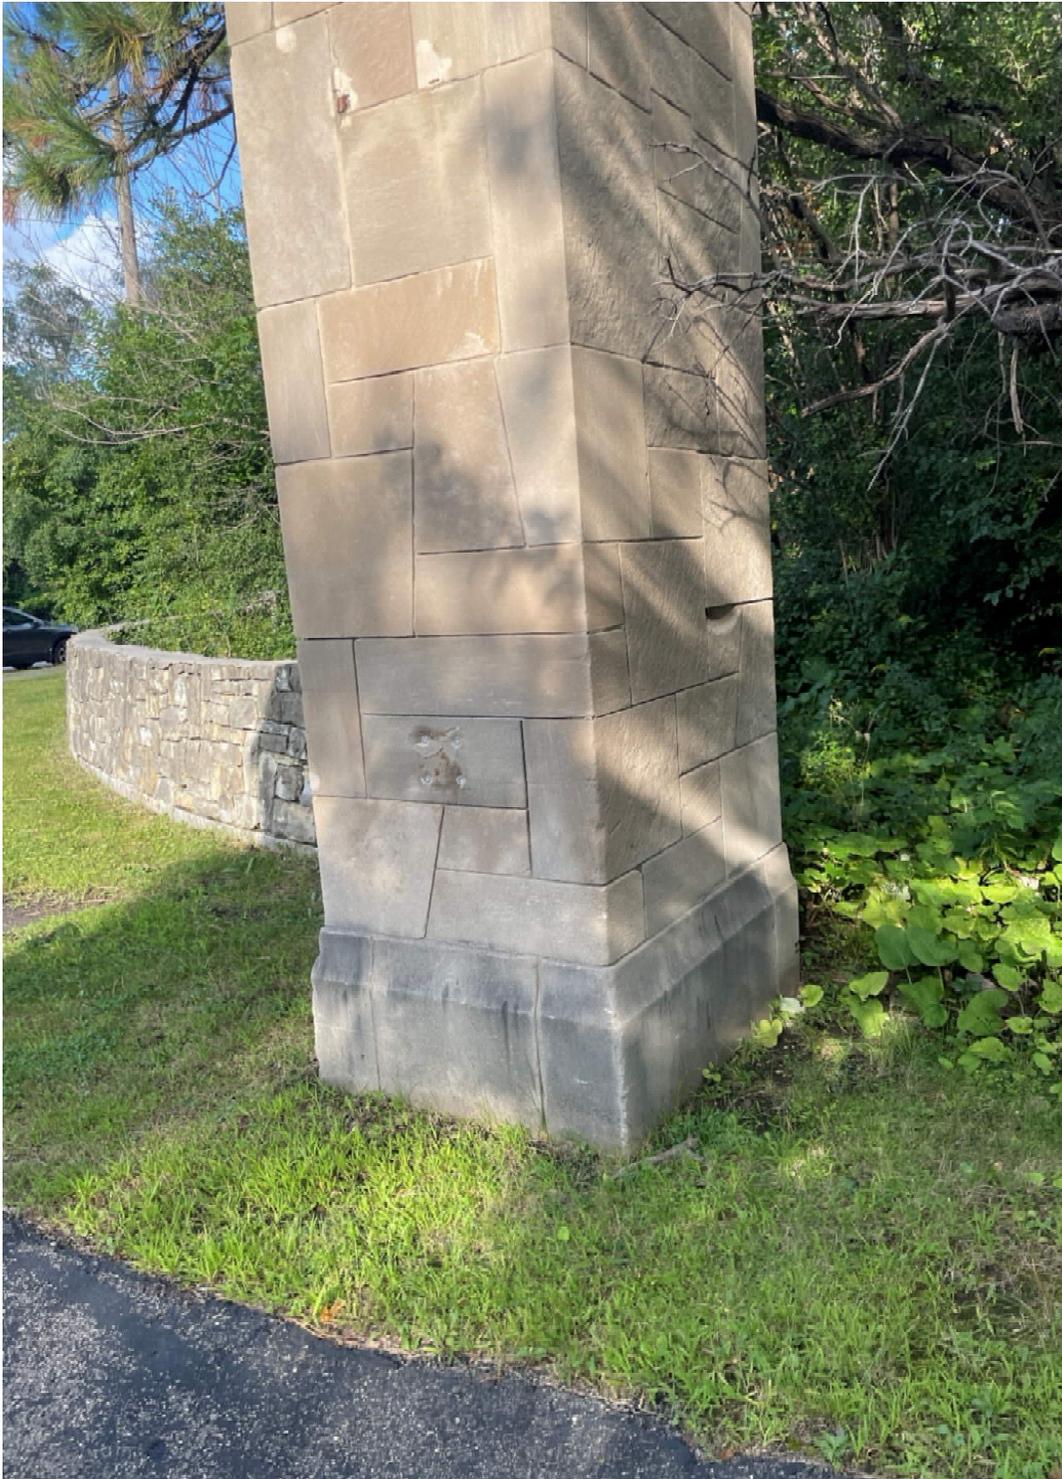
Figure 123 Gate. East pier, note embedded metal.

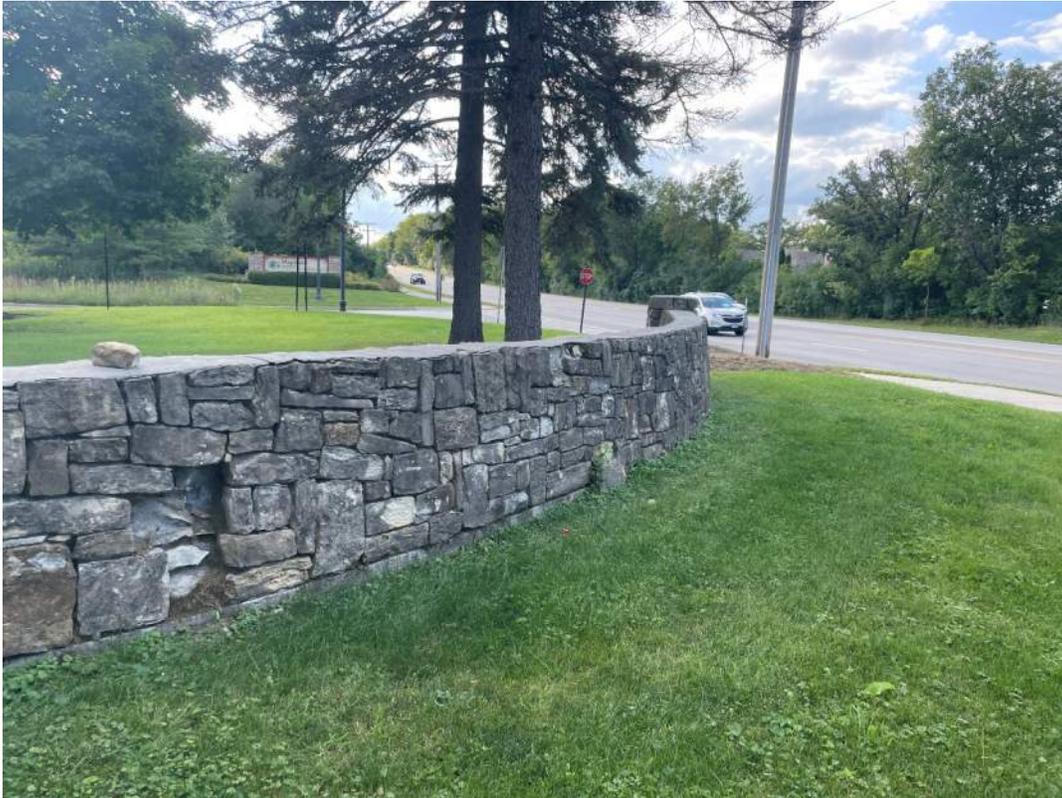
Figure 124 Gate. West low wall, note missing stone.

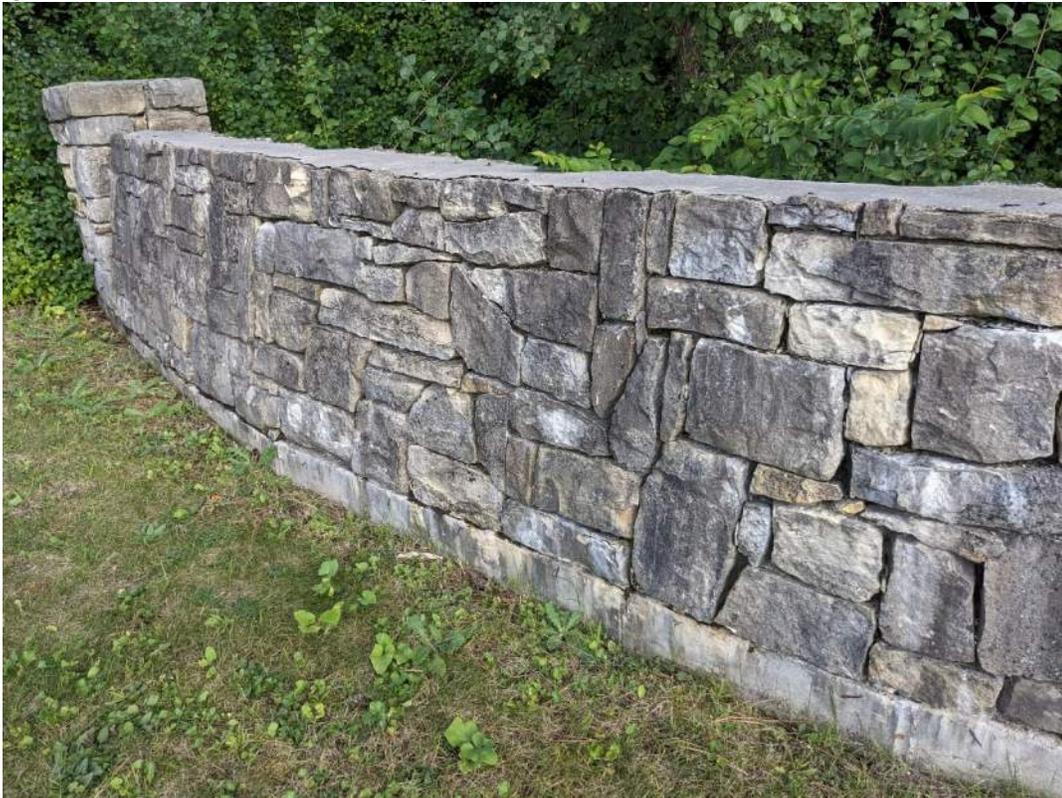
Figure 125 Gate. East low wall.

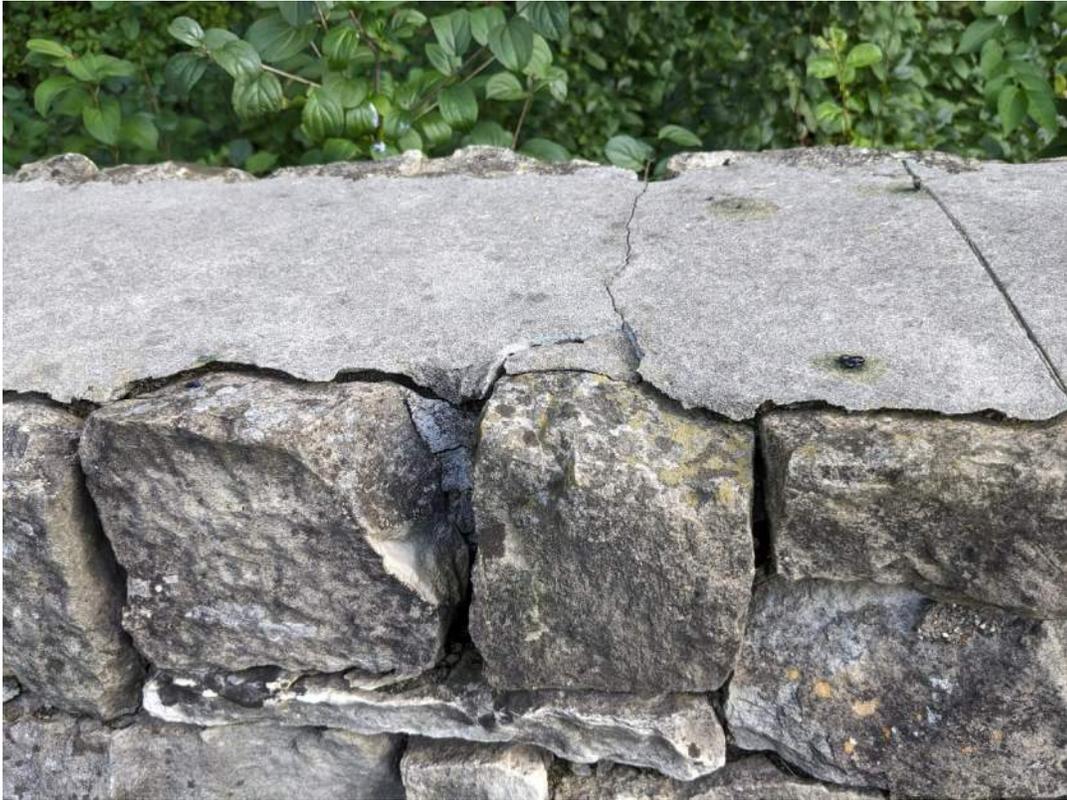
Figure 126 Gate. East low wall. Typical cementitious parge separating from wall.
